## TECHNICAL SERVICE BULLETIN

### 6.7L - Illuminated MIL With DTCs U029D, U029E, P22A7 And/Or P2209 - Built On Or Before 10-Jun-2020

**20-2067**

01 February  
2021

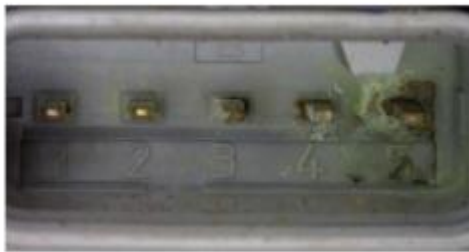
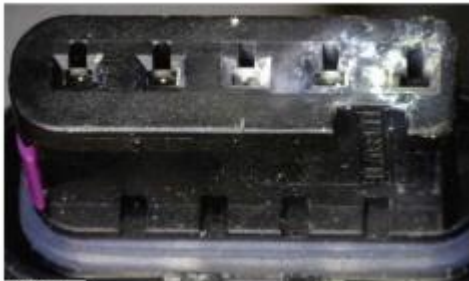
1. Disconnect the affected NOx sensor module and inspect for moisture or corrosion on the pins of the harness and module. Are there any signs of moisture or corrosion present? (Figures 1-2)
  - (1). Yes - replace the NOx sensor module. Refer to Workshop Manual (WSM), Section 303-14. Proceed to Step 2.
  - (2). No - this article does not apply. Refer to the Powertrain Controls and Emissions Diagnosis (PC/ED) Manual for normal diagnostics.
