## TECHNICAL SERVICE BULLETIN

### Illuminated ABS Warning Indicator With DTC C0020 - Built On Or Before 24-Dec-2020

**21-2030**

03 February  
2021

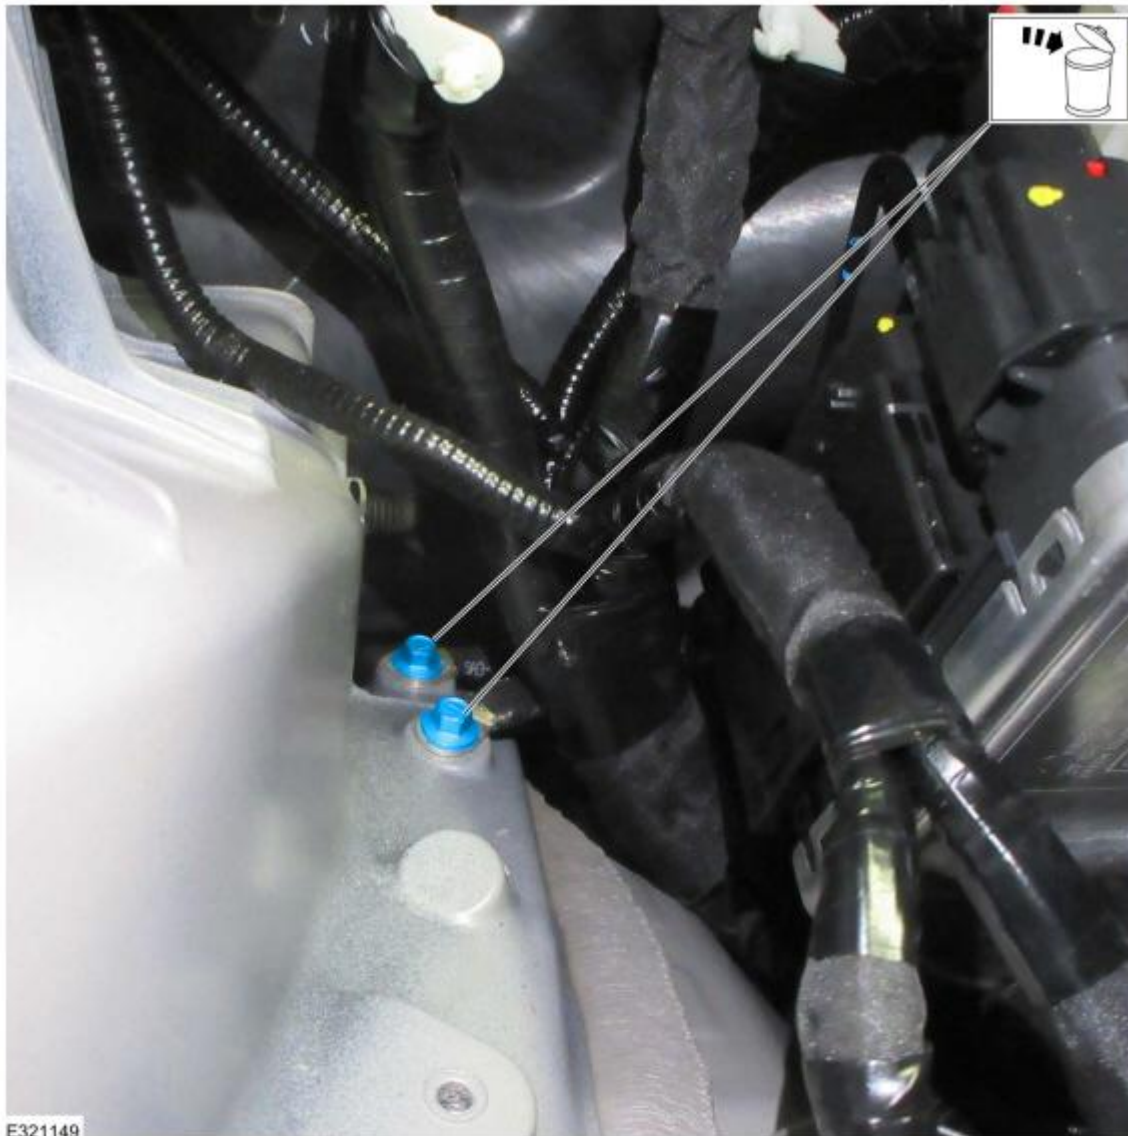
Figure 2

**Issue:** Some 2020-2021 Explorer/Aviator/Police Interceptor Utility vehicles built on or before 24-Dec-2020 may exhibit an illuminated anti-lock brake system (ABS) warning indicator lamp with diagnostic trouble code (DTC) C0020 stored in the ABS module. It may not be necessary to replace the ABS module/hydraulic control unit (HCU) to resolve DTC C0020. This may be due to a poor ground connection and/or improper plating on the attachment bolts at G108. To correct the condition, follow the Service Procedure to replace and properly tighten the ground cable fasteners.

3. Remove and discard the fasteners for ground G108. Refer to Wiring Diagram, Cell 10-4. (Figure 2)

4. Make sure no shrink tube adhesive is interfering with the fastener clamping force or ground path through the fastener. Clean as necessary with a razor blade.

5. Tighten the new fasteners securing the ground cables to 12 Nm (106 lb-in).
6. Apply Motorcraft® Electrical Grease to the fastener and ground cable eyelet.
7. To install, reverse the removal procedure.
8. Clear DTCs from the ABS module.
