MODEL  
**2019MY**  
**Niro (DE HEV/PHEV)**

NUMBER  
**211 (Rev 1, 02/23/2021)**

## TECHNICAL SERVICE BULLETIN

SUBJECT: **AEWP PARTIAL REPLACEMENT FOR DTC P2600/P0C73**

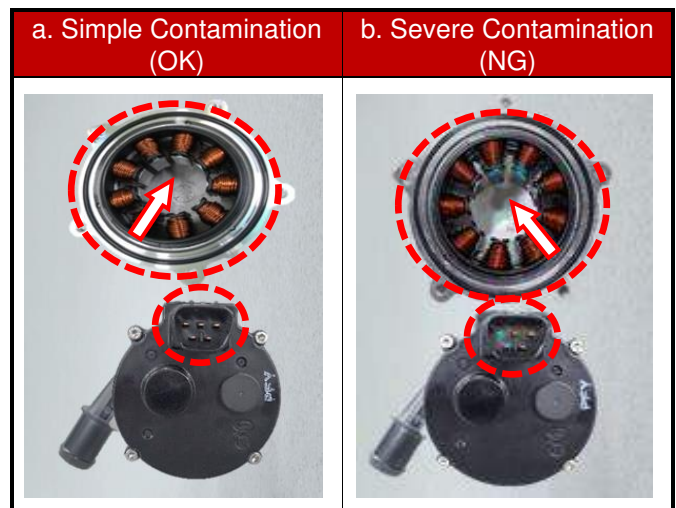
7. Check for coolant intrusion and terminal corrosion in the AEWP housing and take action according to the procedure and example photos.

- a. Simple contamination of the stator coil and power terminal:  
Clean and dry the inside and replace the Kit parts (can case, S-ring, O-ring).
- b. Severe contamination of the stator coil and terminal:  
Replace the AEWP assembly.

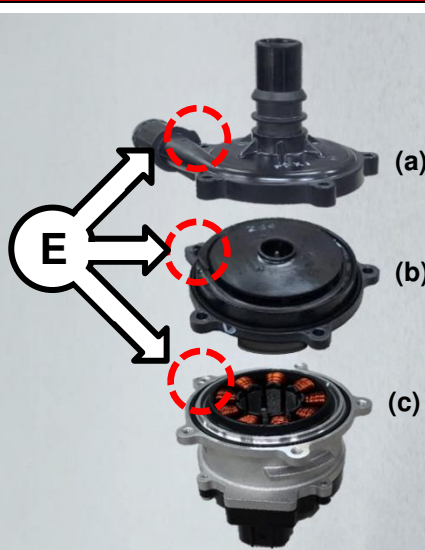
Fit "Center Ball" with "Hole" (E) when assembling Pump Cover (a) Can Case (b) and Housing (c).

- Verify that O-ring is not stuck when assembling.
- Check assembly direction when assembling pump cover, can case, and housing. If center ball and holes do not align, the assembly will not fit correctly. (Refer to diagram at right.)
