## Technical product information

| <b>Topic</b> | TPMS - Warning within the Drivers Information Panel (DIP) - DTC C1239F0 - Tyre pressure display Positioning not possible |
| <b>Brand</b> | Bentley |
| <b>Transaction No.</b> | 2061739/3 |

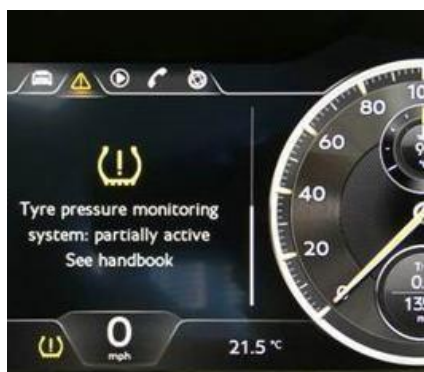
- After a 4 minute drive cycle, The (TPMS) will enter into a partially active mode and outputs a warning within the (DIP) as shown in Figure 1

NOTE: This is a pre-warning to the customer about a potential issue with the TPMS

1) Check the part numbers of all four TPMS transmitters

In the event that 5Q0907275B are fitted - Replace all four transmitters with 5Q0907275F – Refer to Rep.Gr 44 (See parts information section)

In the event that 5Q0 907 275C are fitted - Replace all four transmitters with 5Q0 907 275G – Refer to Rep.Gr 44 (See parts information section)

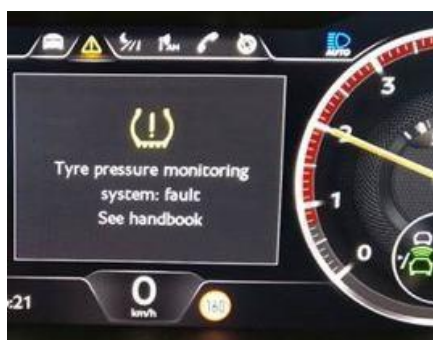
- Should the TPMS control unit not receive any information after a further 5 minutes, the TPMS warning will be as shown in Figure 2
