# Technical Service Bulletin

## 90 Drive select menu is greyed out in the MMI, DTC U111000 is stored in the information electronics control module

90 21 94 2061989/2 March 4, 2021. Supersedes Technical Service Bulletin Group 90 number 21-86 dated January 28, 2021 for reasons listed below.

| Model(s) | Year | VIN Range | Vehicle-Specific Equipment |
|---|---|---|---|
| Q5, SQ5 | 2021 | All | Not Applicable |

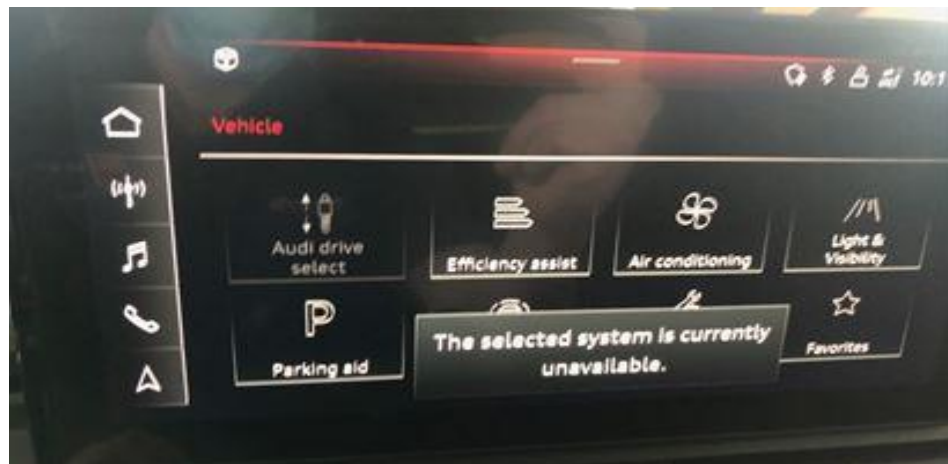
- The drive select menu is greyed out in the MMI and the message "The selected system is currently unavailable" appears (Figure 1).

**Figure 1.** Drive select is unavailable.

If the above condition and DTC are present, perform the replacement test plan for the Gateway, J533 (address word 0019) as follows:
