# Technical Service Bulletin

## 96 Lane change assist does not work, DTCs C1114F0 and C1114F3 stored in lane change assistance control modules

96 21 62 2048470/3 March 2, 2021. Supersedes Technical Service Bulletin Group 96 number 19-37 dated April 17, 2019 for reasons listed below.

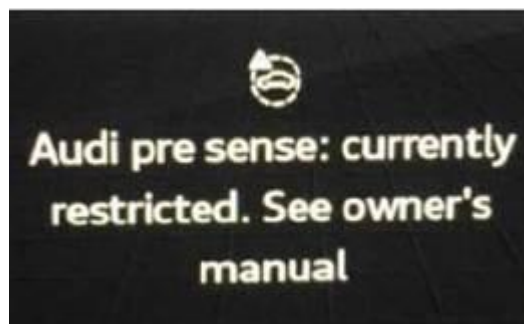
- A message in the instrument cluster, "Audi pre sense: currently restricted. See owner's manual" (Figure 1).

Figure 1. Message in the instrument cluster.

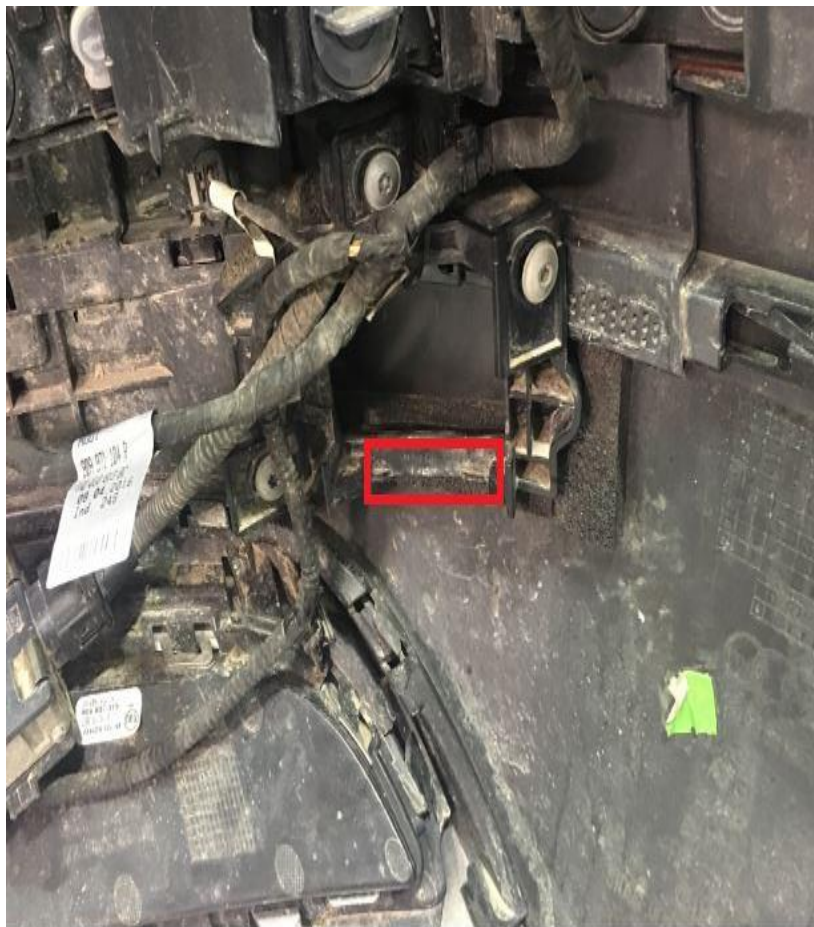
*Figure 2. Bracket part number located on driver's side.*

1. Before removing the bumper, check the bracket part numbers (Figures 2 - 3). If they are not part numbers 80A 907 908 B and 80A 907 907 B then proceed with the instructions below.

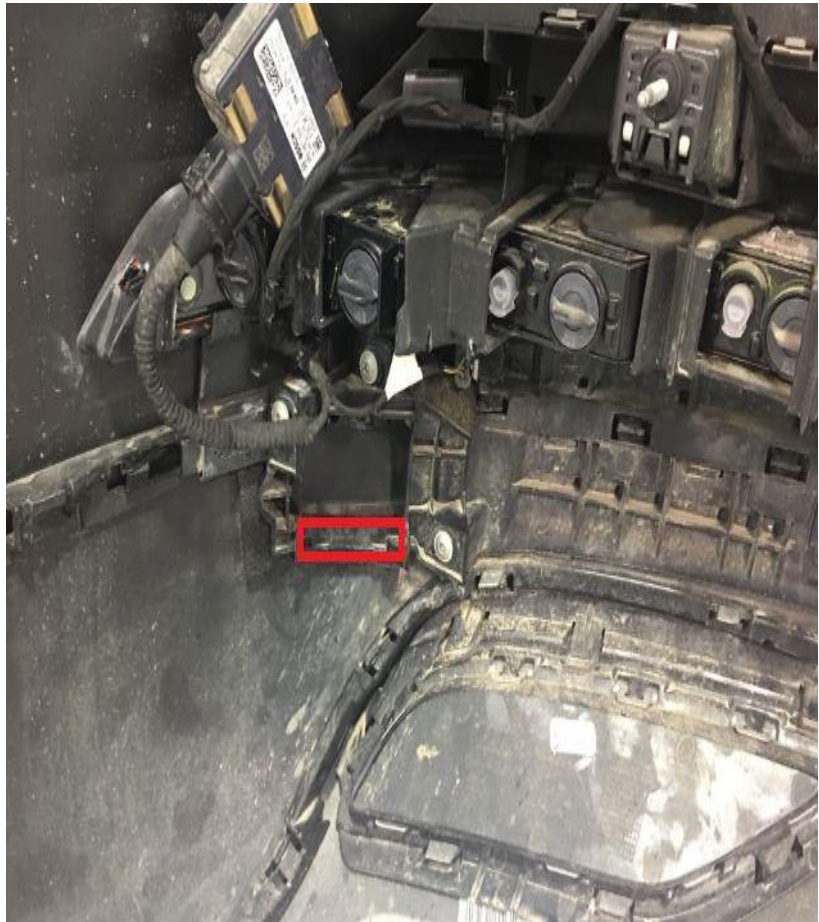
**Figure 3.** Bracket part number located on passenger's side.

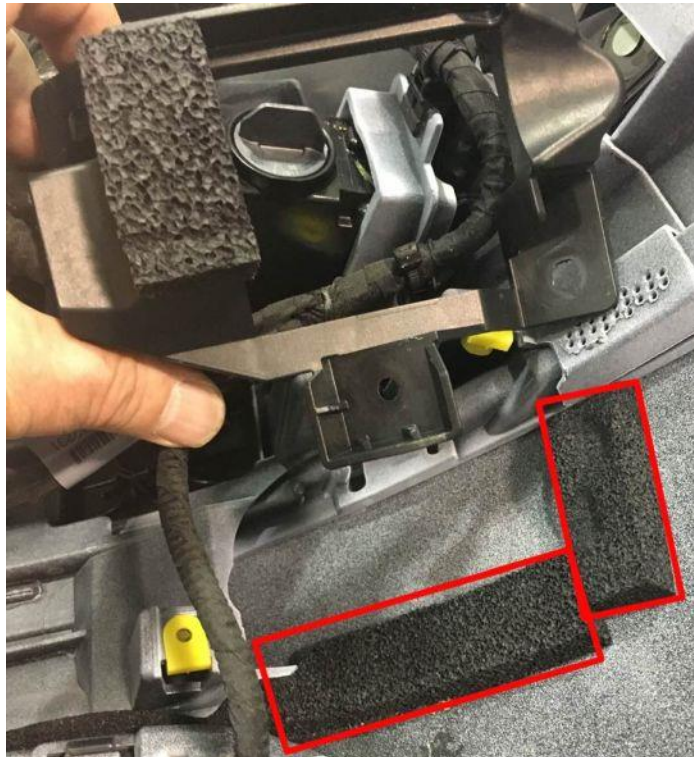
The fault most likely was caused by the improper installation of foam which interferes with the sensor's field of view.

*Figure 4. Foam to be stripped out.*

3. Strip out any foam that is glued to the bumper (Figure 4) marked in the red areas (Figure 5).

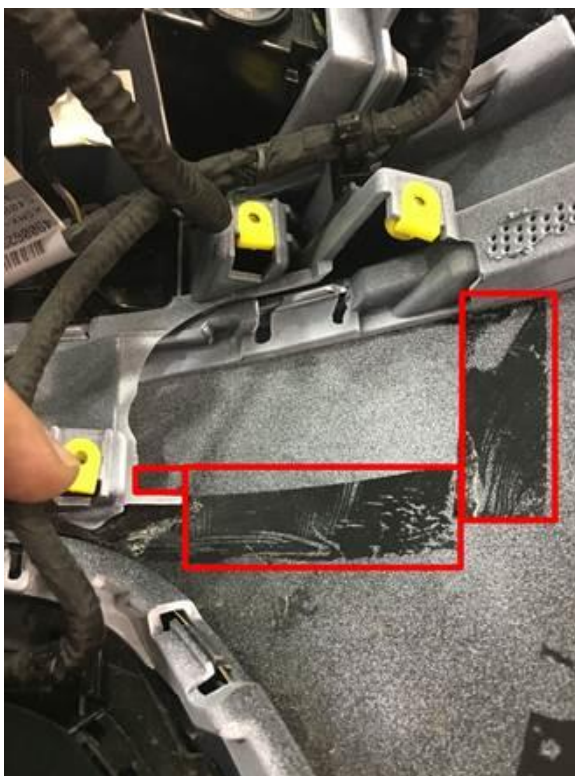
*Figure 5. Removed foam.*

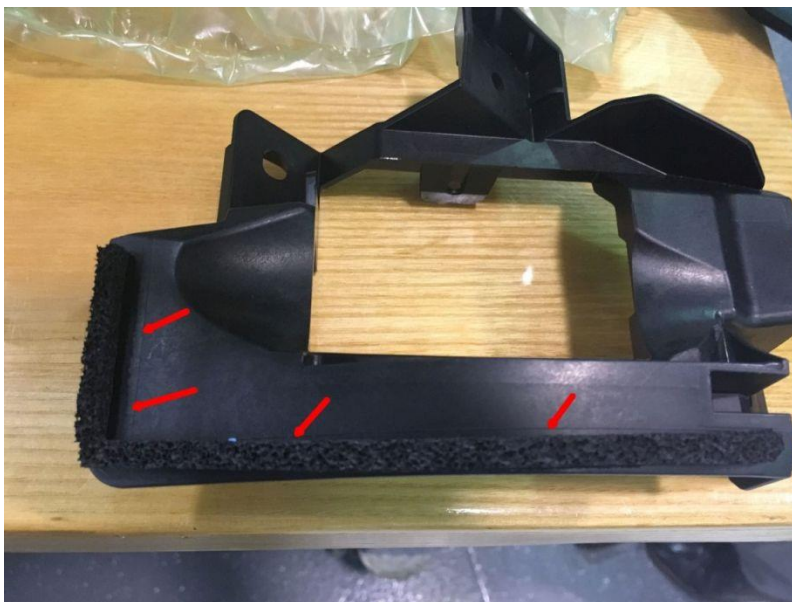
*Figure 6. Indication marks for new foam.*

4. Prepare the new brackets 80A 907 908 B and 80A 907 907 B by applying the foam strips 80A 807 549.

The brackets have indication marks to help to position the foam (Figure 6).
