# MIL ON With DTC P211904 - 2GR-FKS (6MT)

## Applicability

| YEAR(S) | MODEL(S) | ADDITIONAL INFORMATION |
|---|---|---|
| 2016 - 2020 | Tacoma | |

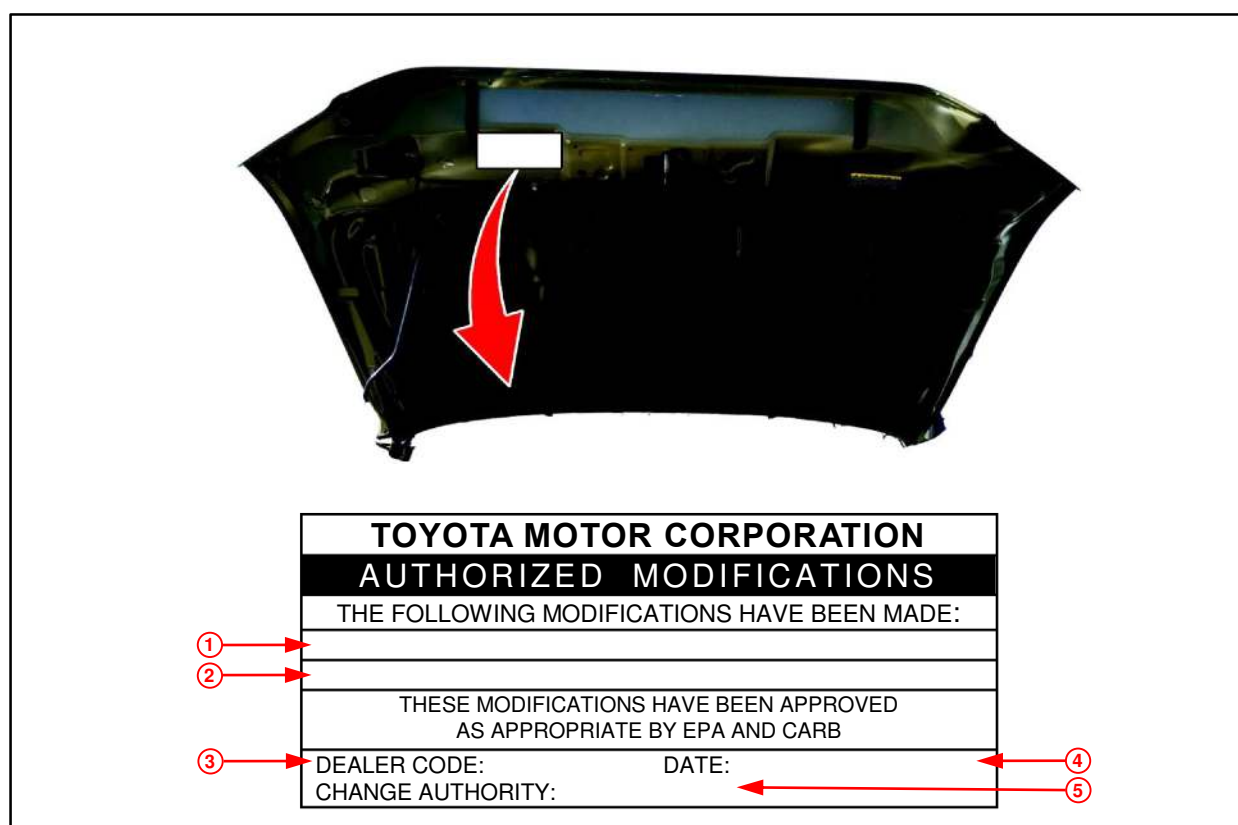
**Figure 1. Location of Authorized Modifications Label on 2016 – 2020 Tacoma**

2. Use Techstream to confirm if the ECM (PCM) calibration has been updated and check for the Authorized Modifications Label affixed to the vehicle in the location shown below.

4. Prepare and install the Authorized Modifications Label.
  - A. Using a permanent marker, enter the following information on the label:
    - ECM (PCM) part number [*Refer to the **Parts Information** section for the **NEW PART NUMBER**.*]
    - Calibration ID(s) [*Refer to the **Calibration Information** section for the **NEW CALIBRATION ID**.*]
    - Dealer Code.
    - Repair Date.
    - Change Authority [***This bulletin number**.*]
  - B. Install the Authorized Modifications Label onto the vehicle at the location shown in Figure 1. The Authorized Modifications Label is available through the MDC, P/N 00451-00001-LBL.
5. Test-drive the vehicle to confirm proper operation.
