## SERVICE BULLETIN

**APPLICABILITY:** 2019MY Forester

**NUMBER:** 07-192-21

**SUBJECT:** DTCs B112C and / or B112E in Driver Monitoring System (DMS)

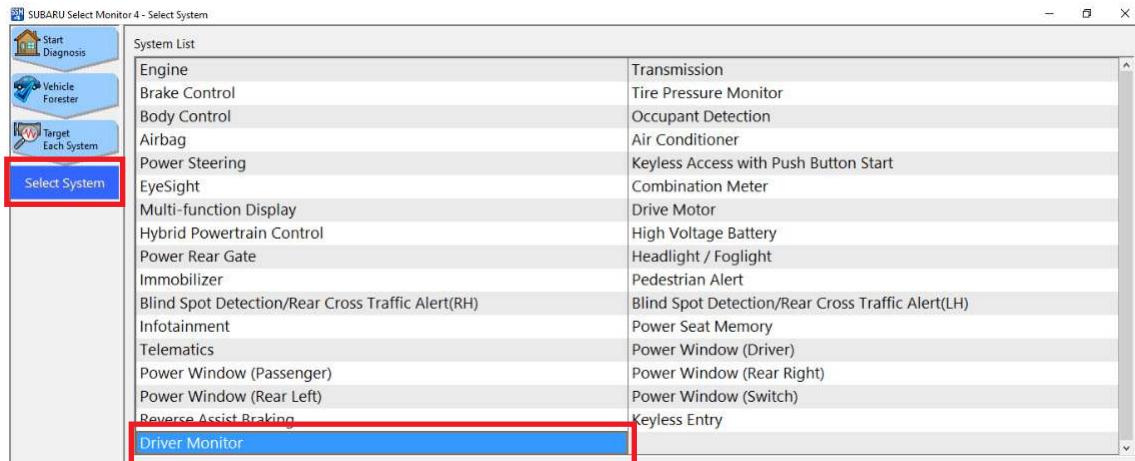
**Step 5)** Check the ROM ID numbers of the DMS C/M using the screen shots below as a guide:

Go to: Diagnosis > Each System > select Driver Monitor from the System List.

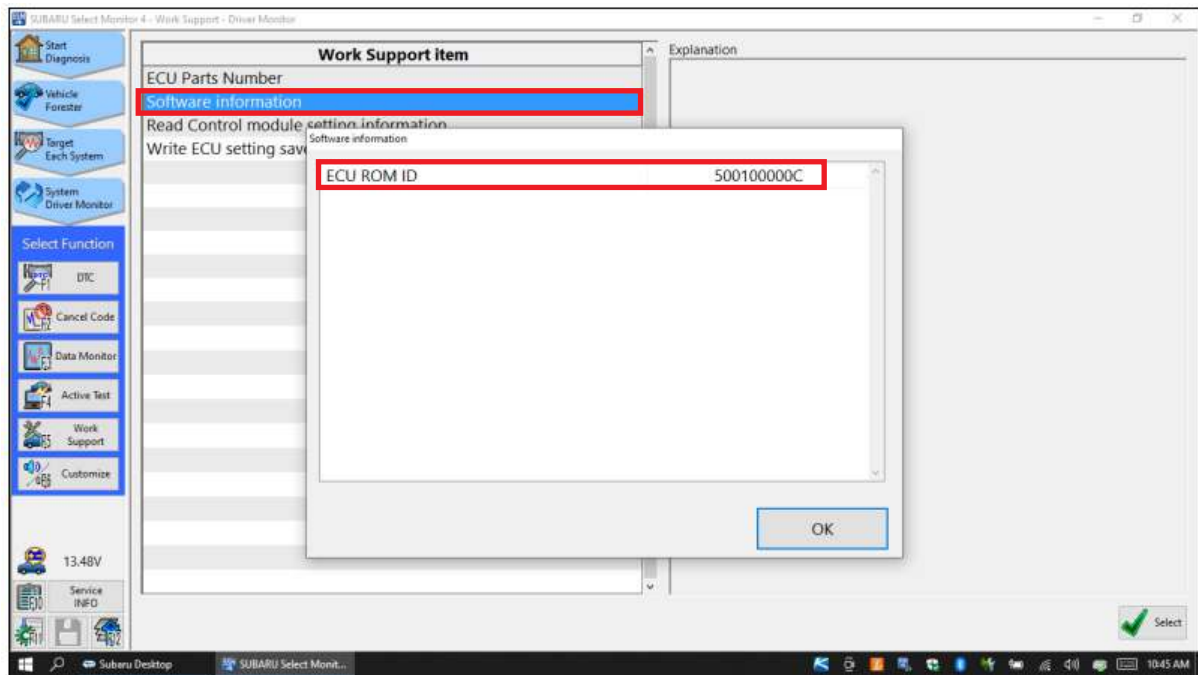
To check the ROM ID, select Software information to display the ROM ID.

**CHECK:** Is the ROM ID 50 0\* 00 00 09, 50 0\* 00 00 0C or 50 0\* 00 00 0D?

**YES:** Proceed with reprogramming the DMS using the normal FlashWrite procedure. Use the Pack File table above to select the proper reprogramming files from the FlashWrite result after entering the Vehicle Spec. parameters.
