ITB19-024A

March 5, 2021

## DTC B00A0-00 STORED

APPLIED VEHICLES: 2009-2013 FX (S51) 2011-2013 QX56 (Z62)  
2013 JX35 (L50) 2014-2020 QX60 (L50)  
2014-2021 Q50 (V37) 2014-2017 QX60 Hybrid (L50H)  
2014-2018 Q50 Hybrid (HV37) 2014-2017 QX70 (S51)  
2017-2021 Q60 (CV37) 2014-2021 QX80 (Z62)  
2019-2021 QX50 (J55)

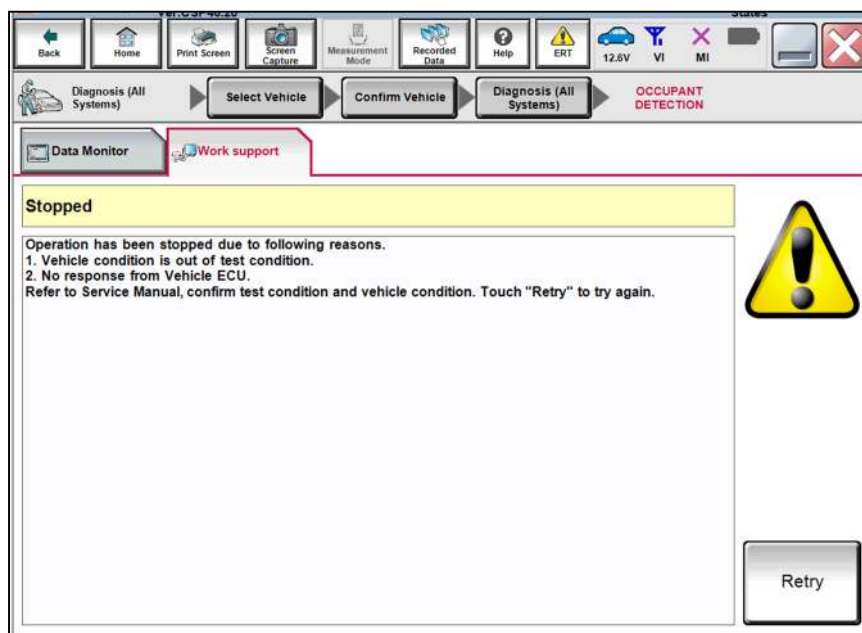
Figure 1

DTC B00A0-00 (OCCUPANT DETECTION SENSOR UNIT) is stored,

OCS zero point reset cannot be performed,

The following screen will display:

1. Check the Occupant Classification System (OCS) control unit using the ODS Analysis tool software.
  - Refer to SERVICE PROCEDURE on the next page.

2. Perform "75-zero RESET".
