## SERVICE BULLETIN

TF15-001A

NTB15-021A

### 2013 – 2014 PATHFINDER 4WD ERROR DISPLAYED AND DTC C1204 STORED

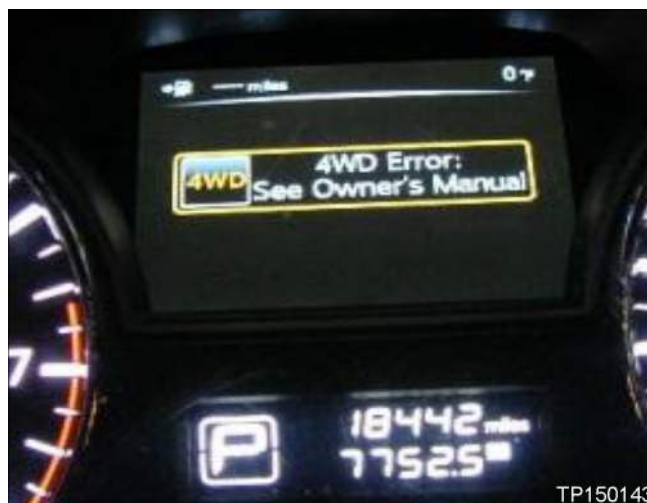
Figure 1

The vehicle has been operated in cold weather, below approximately -18°C (0°F),

“4WD ERROR” is displayed in the Vehicle Information Display,

DTC C1204 (4WD Solenoid) is stored.

Replace the 4WD Control Unit.
