# SERVICE BULLETIN

RS19-004A

NTB19-071A

## DTC B00A0-00 STORED

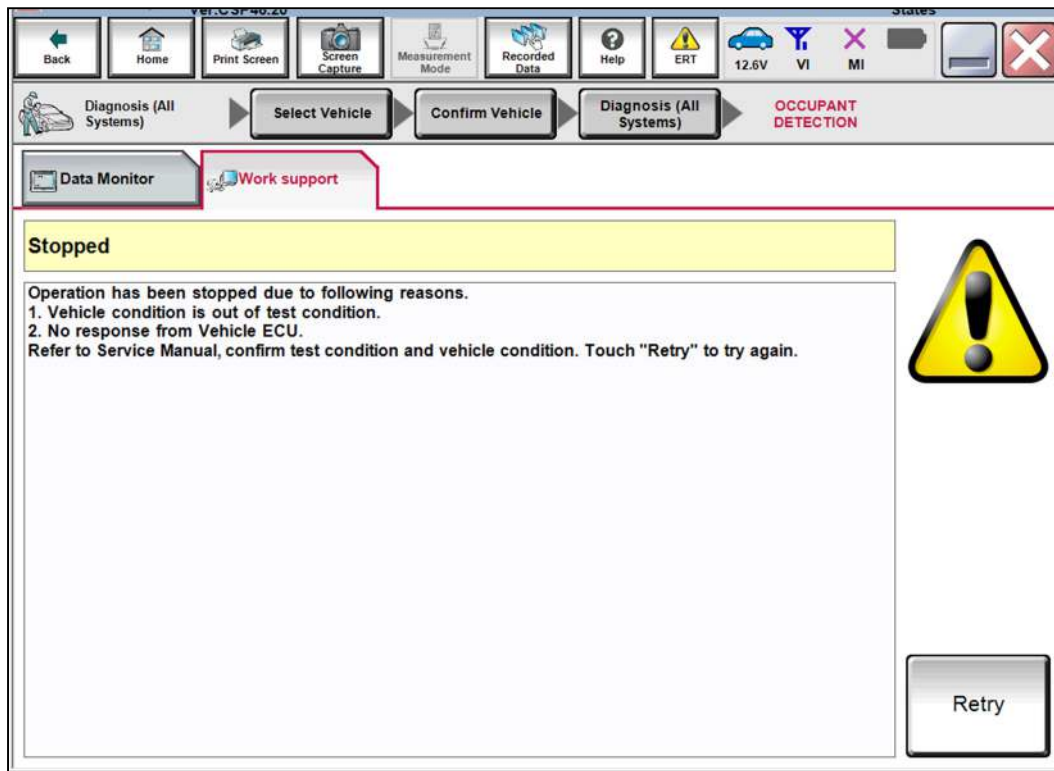
Figure 1

DTC B00A0-00 (OCCUPANT DETECTION SENSOR UNIT) is stored,

OCS zero point reset cannot be performed (continued on the next page)

The following screen displays:

1. Check the Occupant Classification System (OCS) control unit using the ODS Analysis tool software.

2. Perform "75-zero RESET".

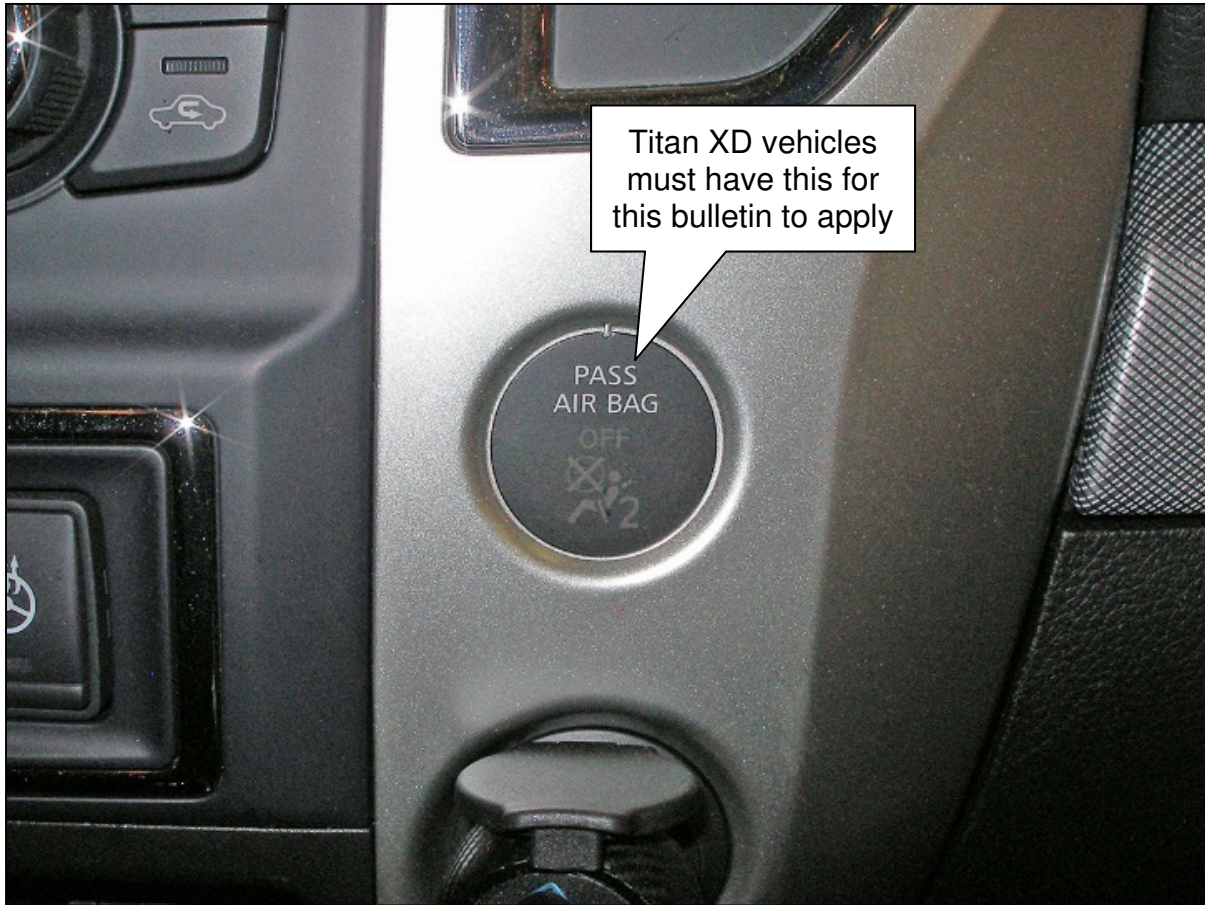
Figure 3

- Titan vehicles: This bulletin applies to ALL Titan vehicles.
- Titan XD vehicles: This bulletin does NOT apply to all Titan XD vehicles. This bulletin applies to Titan XD vehicles equipped with OCS, as indicated by the presence of a front passenger air bag status light (see Figure 3).

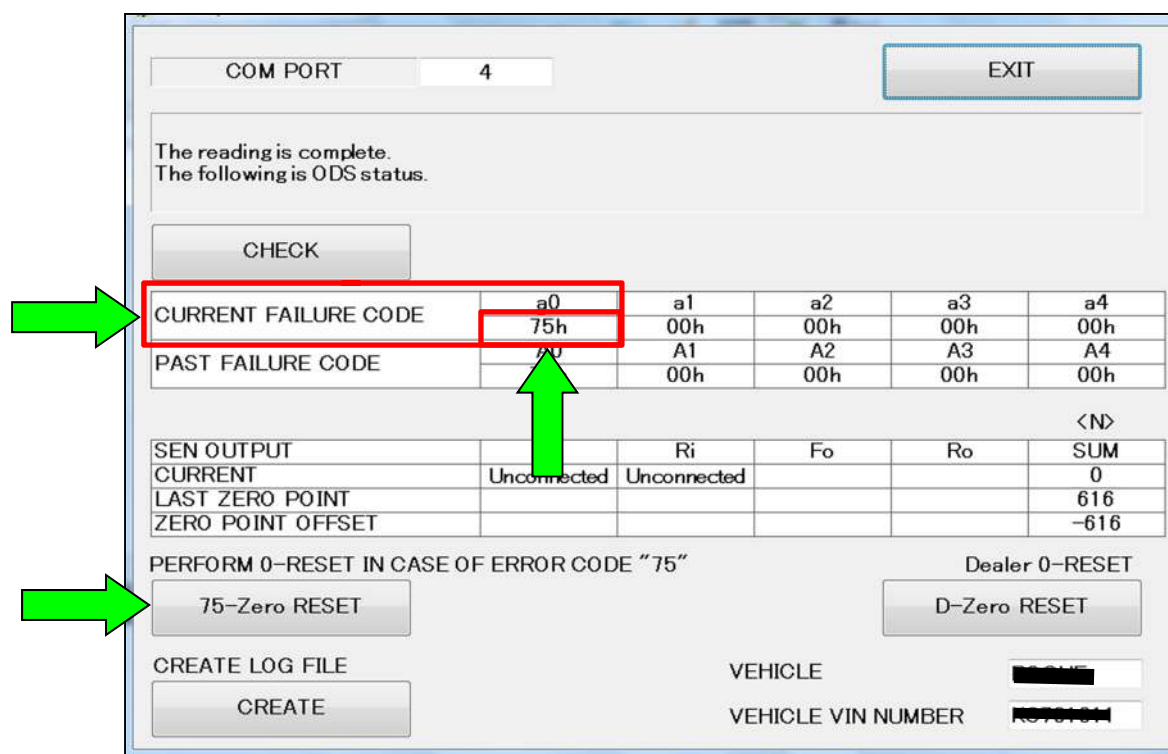
Figure 7

12. Check for code 75h to show under **CURRENT FAILURE CODE**.

- If code 75h shows under **CURRENT FAILURE CODE**, go to step 13.
- If code 75h does NOT show under **CURRENT FAILURE CODE**, STOP HERE. This bulletin does not apply. Refer to ASIST and the ESM for further diagnostic assistance.

13. Select **75-Zero RESET**.

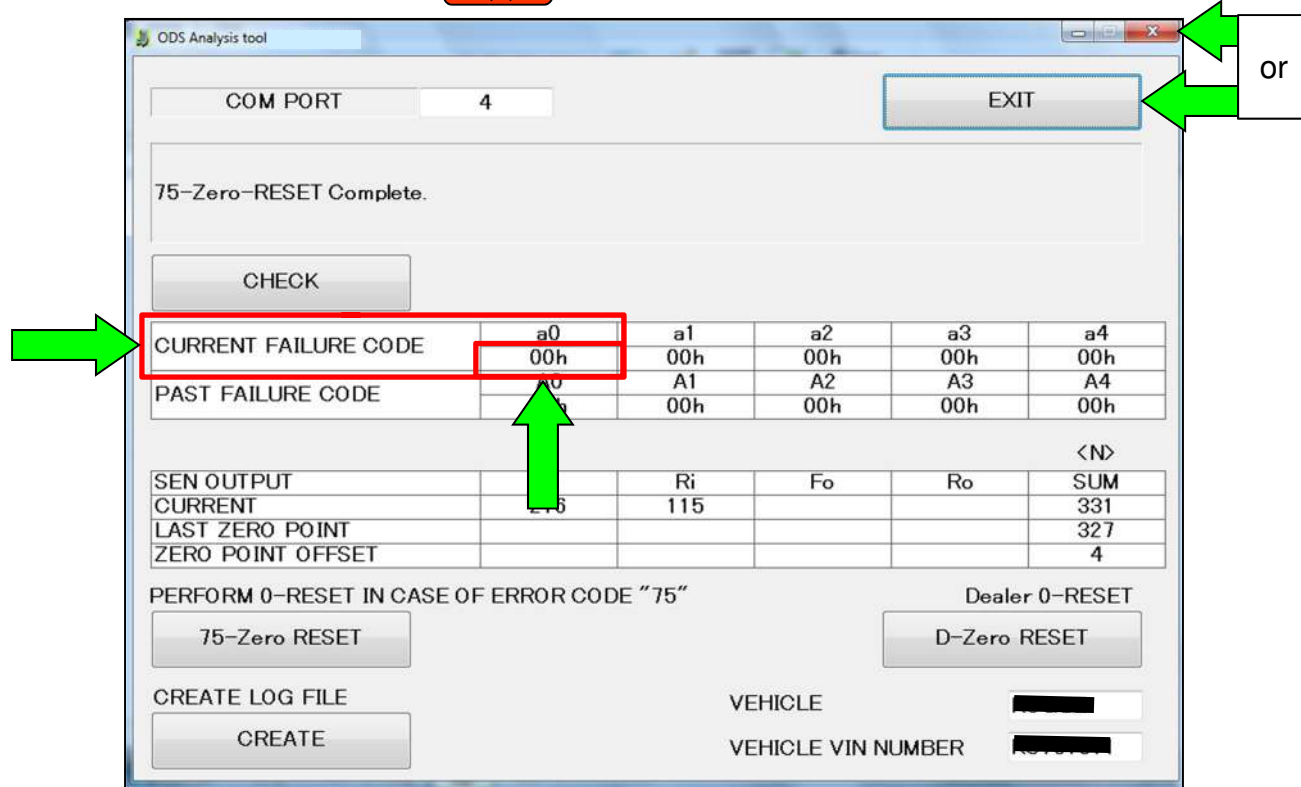
17. When the screen in Figure 10 displays, the 75-zero reset process is complete.
  - Verify code 75h is not displayed under **CURRENT FAILURE CODE**.
18. Select either **EXIT** or the

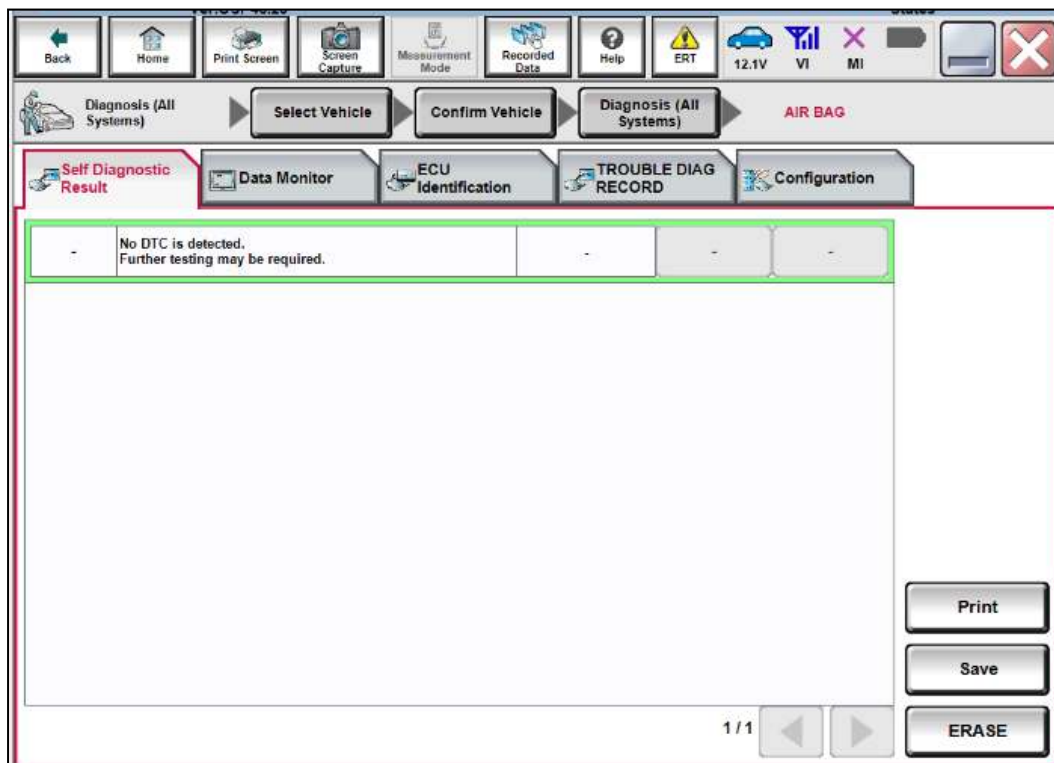
- After selecting **Close**, the screen in Figure 17 should display (the DTC is erased).
