Preliminary Information

PIP5495M Check Engine Light On With P0299 Or P0234

| Cause: | Misdiagnosis Leading to Returned Turbochargers with NTF |

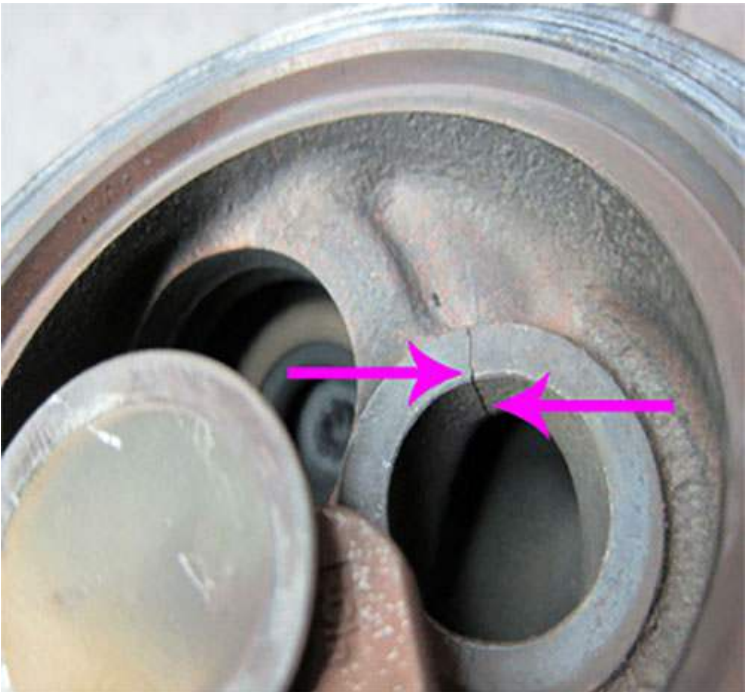
Crack(s) at the wastegate valve port (this is normal and does not affect performance)

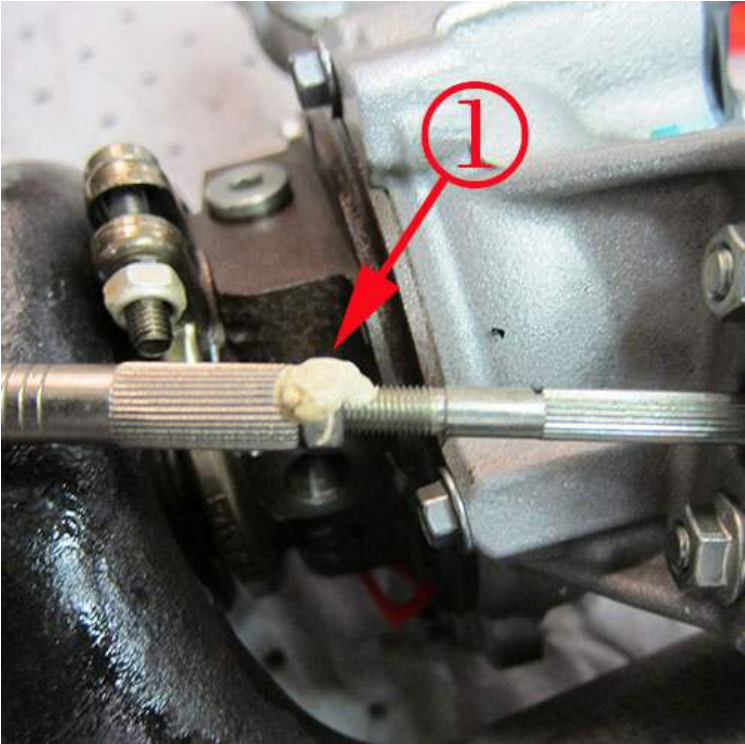
Wastegate actuator clip missing (replace wastegate actuator clip - released for service)

If the tamper paint seal is broken or missing, check the vehicle for any additional sign of modification to the induction, exhaust, or engine calibrations as this may indicate an attempt to adjust the wastegate arm to modify the powertrain operation.

If found, review the powertrain warranty status with your service manager prior to performing repairs

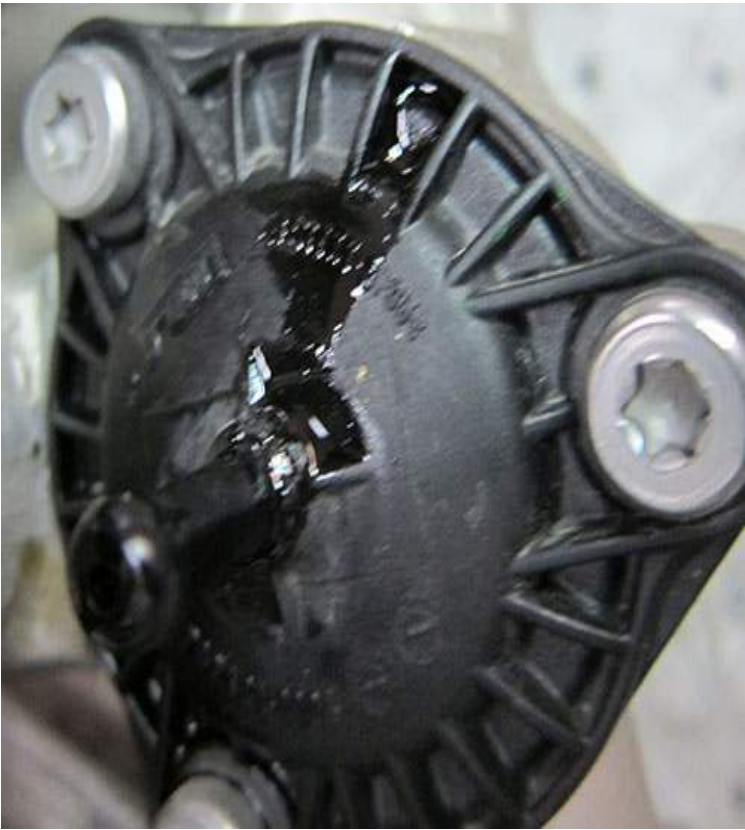
Bypass (recirculation) valve cover port broken or water/oil found inside the valve (clean the components, if necessary replace bypass (recirculation) valve assembly - released for service)

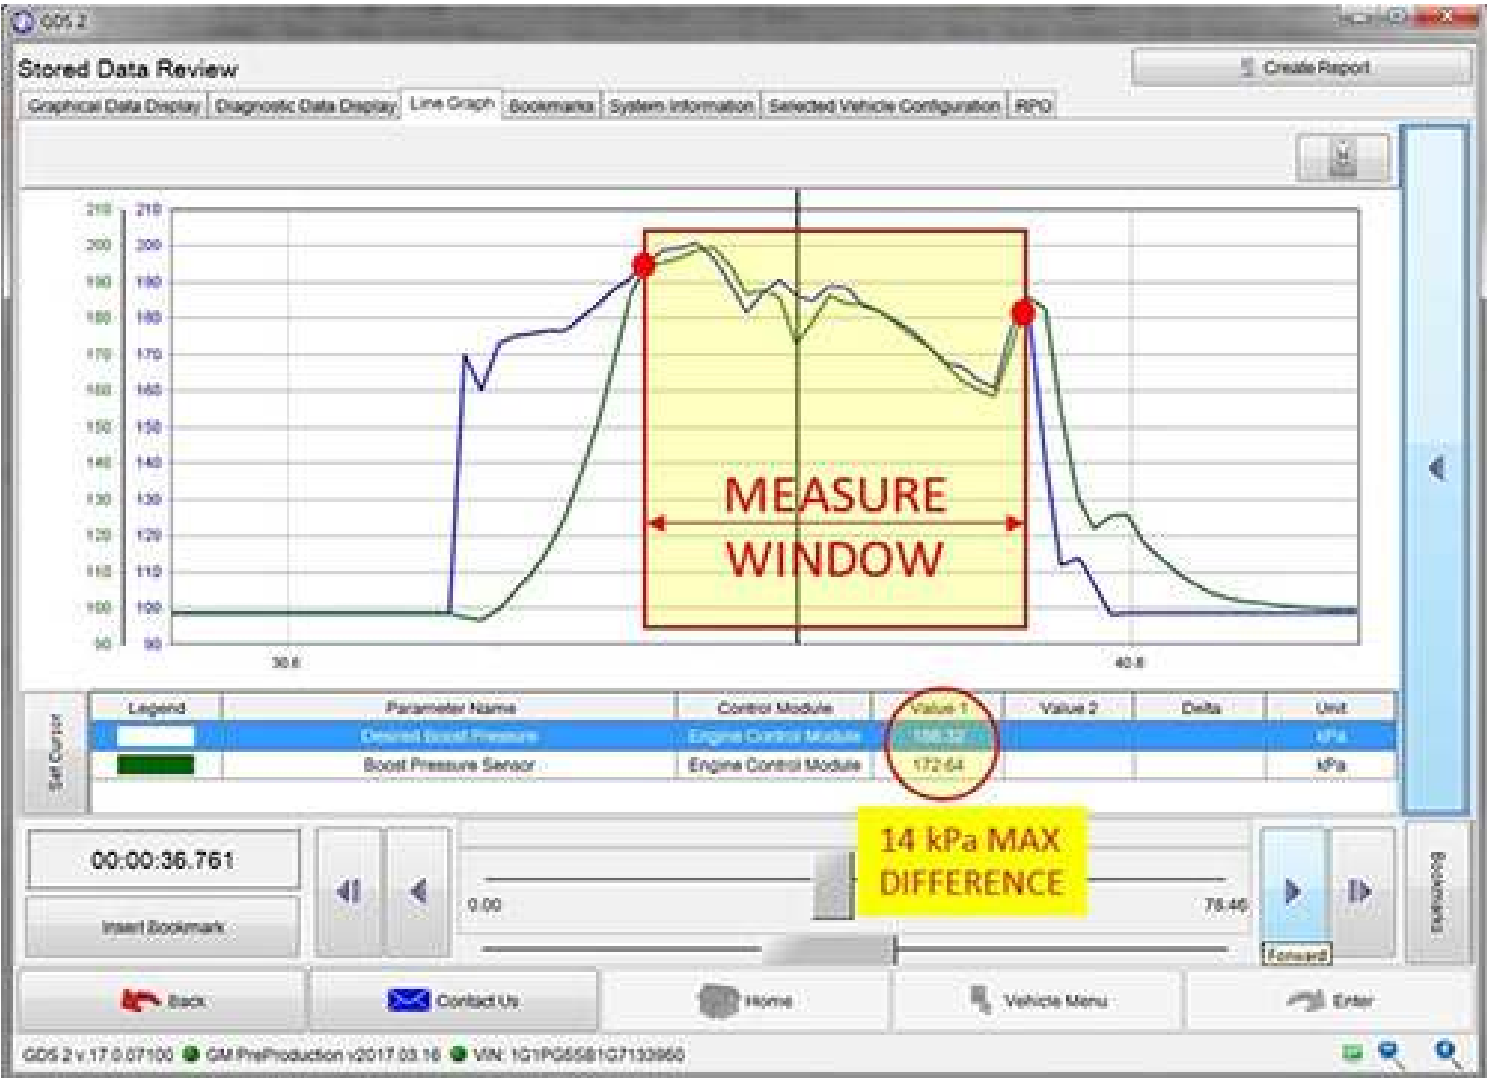
Example of normal turbocharger wastegate operation:

In this example, notice that the measure window begins once the Boost Pressure Sensor reading (Green) meets the Desired Boost Pressure reading (Blue) and ends when the APP is released per the testing instructions.

The Boost Pressure Sensor reading (Green) closely tracks the Desired Boost Pressure reading (Blue) indicating normal Turbocharger operation.
