**NUMBER:** 18-010-21 REV. A

**GROUP:** 18 - Vehicle Performance

Flash: Powertrain Control Module (PCM) Updates

This bulletin involves reprogramming the Engine Control Module (ECM) / Powertrain Control Module (PCM) with the latest available software.

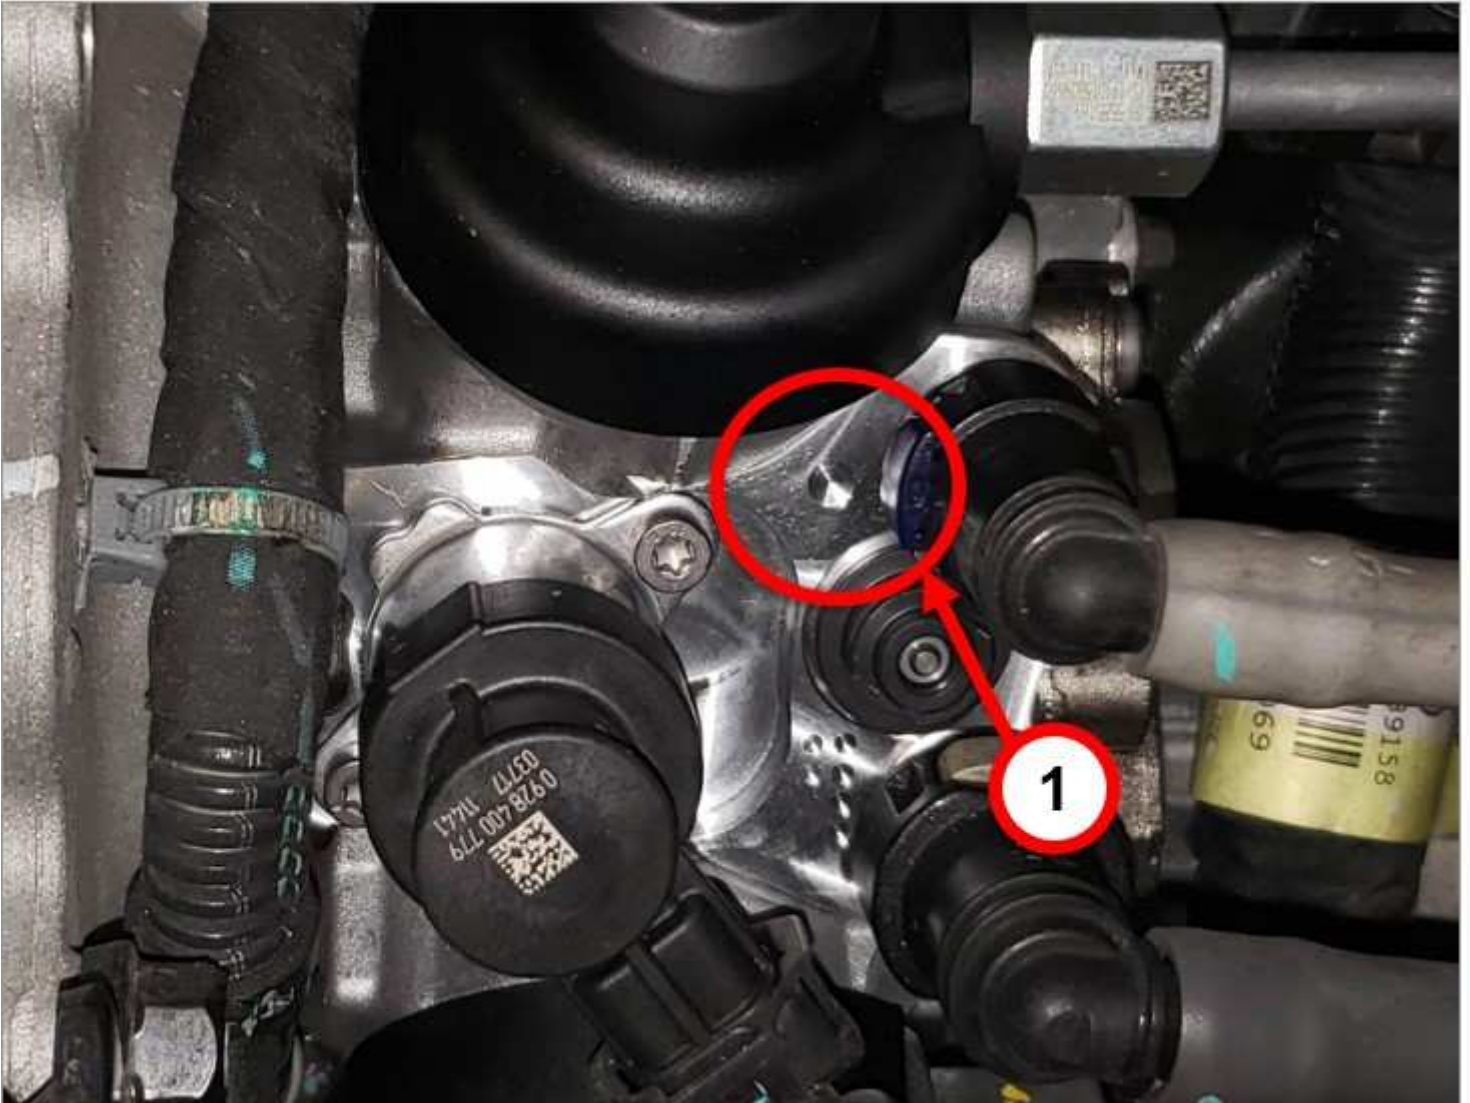
1. Inspect the fuel injection pump to see which pump the vehicle has:
  - Vehicles with the new style Symmetrical Cam design pump will have one large single dot embossed in the pump housing (Fig. 1)
  - For vehicles equipped with a Symmetrical Cam pump, choose the calibration labeled Symmetric Cam, or Sym Cam.

**Fig. 1**  
**New Style Symmetrical Cam Design Pump**

1 - One large Single Dot on Housing

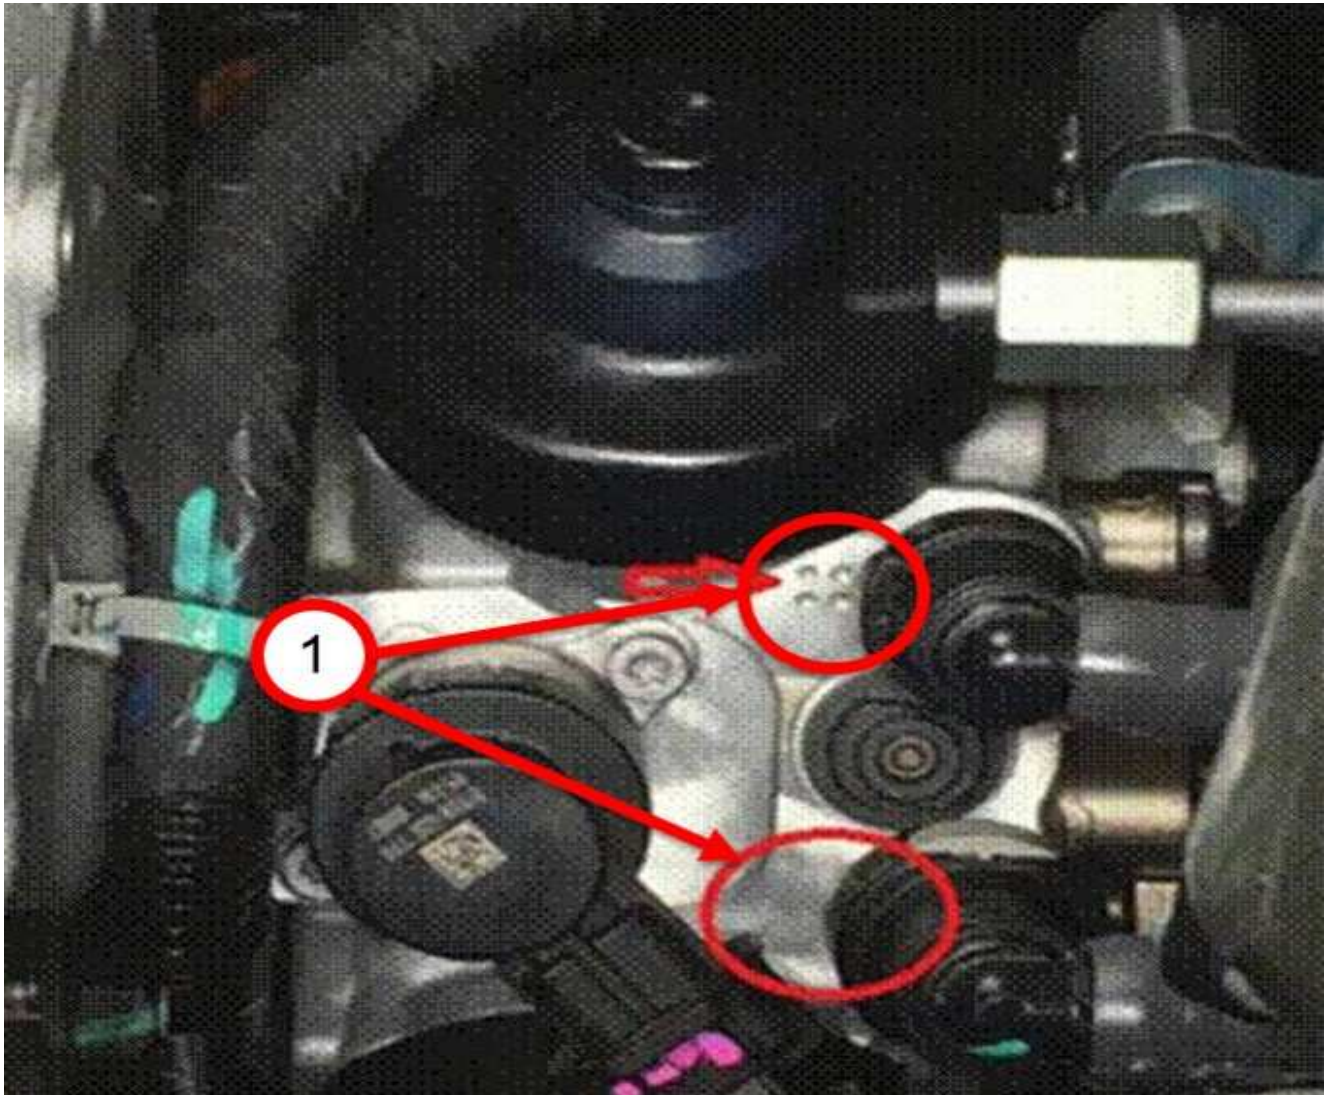
- Vehicles with the old style Asymmetrical Cam design will have multiple dots embossed in the pump housing (Fig. 2) .
- For vehicles with an Asymmetrical Cam pump, choose the calibration labeled Asymmetric Cam or Asym Cam.

**Fig. 2**  
**Old Style Asymmetrical Cam Design Pump**

1 - Multiple Dots on Housing
