## TECHNICAL SERVICE BULLETIN

### Slow Fill And/Or Illuminated MIL With DTCs P0171, P0174, P0451, P0455, P0456, P0496 And/Or P1450 - Built On Or Before 30-Nov-2020

**21-2106**

| Ford<br>2017-2021 Transit |

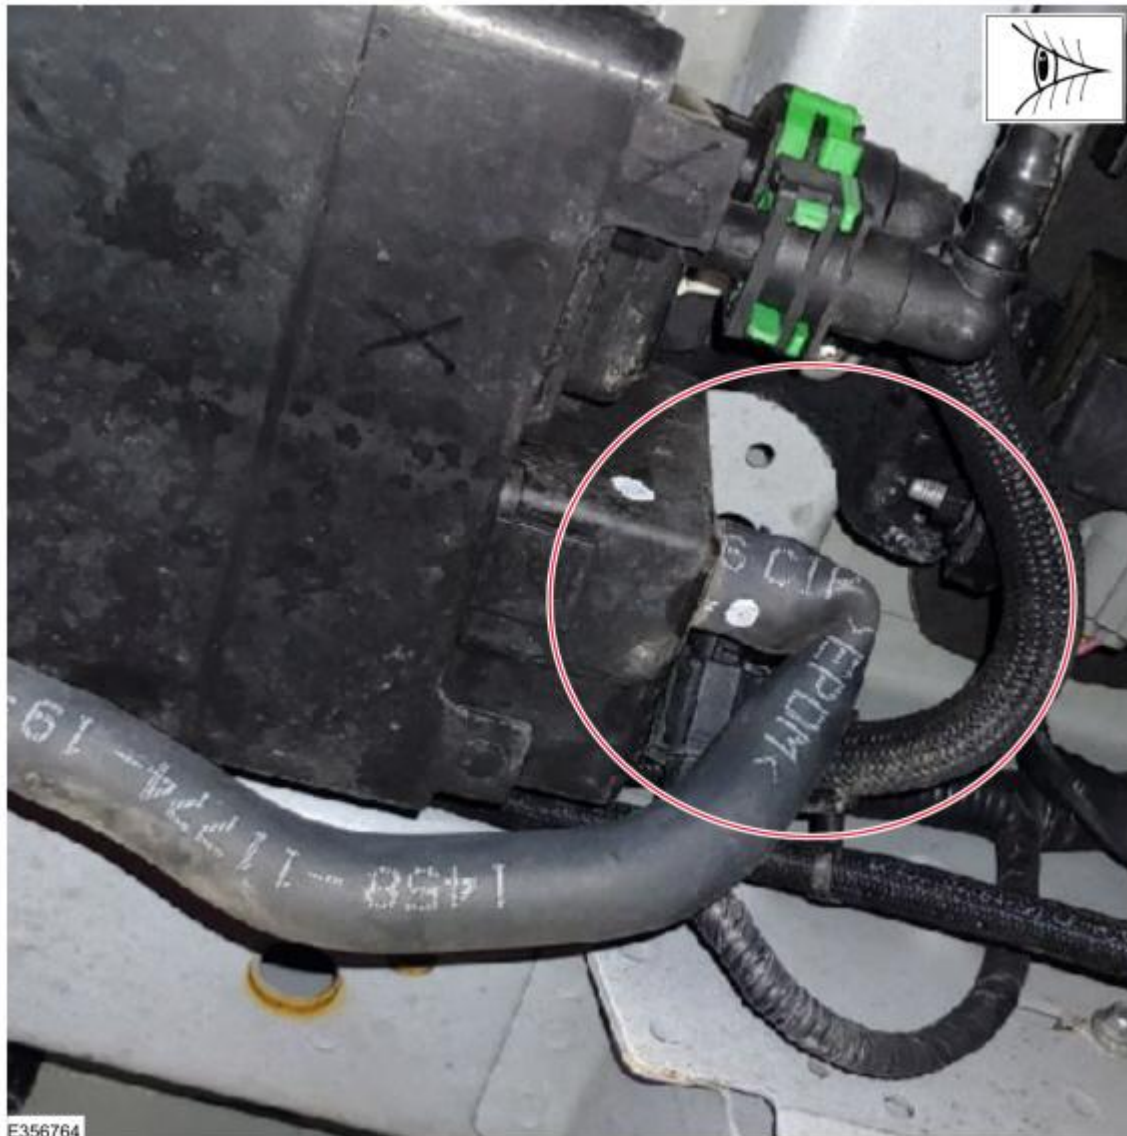
Figure 1

1. Inspect the evaporative emissions fresh air vent line near the carbon canister. Is the line kinked? (Figure 1)
  - (1). Yes - proceed to Step 2.
  - (2). No - this article does not apply. Refer to the Workshop Manual (WSM), Section 303-13 for normal diagnostics.
