# Technical Service Bulletin

**94 Various warnings displayed in cluster, DTCs U121C00, U011000, U003600, U002800, U002900, U140500, P0A2F00, P0A1B00**

94 21 37 2063075/1 April 30, 2021.

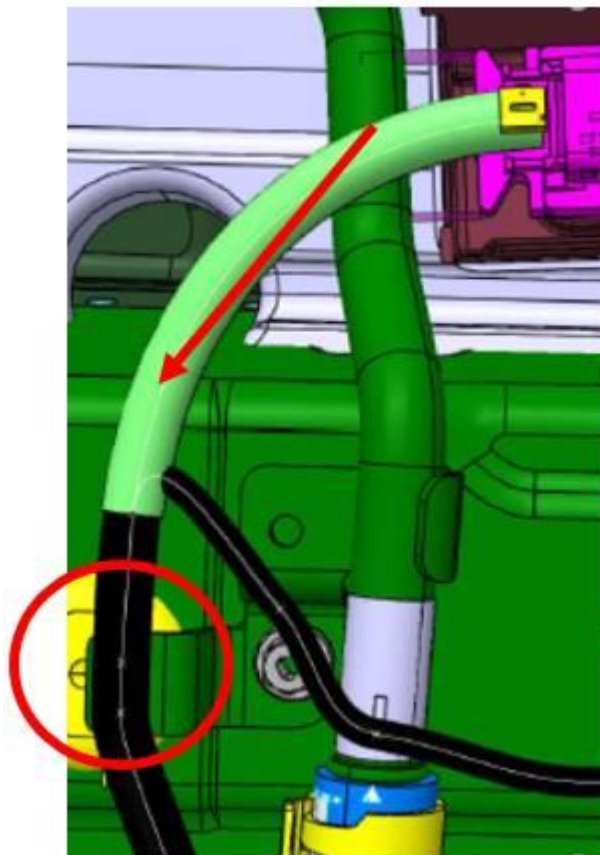
**Figure 2.** *Harness modification diagram.*

4. Expose and release retaining clip (see red circle in Figure 2).

5. Pull wiring harness 5 mm (see red arrow in Figure 2) away from power electronics.
6. Secure clip again with textile tape N 107 290 02. Clip must be replaced if it is damaged during removal (part number 6Q0 971 848 P).
7. Wrap textile tape N 107 290 02 around entire wiring harness as far as connector.

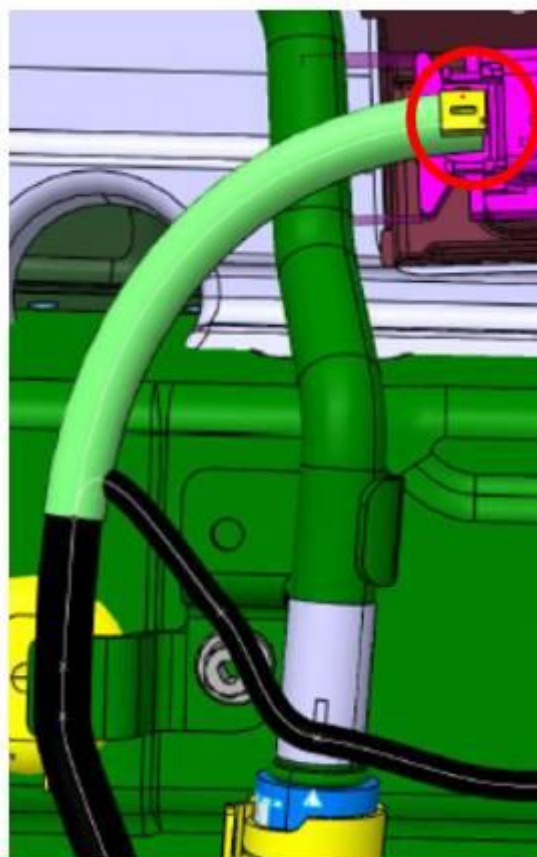
**Figure 3.** Secure the cable tie.

8. Secure cable tie N 106 232 01 around wiring harness and connector so that wiring harness is pulled upward (see red circle in Figure 3).

9. Ensure the wire does not make contact with any components including the undershield after the repair work is performed.
