# Service Bulletin

Bulletin No.: 21-NA-071

Subject: DTC's P05AE or P059F Set Current or History

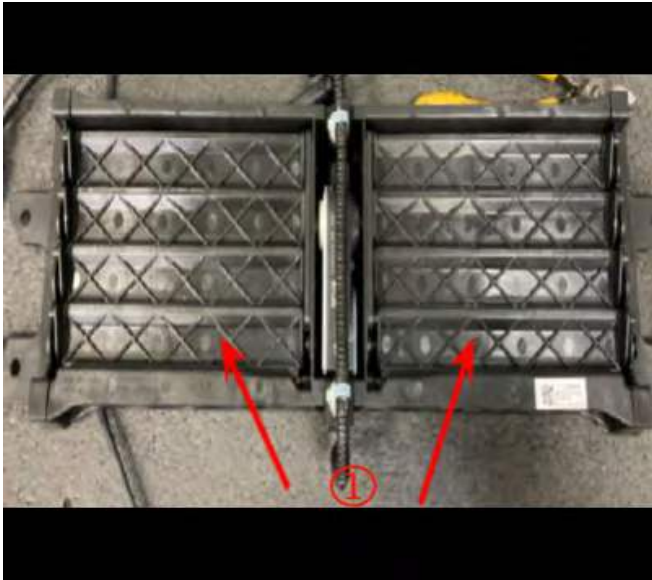
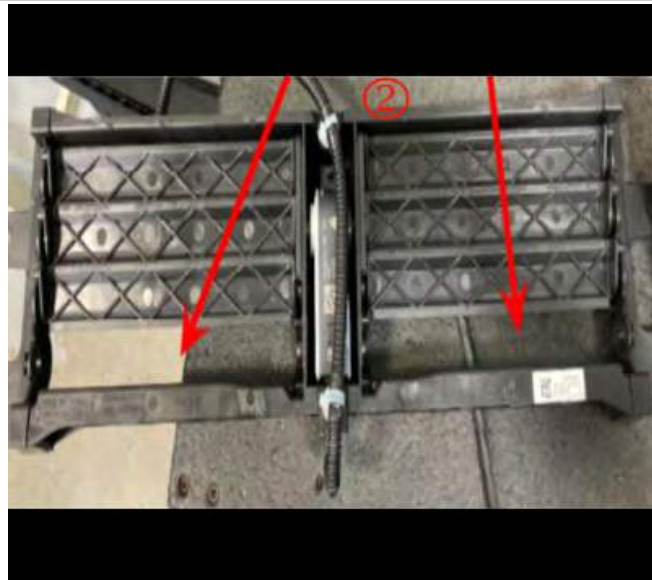
| Cause | The cause of the condition may be road debris like small stones, or ice, may collect at the bottom of the front bumper lower shutter assembly and can prevent the louver from fully closing, causing the DTC's to set. |

Note: The graphics above show before (1), and after (2), examples of the lower shutter modification.

Remove the front bumper lower shutter and complete the Lower Shutter Louver Modification Procedure below, to remove the lowest row of louvers from the shutter.
