# Service Bulletin

Bulletin No.: 21-NA-074

**Subject:** Malfunction Indicator Lamp Illuminated On Driver Information Center (DIC) with DTC P0300 and/or P0299/P2227 Set

| Brand: | Model: | Model Year: | | VIN: | | Engine: | Transmission: |
|---|---|---|---|---|---|---|---|
| Buick | Envision | 2016 | 2020 | - | - | Equipped with 2.0L Engine (RPO LTG) | All |

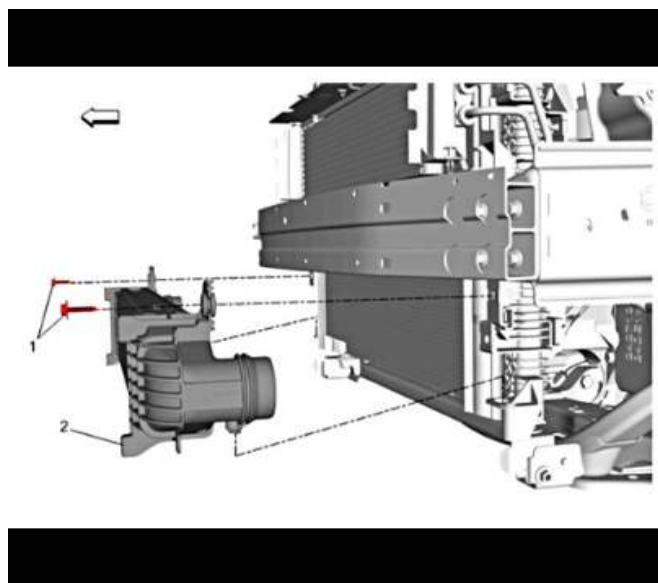
5779438

Important: The latest designed charge air cooler is wider, as shown in the picture above, and is NOT compatible with the existing lower baffle on vehicles built BEFORE January 5, 2019. The baffle will need to be replaced to accommodate the larger charge air cooler if the charge air cooler is being replaced
