# Technical Service Bulletin

## 20 Vehicle does not start; fuel pressure below specification (DTC P0087)

20 16 73 2044478/1 July 5, 2016.

| Model(s) | Year | VIN Range | Vehicle-Specific Equipment |
|---|---|---|---|
| A4 | 2017 | 000001 - 020055 | Not Applicable |

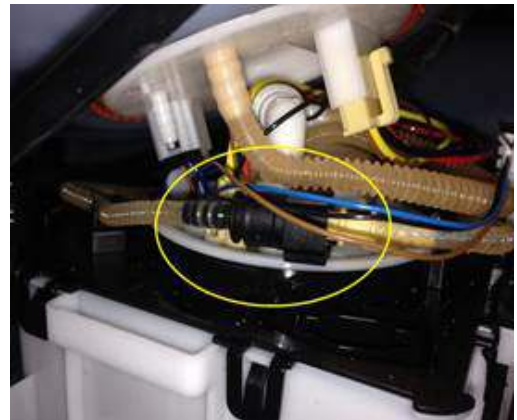
**Figure 1.** Fuel line.

The fuel hose inside the tank is disconnected and cannot be reconnected.

3. Identify the fuel line inside of the tank (Figure 1). The line may be partially or completely disconnected.
