# Technical Service Bulletin

## 17 MIL on or noises from the crankcase breather, DTC P052E00 is stored in the ECM

17 21 16 2060033/3 May 6, 2021. Supersedes Technical Service Bulletin Group 17 number 20-10 dated August 26, 2020 for reasons listed below.

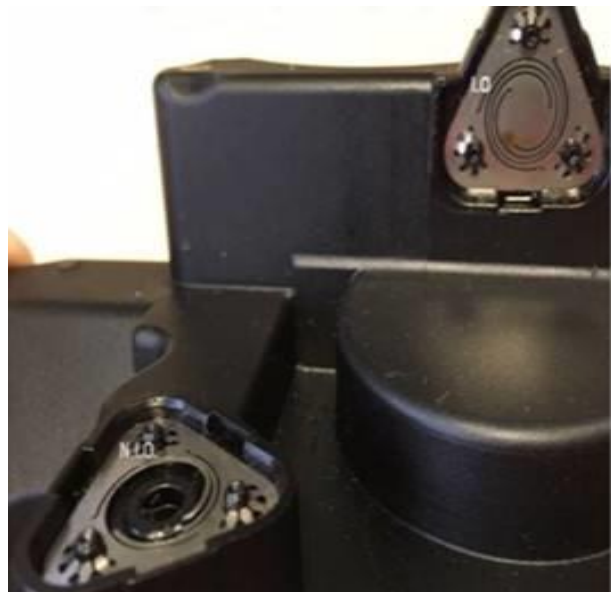
**Figure 1.** Metal plates.

Fuel additives can cause the membrane to crack.

1. Using the hand vacuum pump VAS 6213 check the membrane of the crankcase breather for leaks; a leak can mean a faulty membrane or elbow piece (see TSB 2060259: *17 MIL on or noises from the engine compartment, DTC P052E00 is stored in the ECM for the elbow piece repair*).
2. Remove the compressor/intake manifold and check the membrane for leaks directly on the crankcase breather. Remove the crankcase breather and check the two metal plates for damage (Figure 1).

If a plate is defective, please use the repair kit 06E 103 772H.
