Preliminary Information

PIP5773B DTC P0331 Knock Sensor 2 Performance Under Engineering Investigation

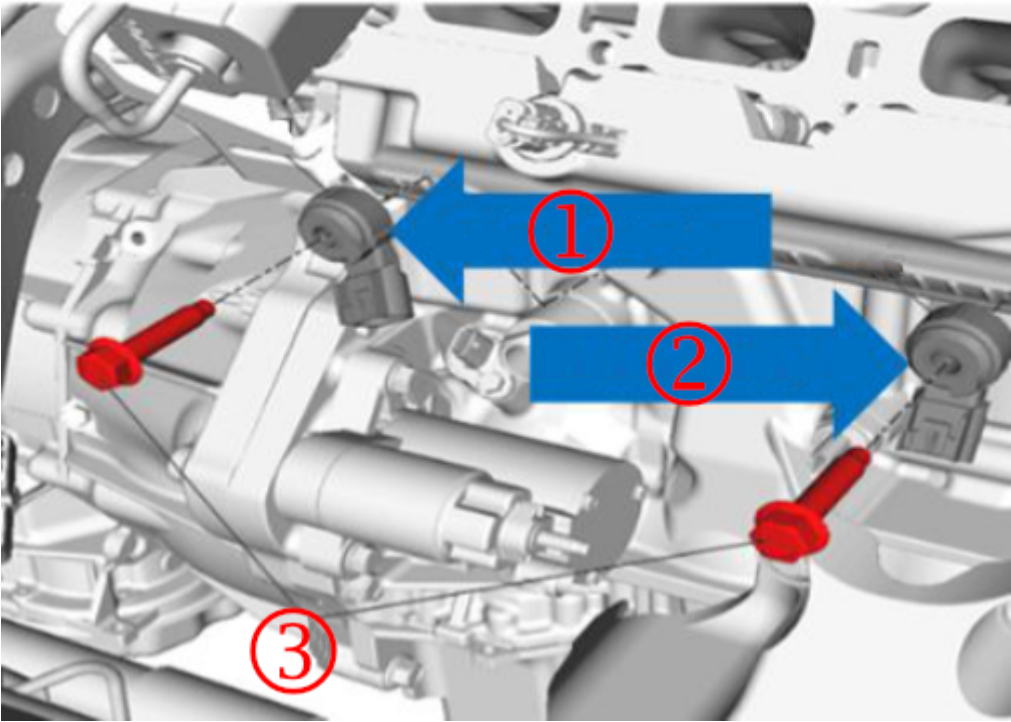
| Condition | SES light on and technician may find DTC P0331 set. |

- 1 - Knock Sensor #2
- 2 - Knock Sensor #1
- 3 - Bolts for knock sensors

Perform a visual inspection to make sure the wire harness is connected and the sensor is bolted into place.  
If no trouble found, do not replace any parts, clear the code and return the vehicle back to the customer.
