# Service Bulletin

Bulletin No.: 20-NA-047

**Subject:** Front or Rear Crankshaft Oil Leak, Malfunction Indicator Lamp (MIL) Illuminated - DTC P1101 Set

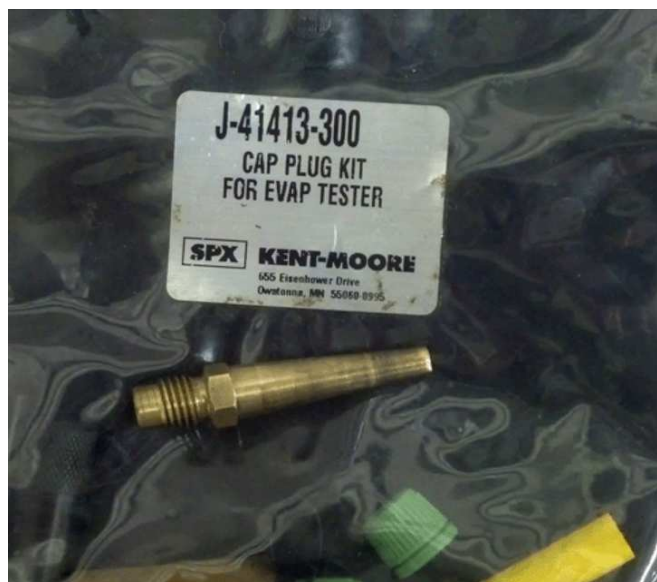
3416804

## EEST hose adaptor

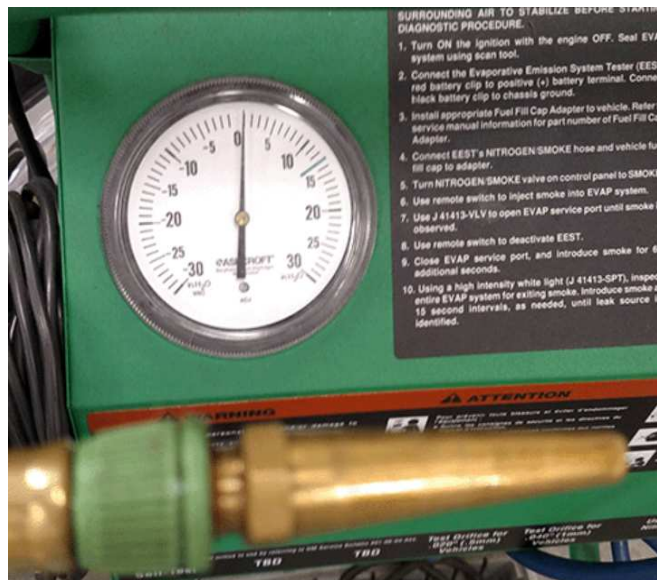
4573240

## EEST Gauge at 0 reading

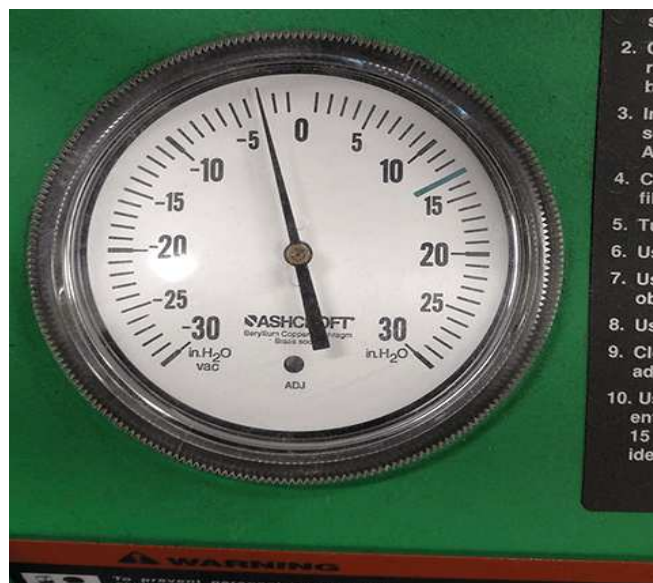
4573243

Normal crankcase pressure readings for the L3A, LE2, LFV and LYX are between -1 & -5 inches of water in park at hot idle.

- " If the crankcase pressure is in the proper range, follow Strategy Based Diagnostics for engine oil leaks and/or P1101 per SI.
- " If the crankcase pressure is excessively positive, above 0 inches of water (0 inches of HG / vacuum), then a positive crankcase pressure concern exists requiring further diagnostics.

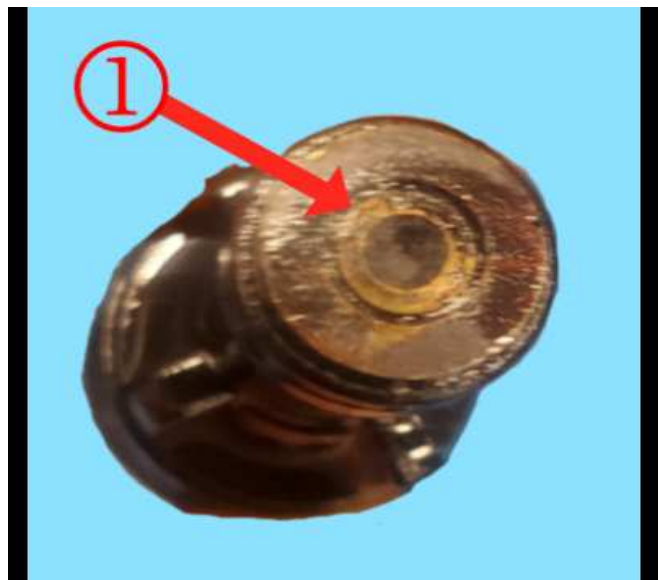
5513764

If diagnosing for oil leaks and/or DTC P1101 with no engine oil leaks and excessive positive crankcase pressure exists, an obstructed PCV orifice (1) would be suspect requiring a PCV orifice replacement.

Remove the camshaft cover and remove the PCV orifice and inspect for blockage. Replace the orifice as necessary along with the camshaft cover gaskets. Make sure the camshaft cover does not have any blockages in the PCV passages.
