# Service Bulletin

Bulletin No.: 20-NA-233

Subject: Long Range Radar Setting DTC U3000 49

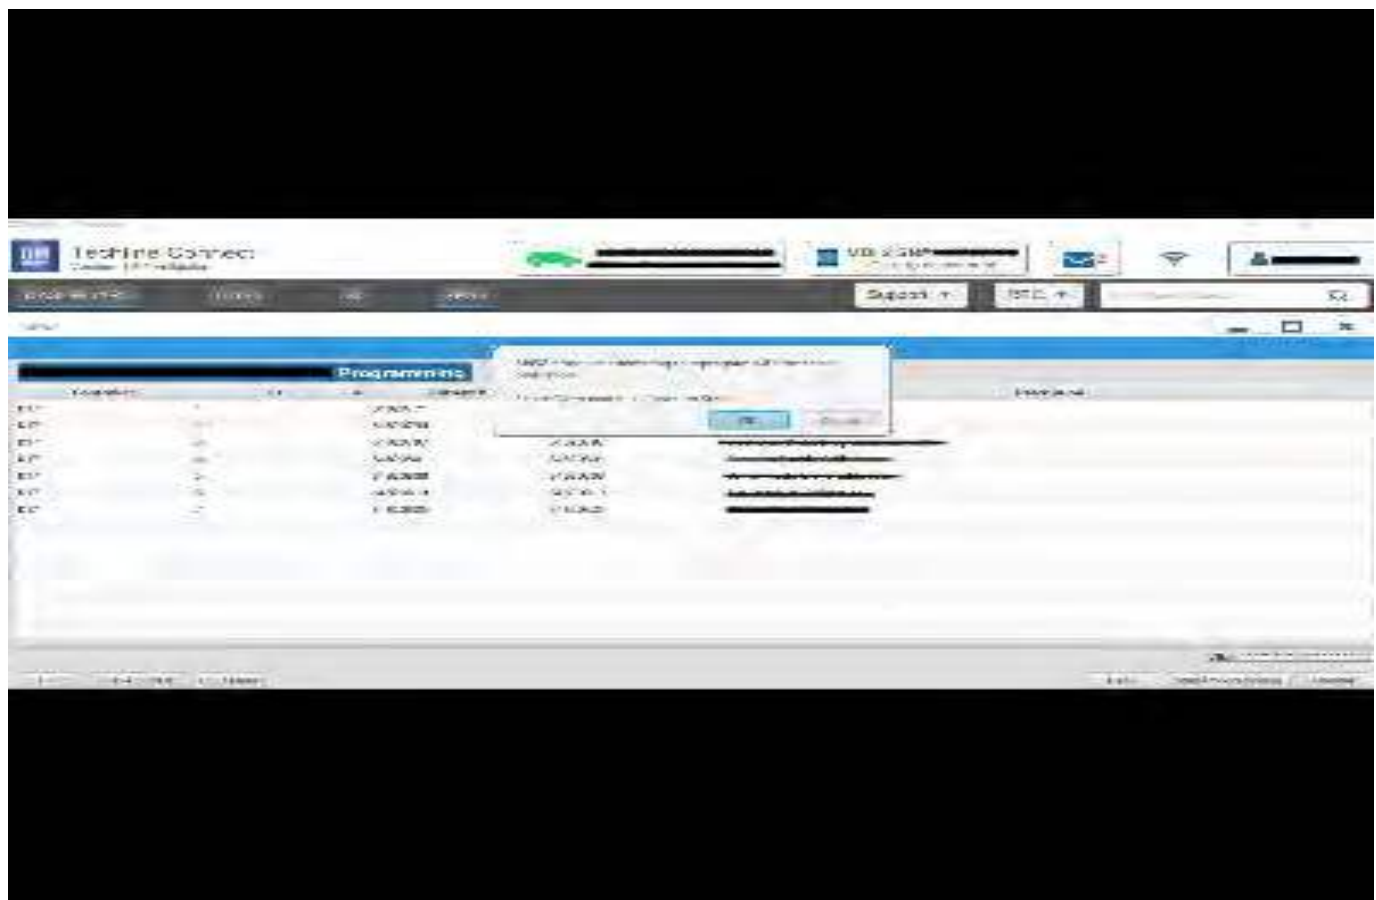
5644477

**Caution:** Be sure the VIN selected in the drop down menu (1) is the same as the vehicle connected (2) before beginning programming.

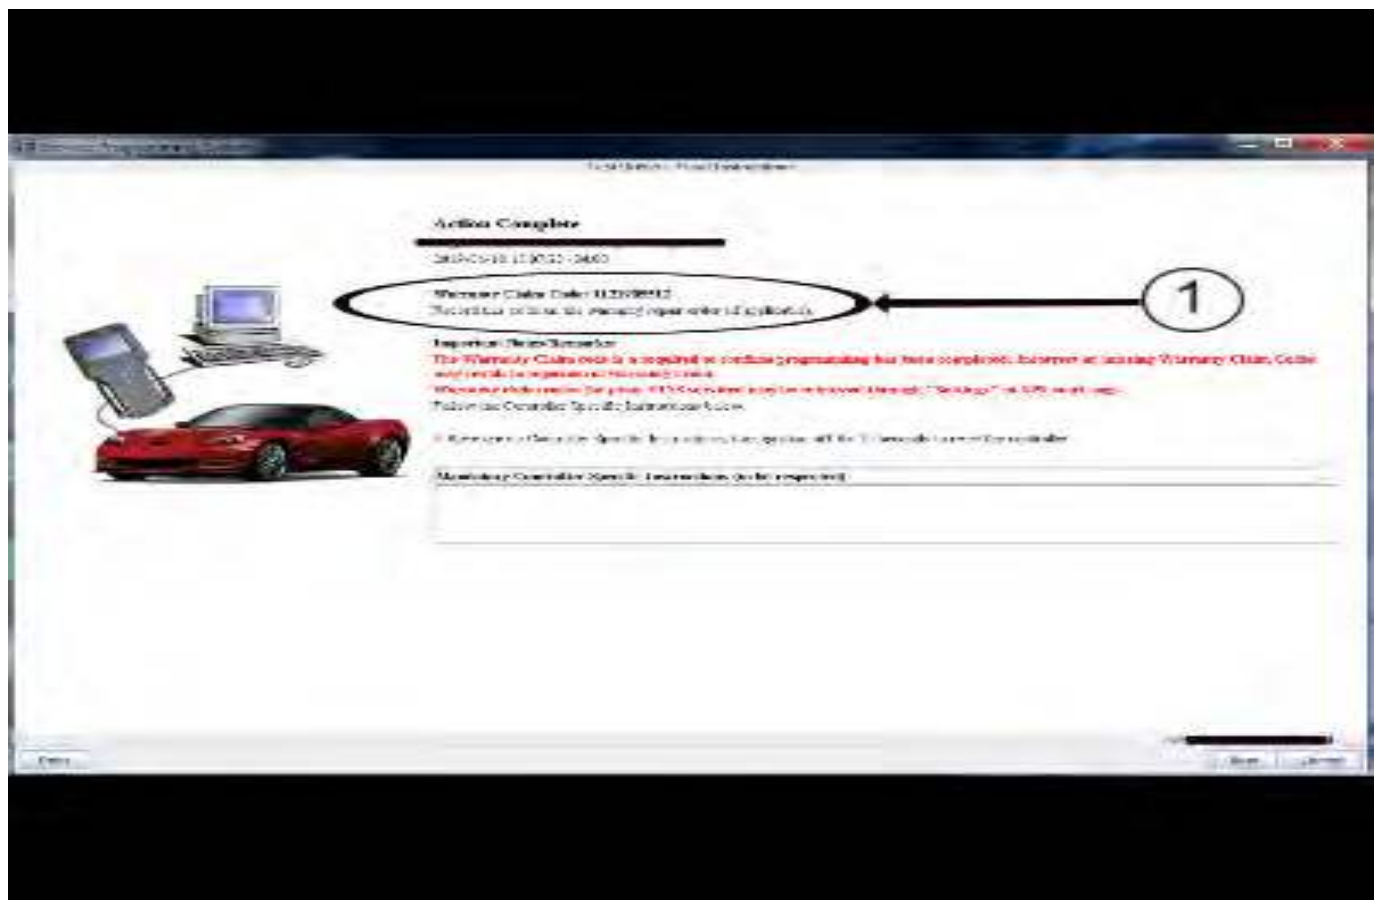
5431209

Important: To avoid warranty transaction rejections, you MUST record the warranty claim code provided on the SPS Warranty Claim Code (WCC) screen shown above on the job card. Refer to callout 1 above for the location of the WCC on the SPS screen.

- 2. Record the SPS Warranty Claim Code on the job card for warranty transaction submission.
