GLOBAL SAFETY FIELD INVESTIGATIONS  
DCS5743  
URGENT - DISTRIBUTE IMMEDIATELY

Subject: N212331790 - Service Update  
NOx Sensor False Failure

Models: 2021 Chevrolet Silverado 2500/3500 HD  
2021 GMC Sierra 2500/3500 HD  
Equipped with 6.6L, 8-Cylinder Diesel Engine (RPO L5P)

## N212331790 NOx Sensor False Failure

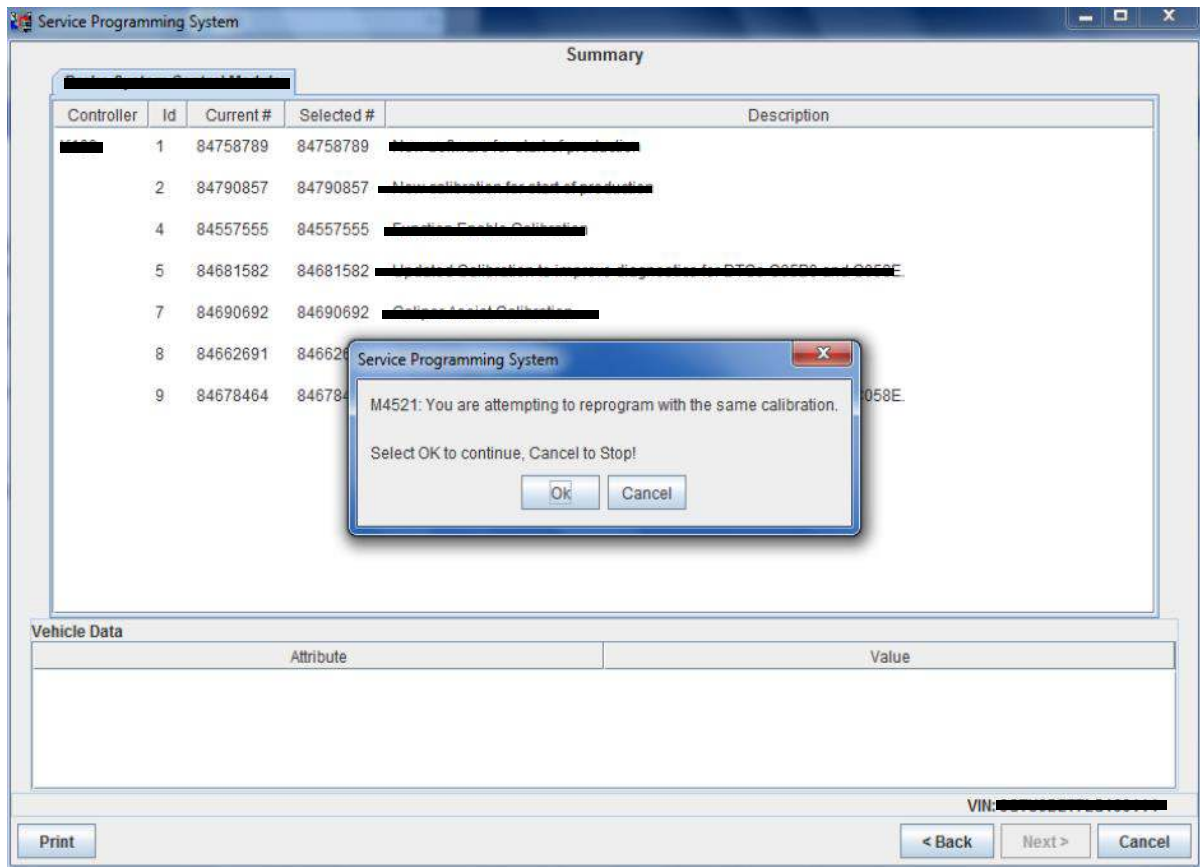
**Important:** Techline Connect and TIS2WEB screens shown above.

**Important:** If the same calibration/software warning is noted on the TLC or SPS Summary screen, select OK and follow screen instructions. After a successful programming event, the WCC is located in the Service Programming System dialogue box of the SPS Summary screen. No further action is required. Refer to the Warranty section of the bulletin.

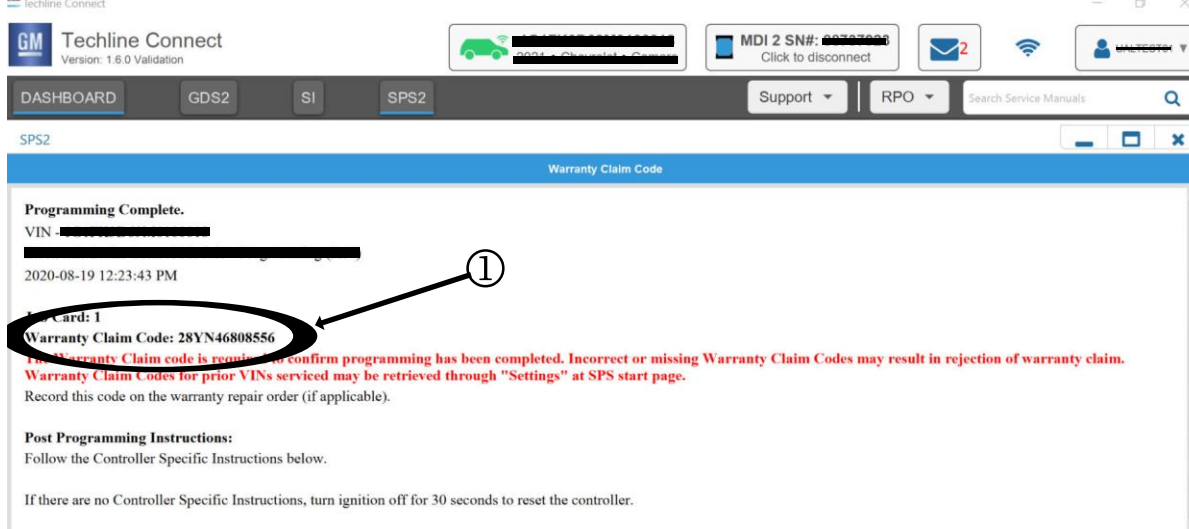
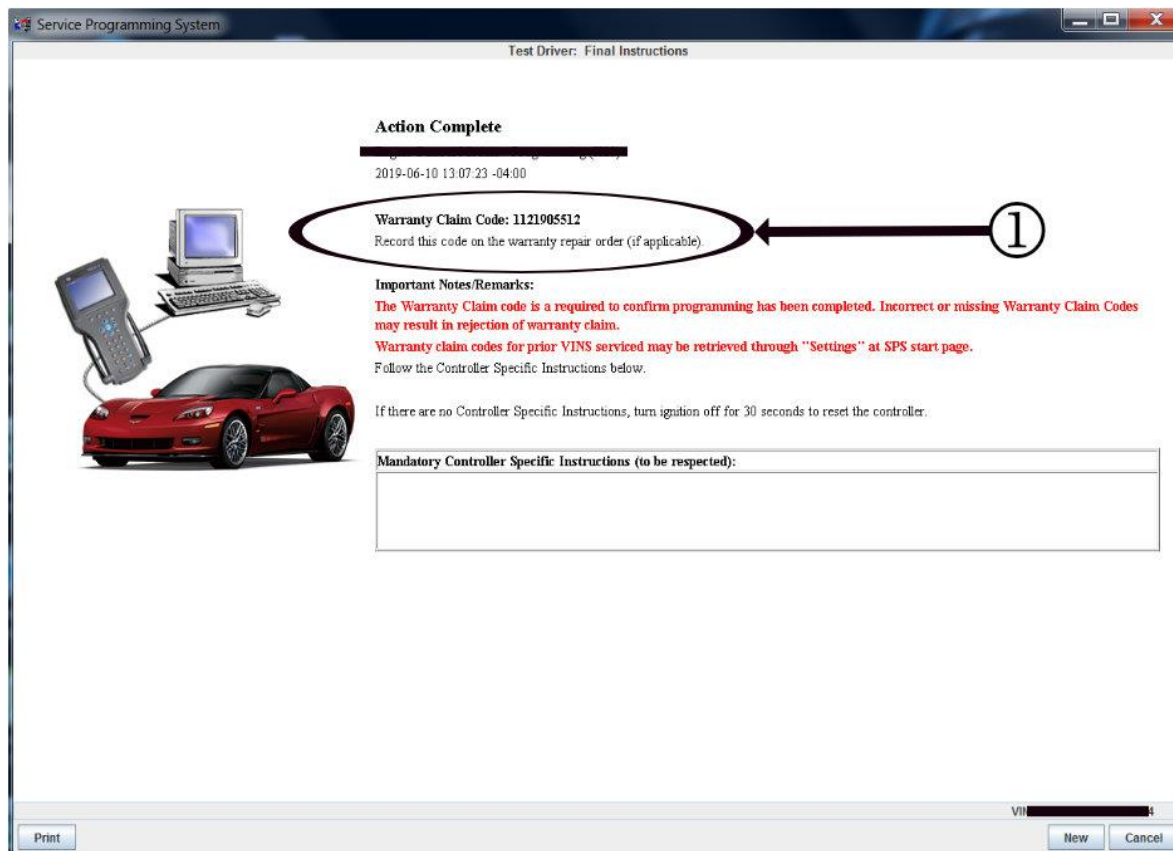
**Note:** The screenshots above are an example of module programming and may not be indicative of the specific module that is being programmed. Module selection and VIN information have been blacked out.

1. Reprogram the Engine Control Module. Refer to *K20 Engine Control Module: Programming and Setup* in SI.

**Important:** To avoid warranty transaction rejections, you **MUST** record the warranty claim code provided on the Warranty Claim Code (WCC) screen shown above on the job card. Refer to callout 1 above for the location of the WCC on the screen.

2. Record SPS Warranty Claim Code on job card for warranty transaction submission.
