## **\* \* TECHNICAL INFORMATION NOTICE \* \***

**DATE:** September 23, 2015  
**TO:** Mitsubishi Motors US & Puerto Rico Dealer Parts and Service Managers  
**RE:** Driver's Seat Slide Sensor Wiring Harness Damage Under Driver's Seat  
**TIN NO.** TIN-15-52B-001

**AFFECTED VEHICLES:** 2013 - 2015 Outlander Sport

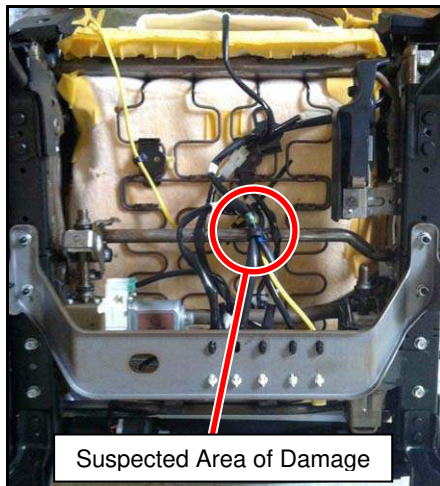
**View from under Driver's Seat**

During diagnosis for this condition, dealers should check for damage to the driver's seat slide position sensor harness. If a damaged harness is found, DO NOT replace the front seat adjuster or SRS ECU for this condition. Please have the Technician working on the vehicle create a Techline case & call Techline (1-800-446-6064). Techline will then discuss the condition and arrange for a replacement harness to be sent to the dealer as appropriate.
