## SERVICE BULLETIN

EC16-003

### 2013 – 2015 SENTRA; MIL ON WITH DTC P0101

**APPLIED VEHICLE:** 2013 – 2015 Sentra (B17)

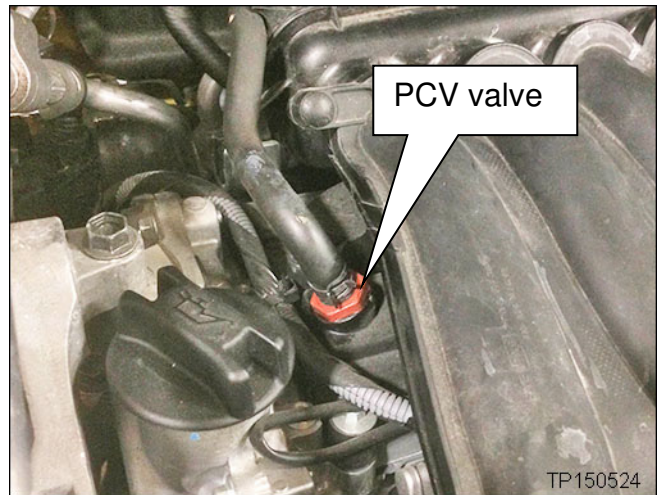
- Inspect the color of the PCV valve, replace if the color is orange (see Figure A on page 2).

**If PCV valve is orange, as shown in Figure A:**

- Replace the PCV valve.
- If needed, refer to the Electronic Service Manual ESM, section EM-Engine Mechanical, for replacement information.
- Use the new PCV valve listed in the Parts Information.
- The new PCV valve is “black” color.
