## SERVICE BULLETIN

EC16-007

March 23, 2016

### 2013-2015 PATHFINDER; MIL ON WITH DTC P0116

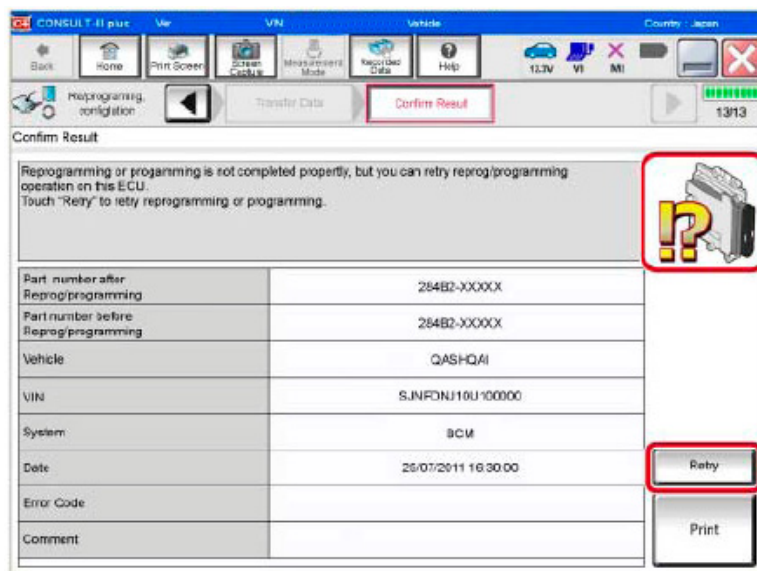
Figure 5

If reprogramming does not complete and the “!” icon displays as shown in Figure 5:

- Check battery voltage (12.0–15.5 V).
- Ignition is ON, engine OFF.
- External Bluetooth® devices are OFF.
- All electrical loads are OFF.
- **Select retry and follow the on screen instructions.**
- “Retry” may not go through on first attempt and can be selected more than once.

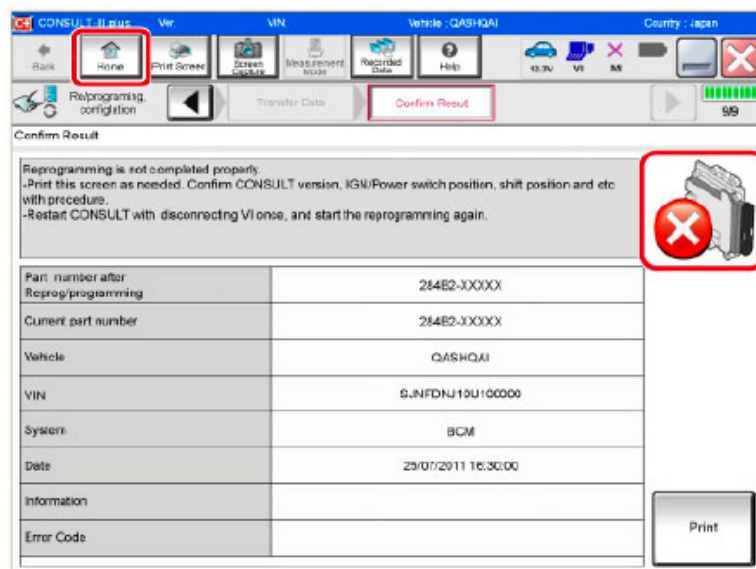
Figure 6

If reprogramming does not complete and the “X” icon displays as shown in Figure 6:

- Check battery voltage (12.0 – 15.5 V).
- CONSULT A/C adapter is plugged in.
- Ignition is ON, engine OFF.
- Transmission is in Park.
- All C-III plus / VI cables are securely connected.
- All C-III plus updates are installed.
- **Select Home, and restart the reprogram procedure from the beginning.**
