## SERVICE BULLETIN

EC16-011

### 2016 ALTIMA; MIL ON WITH DTC P0101

**APPLIED VEHICLES:** 2016 Altima (L33)

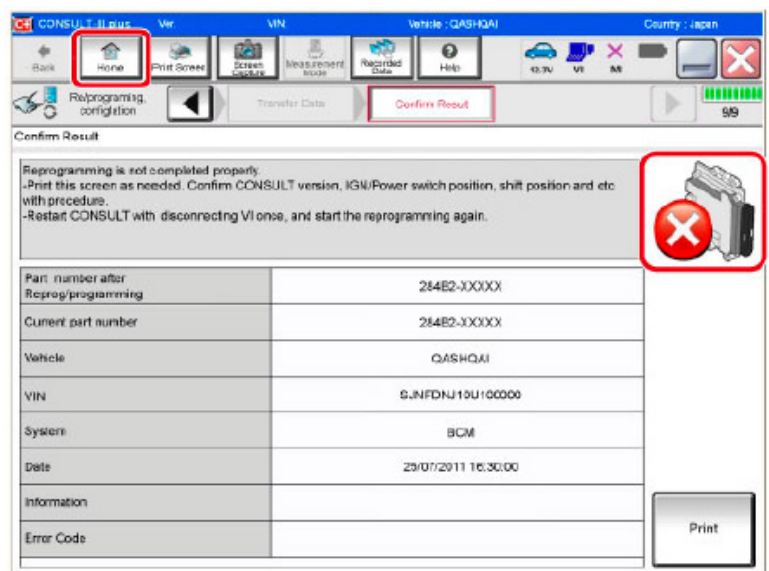
Figure 6

If reprogramming does not complete and the “X” icon displays as shown in Figure 6:

- Check battery voltage (12.0 - 15.5 V).
- CONSULT A/C adapter is plugged in.
- Ignition is ON, engine OFF.
- Transmission is in Park.
- All C-III plus / VI cables are securely connected.
- All C-III plus updates are installed.
- **Select Home, and restart the reprogram procedure from the beginning.**
