## SERVICE BULLETIN

EC16-009

### 2013-2016 ALTIMA WITH QR25DE ENGINE; MIL ON WITH DTC P0116

**APPLIED VEHICLE:** 2013-2016 Altima (L33)

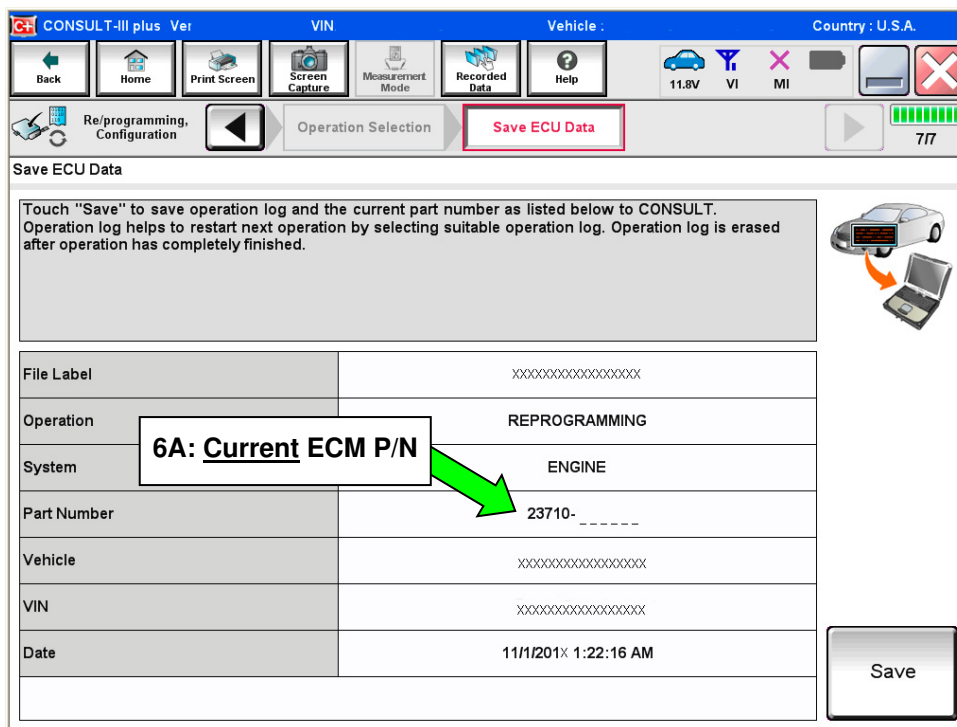
Figure 2

6. When you get to the screen shown in Figure 2, confirm this bulletin applies as follows.

A. Find the ECM **Part Number** and write it on the repair order.

B. Compare the P/N you wrote down to the numbers in the **Current ECM Part Number** column in **Table A** on the next page.

- If there is a match, this bulletin applies. Continue with the reprogramming procedure.
- If there is not a match, this bulletin does not apply. Close C-III plus and refer to ASIST for further diagnostic information.

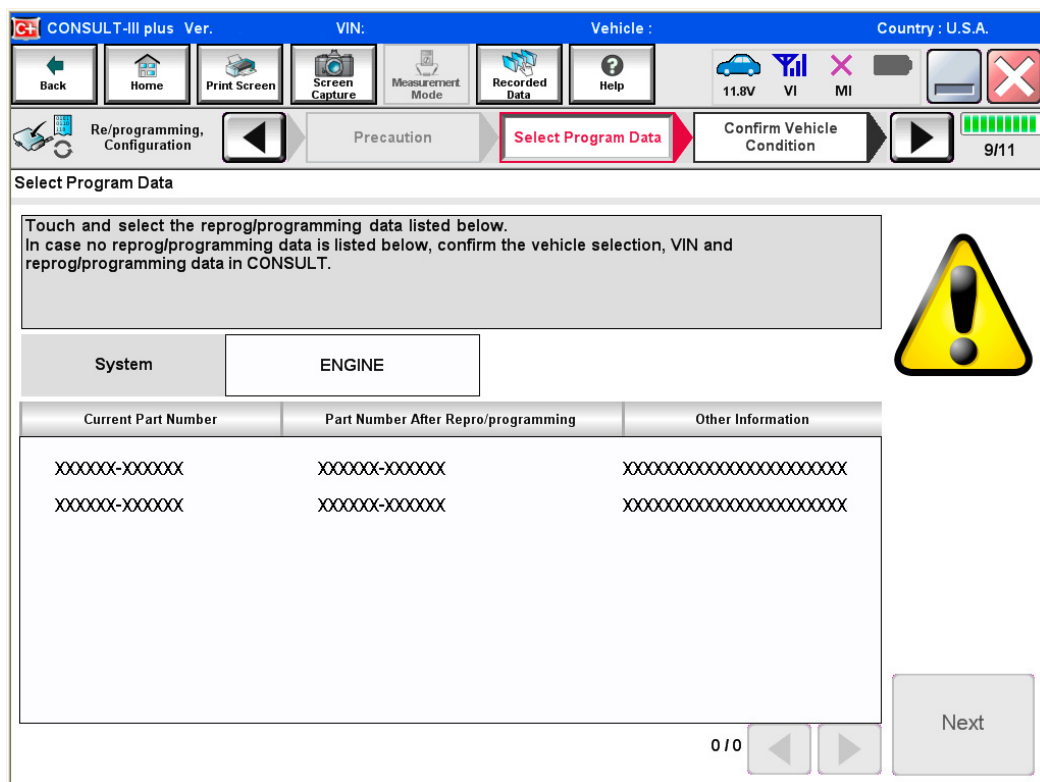
- In some cases, more than one new P/N for reprogramming is available.
  - If more than one new P/N is available, the screen in Figure 3 displays.
  - Select and use the reprogramming option that **does not** have the message “Caution! Use ONLY with NTBXX-XXX”.
- If you get this screen and it is blank (no reprogramming listed), it means there is no reprogramming available for this vehicle. Close C-III plus and refer back to ASIST for further diagnosis.

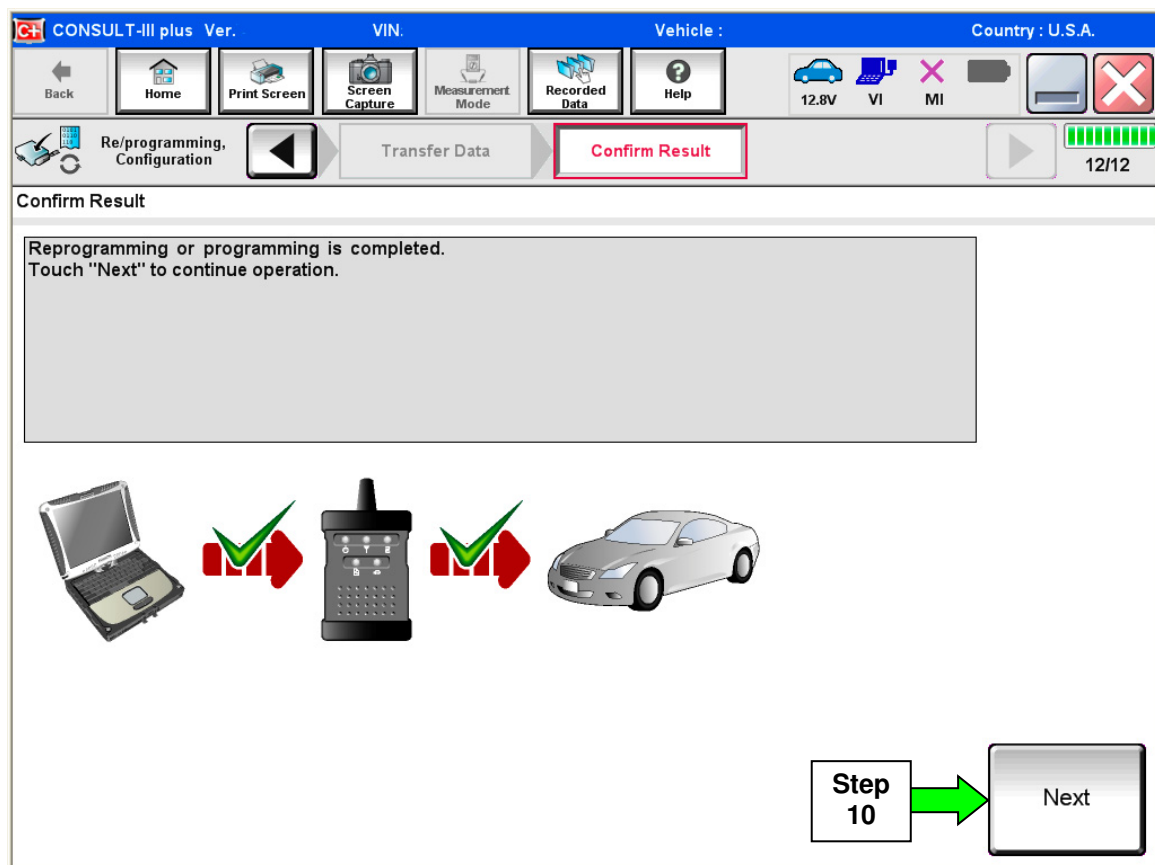
8. When the screen in Figure 4 displays, reprogramming is complete.

**NOTE:** If the screen in Figure 4 does not display (indicating that reprogramming did not complete), refer to the information on page 8.

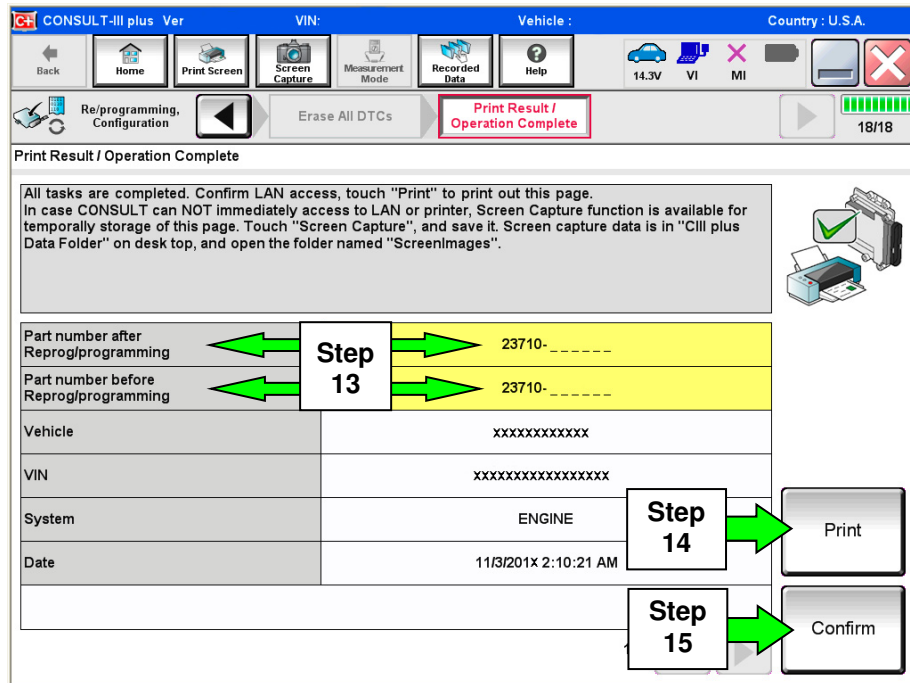
12. When the entire reprogramming process is complete, the screen in Figure 7 will display.
13. Verify the before and after part numbers are different.
14. Print a copy of this screen (Figure 7) and attach it to the repair order for warranty documentation.
15. Select **Confirm**.
