# Technical Service Bulletin

## 91 MIB2 High: Navigation data read error/reboots, DTC B126CF0 and/or B126CF1 stored in the information module

91 21 02 2057052/4 May 17, 2021. Supersedes Technical Service Bulletin Group 91 number 20-78 dated June 18, 2020 for reasons listed below.

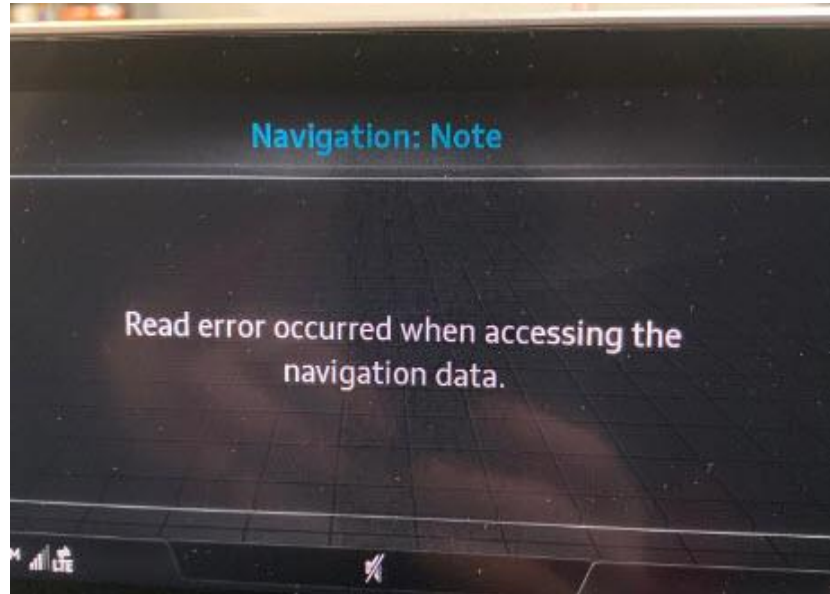
- The MMI shows the message “Read error occurred when accessing the navigation data” after initialization (Figure 1).
- The MMI reboots constantly.

**Figure 1.** The error message is shown on initialization.

If the navigation map database is corrupted during an online update, the message from Figure 1 is displayed and the navigation system is unavailable. The DTC B126CF0 is entered into the information electronics, J794 (address word 005F).
