# Technical Service Bulletin

LIFTGATE SWITCH DOES NOT WORK

Bulletin No.: 09-015/21

Last Issued : 05/25/2021

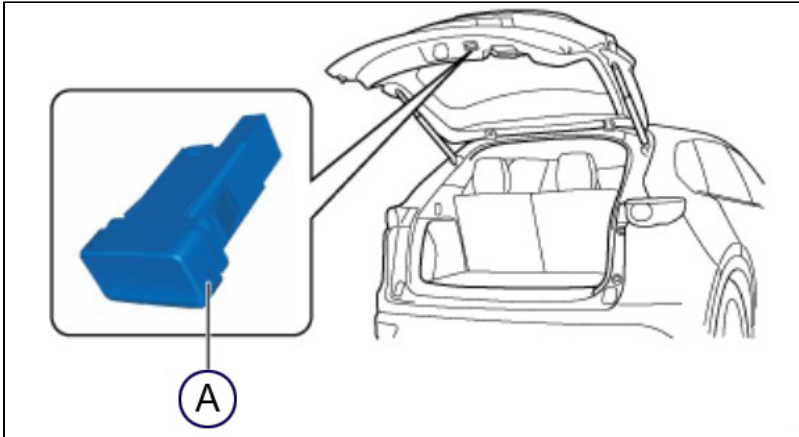
**NOTE:** CX-5 shown below

Some CX-5 customers may find that the liftgate does not close when pressing the power liftgate (PLG) rear switch (A) located on the interior liftgate trim. This may be caused by PLG switch corrosion. Water from condensation may drip onto the switch connector and cause corrosion. To eliminate this concern, the PLG rear switch has been modified with a waterproof connector.

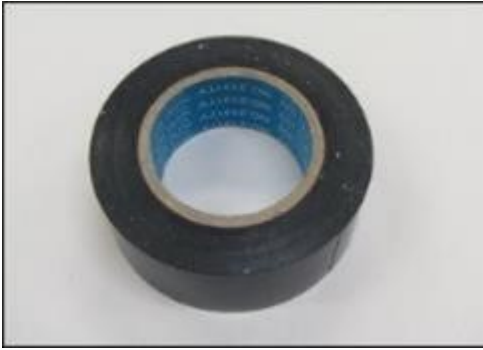
2. Inspect the connector for traces of water or moisture.

- If water or moisture is visible, but the parts are not rusted, wrap the connector with PVC tape to make it waterproof according to "INSTRUCTIONS FOR WRAPPING THE CONNECTOR".

- If some rust is visible, replace the rusted parts with new ones following steps a) and b) below.
