Preliminary Information

PIP5495N Check Engine Light On With P0299 Or P0234

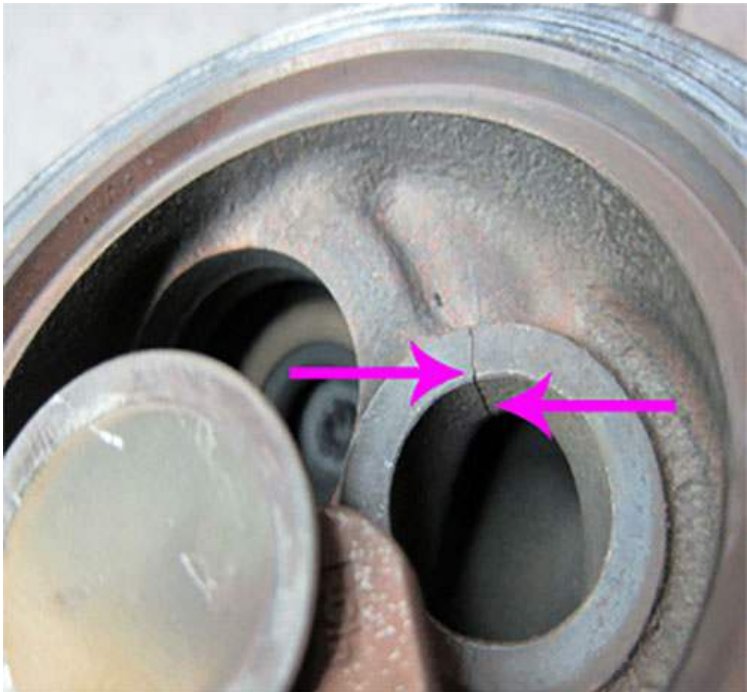
Crack(s) at the wastegate valve port (this is normal and does not affect performance)

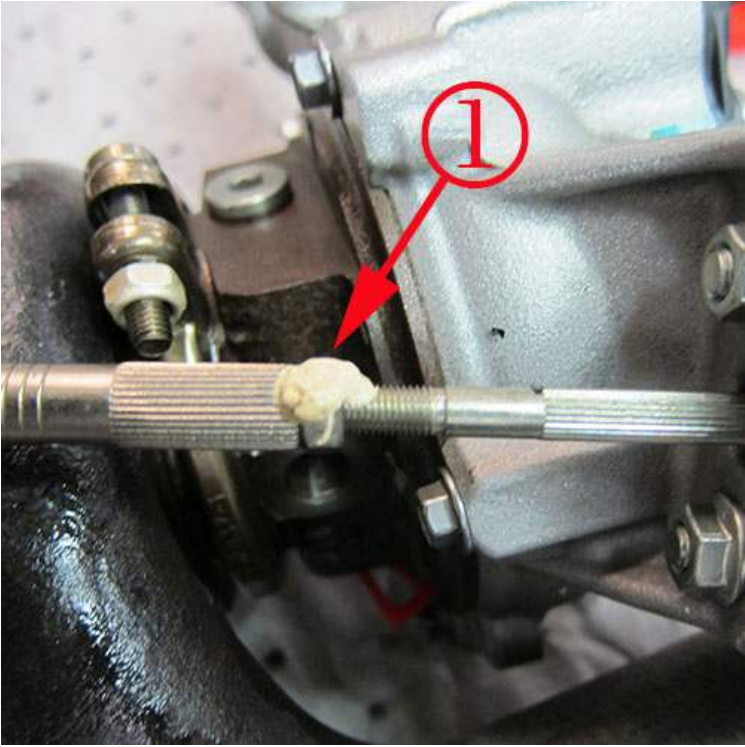
Wastegate actuator clip missing (replace wastegate actuator clip - released for service)

If the tamper paint seal is broken or missing, check the vehicle for any additional sign of modification to the induction, exhaust, or engine calibrations as this may indicate an attempt to adjust the wastegate arm to modify the powertrain operation.

If found, review the powertrain warranty status with your service manager prior to performing repairs

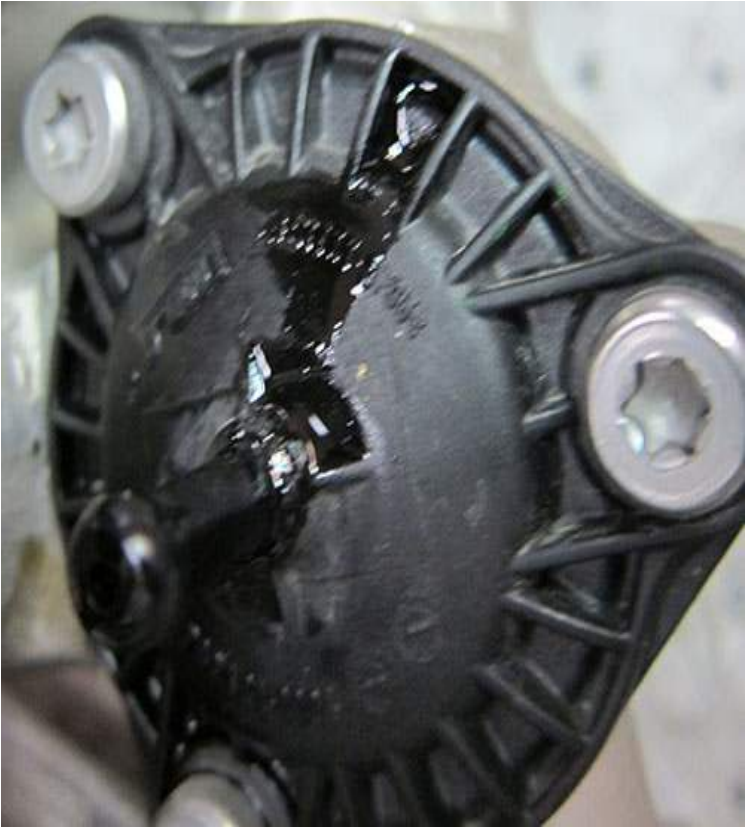
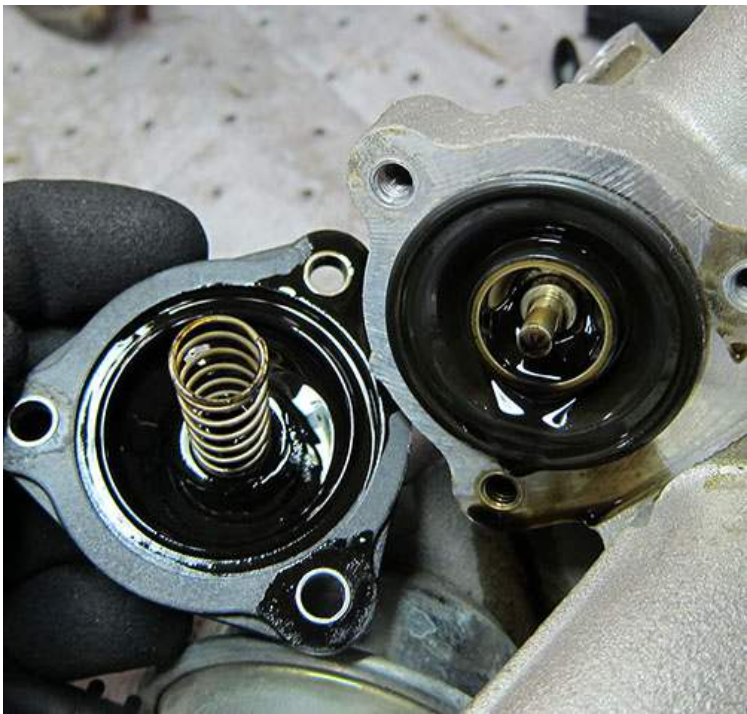
Bypass (recirculation) valve cover port broken or water/oil found inside the valve (clean the components, if necessary replace bypass (recirculation) valve assembly - released for service)

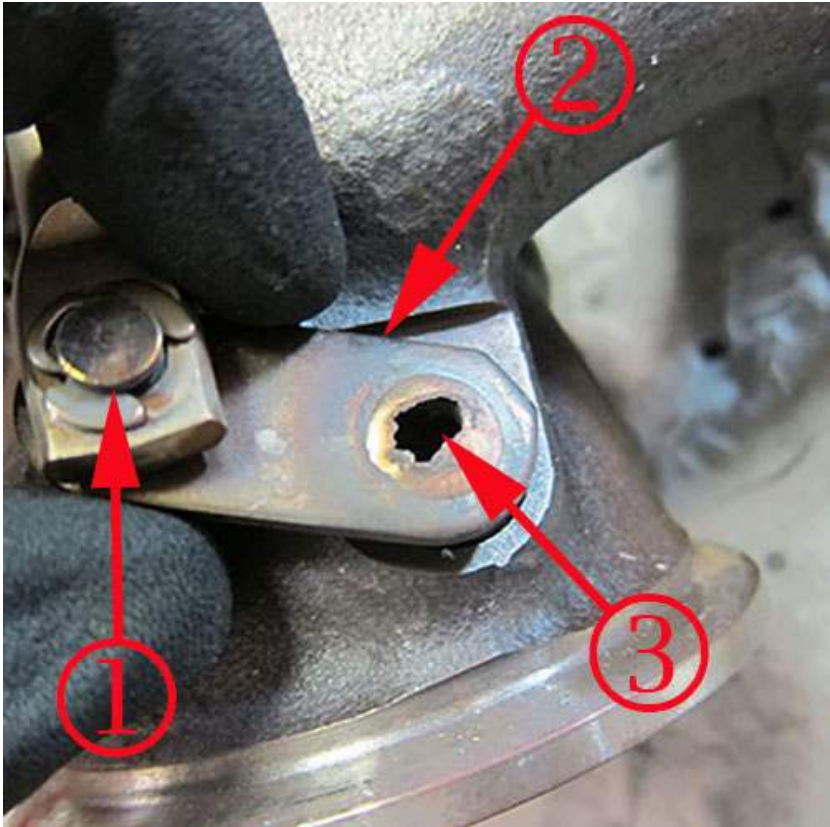
Replace the turbocharger if P0299 is set and at least one of the following is present:  
If the following failures are identified, it is not necessary to perform the Turbocharger Boost Control Test.  
Disconnected wastegate lever arm (crank) (2) from the shaft (3).

Disconnected wastegate lever arm pin (1) from the lever arm (crank) (2).  
Wastegate valve/linkage seized (cannot move).  
Turbine wheel not rotating, turbine wheel shaft broken or missing wheel nut.  
If wheel nut is missing, be sure to locate prior to turbocharger replacement.  
If the Wastegate lever arm (crank) (2) is bent, performing the Turbocharger Boost Control Test is required.  
Insufficient wastegate preload.  
Wastegate lever arm (1) moves with little effort in the direction as shown (2) while the actuator rod remains static, see picture below "Wastegate Preload Inspection".

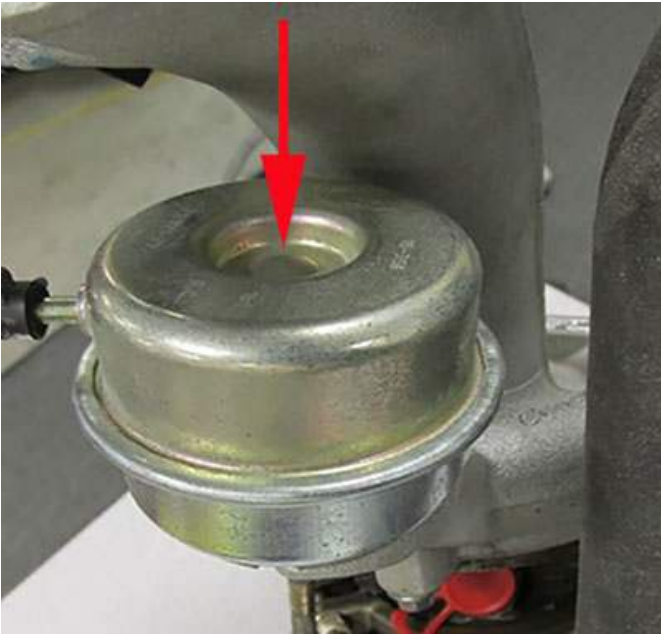
The original equipment wastegate actuator found on 2011 and 2012 model years shown below, has a recessed stop at the head of the actuator.

Original equipment actuator is found on 2011 and 2012 model years.

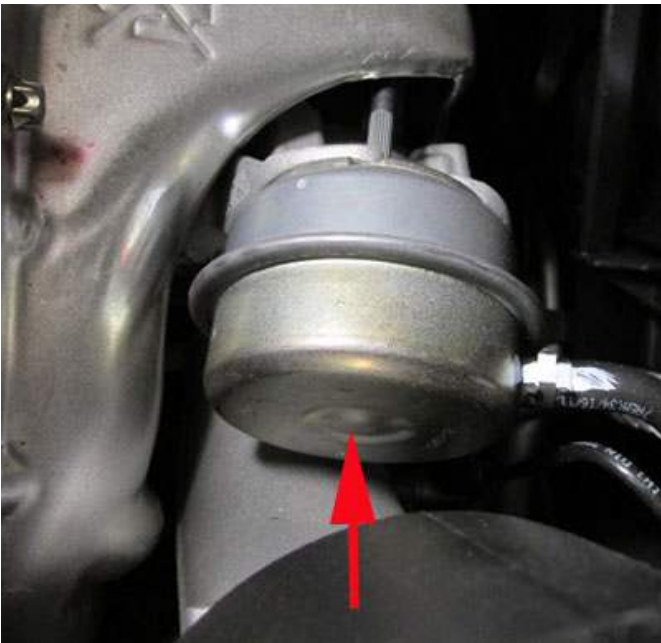
The updated design actuator show below has a stop that is not recessed and allows 5mm more travel in the closed direction.

With this updated design, it is very unlikely that an insufficient preload issue exists.

Updated design.

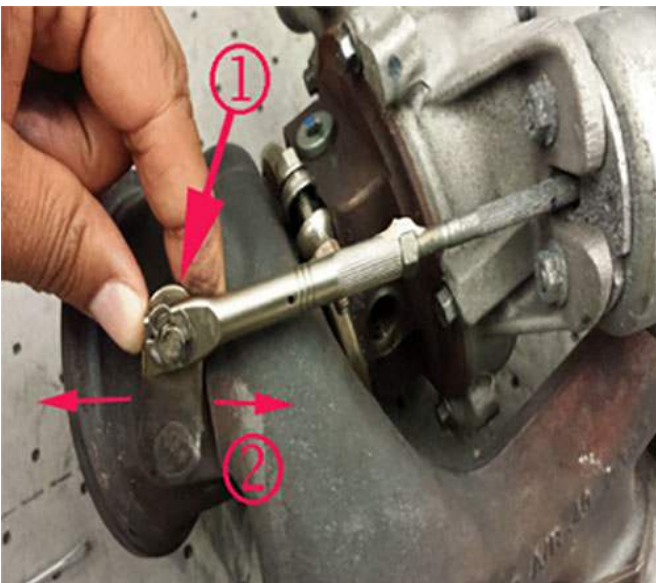
Wastegate Preload Inspection.

If the lever wiggles with little effort while the actuator rod remains static, the pre-load is insufficient and the turbocharger must be replaced.

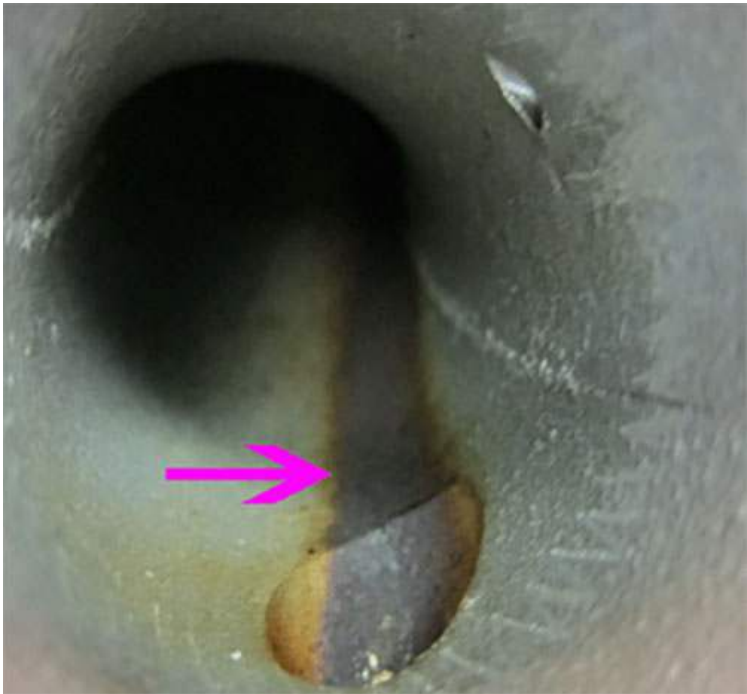
Note: The view shown below indicates NORMAL oil staining in the turbocharger outside air inlet. This dry stain does not represent an oil leak.

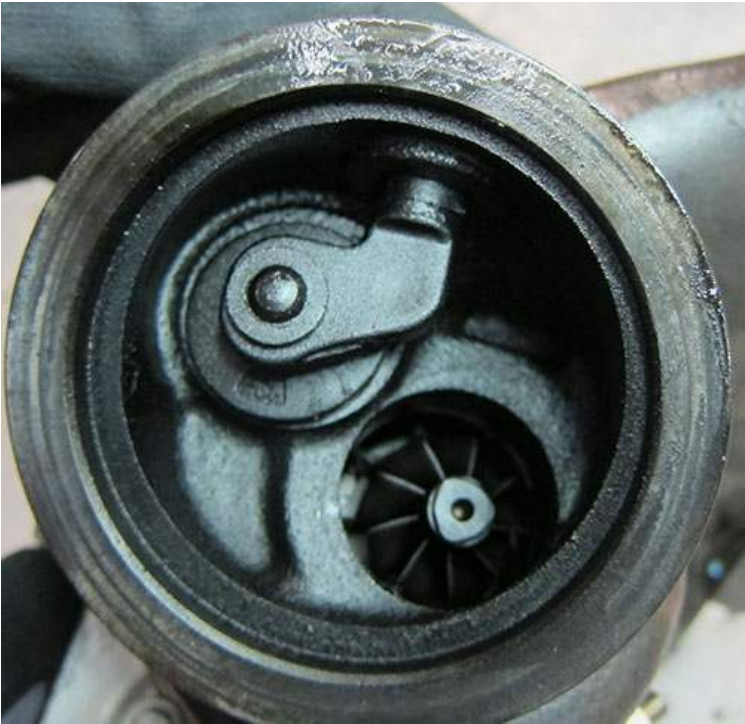
Inspect for the presence of oil in the exhaust system.

If oil is present in the exhaust system, then inspect the turbocharger turbine and compressor wheels to be sure that they are not broken off.

It is very unlikely that the turbocharger will leak oil internally if the turbine and compressor wheel shaft is not broken.

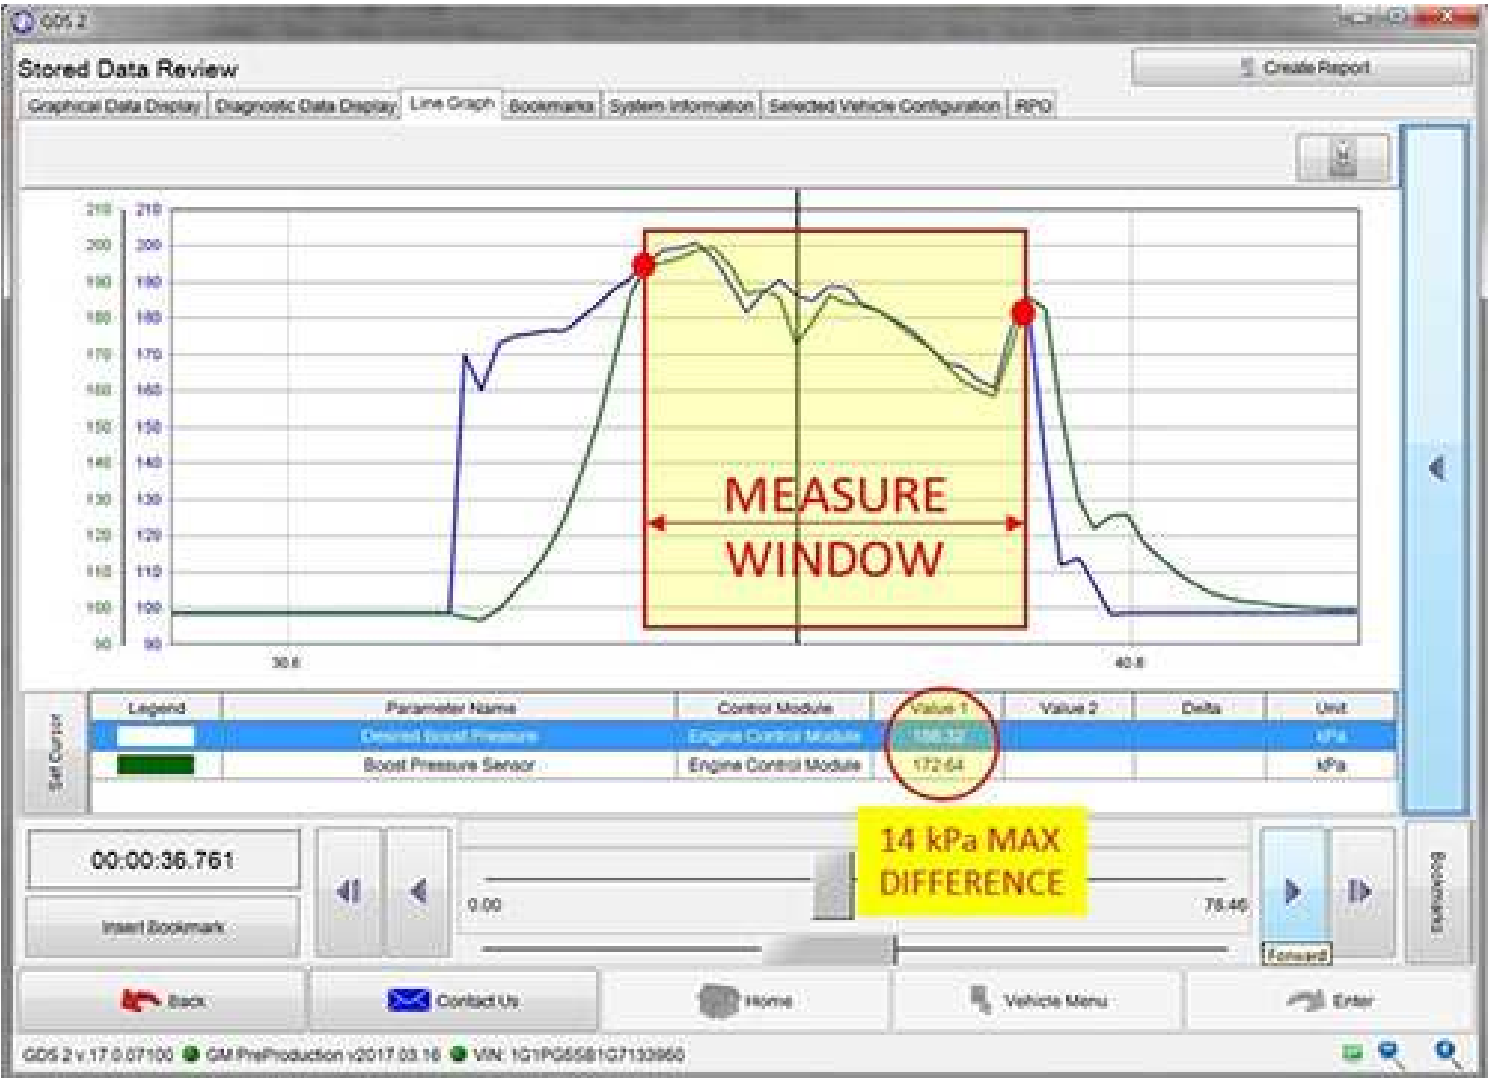
Example of normal turbocharger wastegate operation:

In this example, notice that the measure window begins once the Boost Pressure Sensor reading (Green) meets the Desired Boost Pressure reading (Blue) and ends when the APP is released per the testing instructions.

The Boost Pressure Sensor reading (Green) closely tracks the Desired Boost Pressure reading (Blue) indicating normal Turbocharger operation.

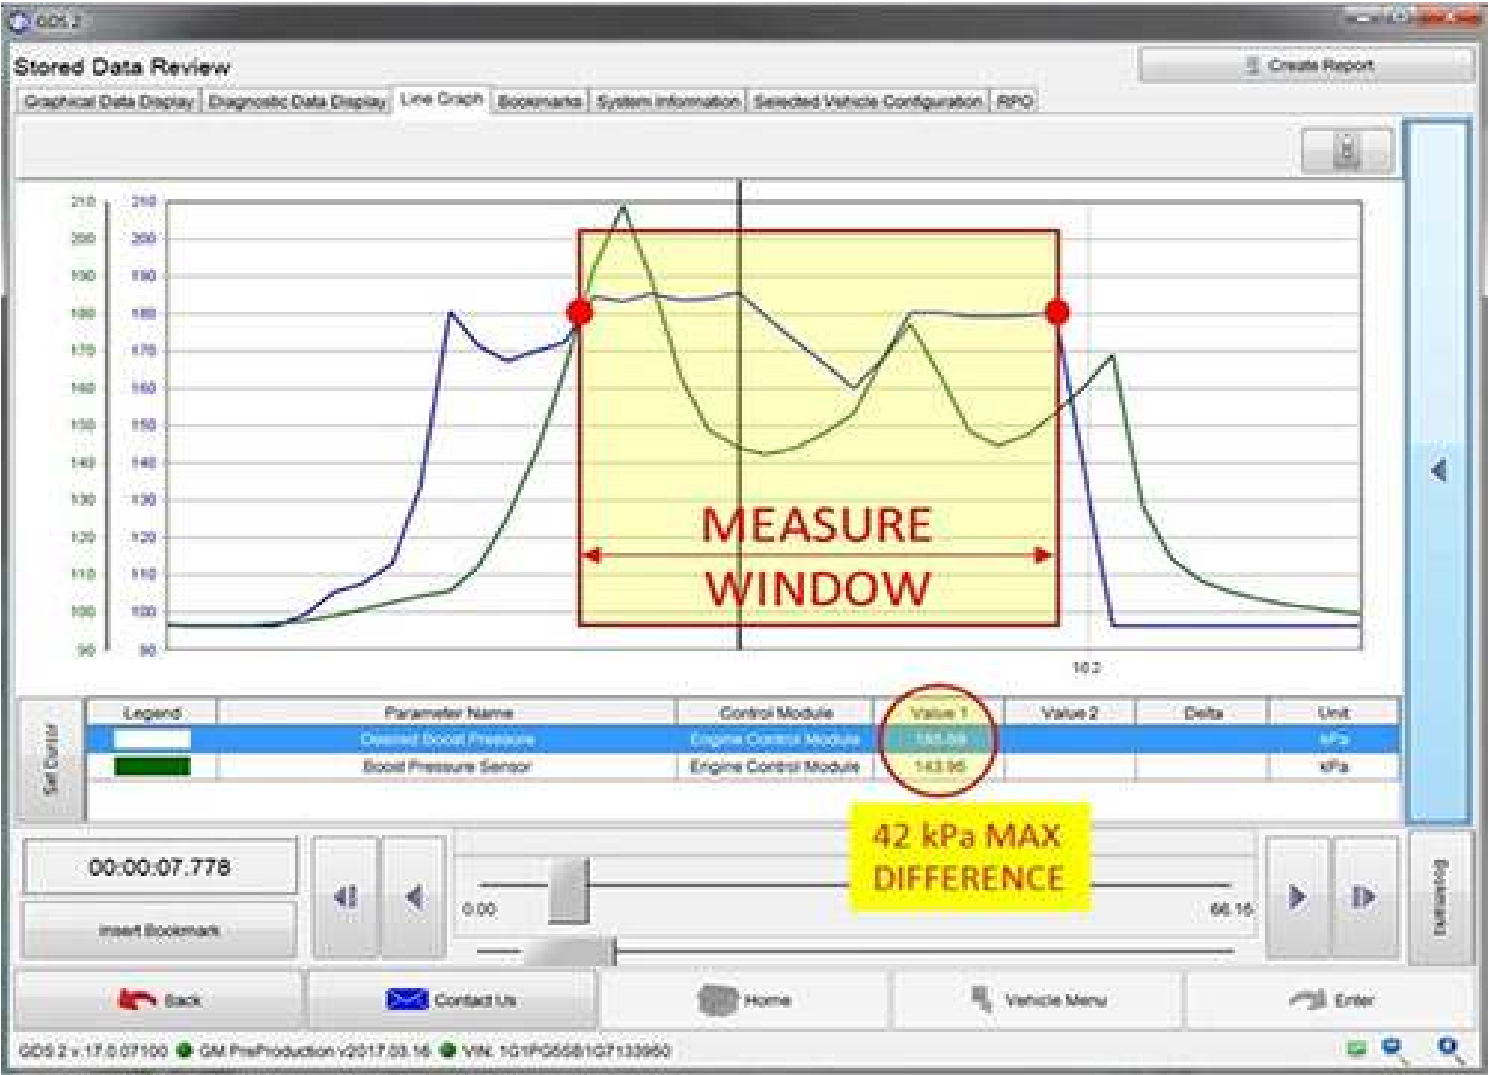
Example of a malfunctioning turbocharger wastegate:

In this example, notice that the Boost Pressure Sensor reading (Green) moves thru and well above the Desired Boost Pressure reading (Blue).

As the abnormally high pressure is corrected by the management system, the Boost Pressure Sensor reading (Green) over reacts and dips well below Desired Boost Pressure reading (Blue).

A difference of 14 KPA (2 PSI) between the Boost Pressure reading (Green) and the Desired Boost Pressure Sensor reading (Blue) Indicates a Malfunctioning Turbocharger.
