# Transaxle Whine Noise, Harsh Shift, MIL ON, or Reduced Power

## Applicability

| YEAR(S) | MODEL(S) | ADDITIONAL INFORMATION |
|---|---|---|
| 2017 - 2018 | Highlander, Sienna | Transmission(s): 8AT |

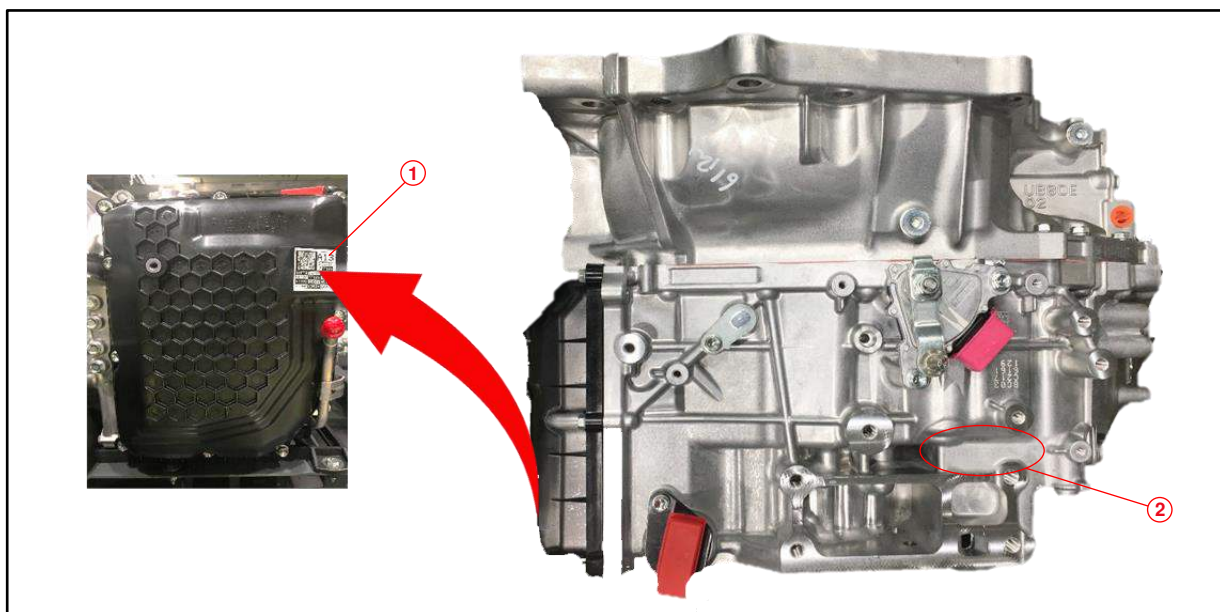
**Figure 1. Serial Number Sticker and Engraved Serial Number Location**

Locate the transaxle serial number, found on the sticker located on the transaxle assembly side cover or on the engraved location as shown. A serial number decoder is also provided below.

| 1 | Serial Number Sticker |
| 2 | Engraved Serial Number Location |

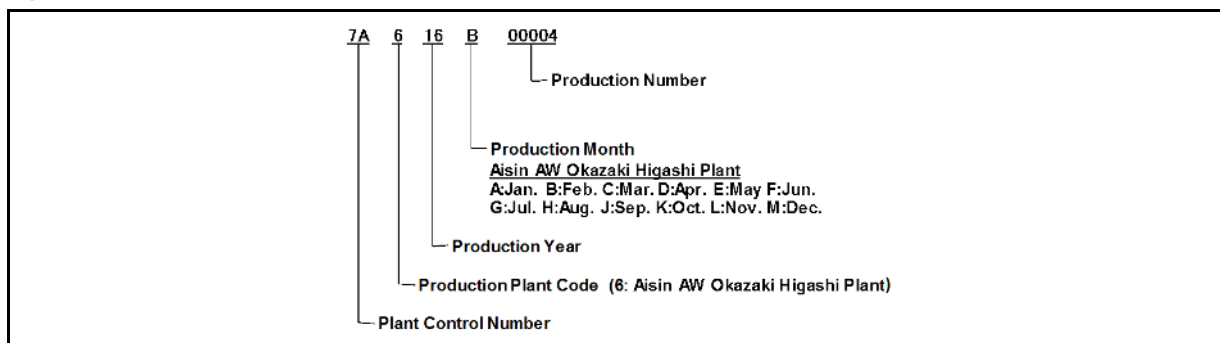
**Figure 2. AW Plant Serial Number Decoder**

| MODEL | PLANT | DRIVETRAIN | PRODUCTION CHANGE EFFECTIVE AT SERIAL NUMBER |
|---|---|---|---|
| Highlander | AW | 8AT | 7A617E03416 |

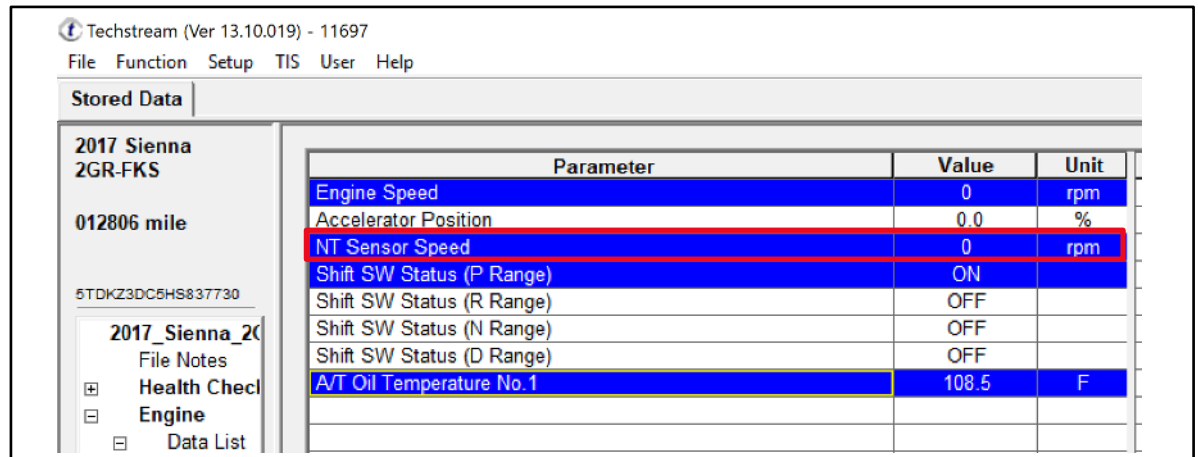
**Figure 3.**

Is the NT sensor speed less than or equal to the specification in Table 1 at the given parameter?

| PARAMETER | | | | NT SENSOR SPEED (rpm) | |
|---|---|---|---|---|---|
| 1 | P | 1,000 | 81° – 104°F (27° – 40°C) | Greater Than 850 | 850 or Under |
| 2 | | | 105° – 212°F (41° – 100°C) | Greater Than 900 | 900 or Under |
