## TECHNICAL SERVICE BULLETIN

### Lack Of Heat Or Cooling From The Cabin Vents - Temperature Door Or Door Actuator Binding/Inoperative - DTC B1081:07

**21-2199**

28 June 2021

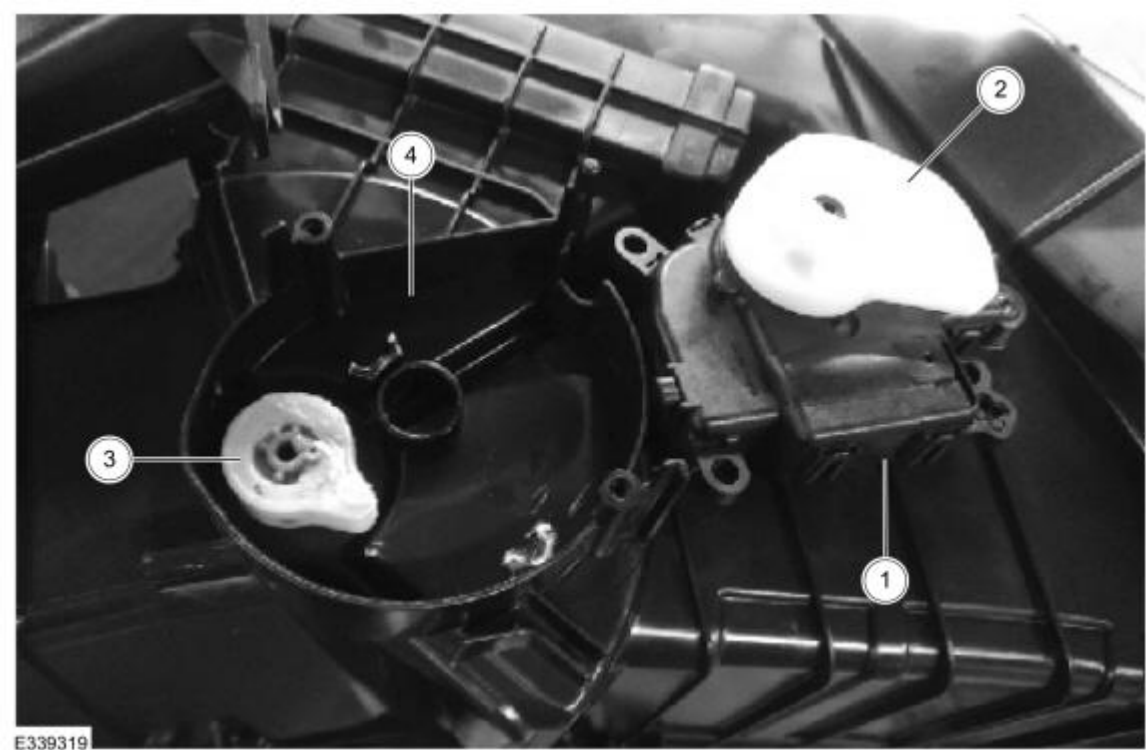
**NOTE: Do not remove the cam follower from the climate control housing blend door. It is critical to be gentle when cleaning the cam follower as damaging the temperature blend door shaft will require replacement of the climate control housing. (Figure 1)**

1. Gently wipe the driver side temperature blend door actuator, cam, and cam follower attached to the climate control housing blend door to remove any debris and existing lubricant.

2. Replace the driver side temperature door actuator and cam. Refer to WSM, Section 412-00. Lubricate the new cam and cam follower pin using Motorcraft® HVAC Duct Component Grease.
3. Reassemble per WSM. Test the temperature blend door operation. Does the system operate properly?

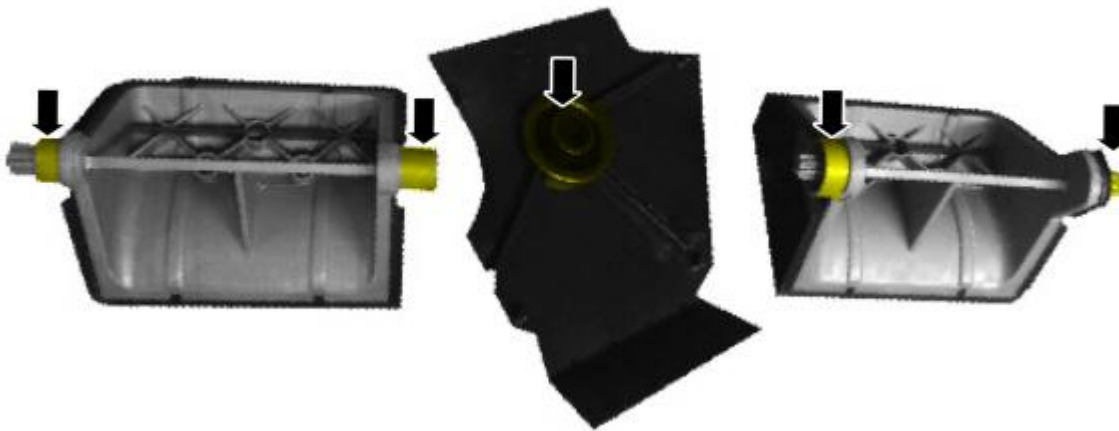
Figure 5 - Arrows indicate where to lubricate the temperature blend door bearing

4. Lubricate the climate control housing and temperature blend door bearing surfaces with Motorcraft® HVAC Duct Component Grease. (Figures 5-7)

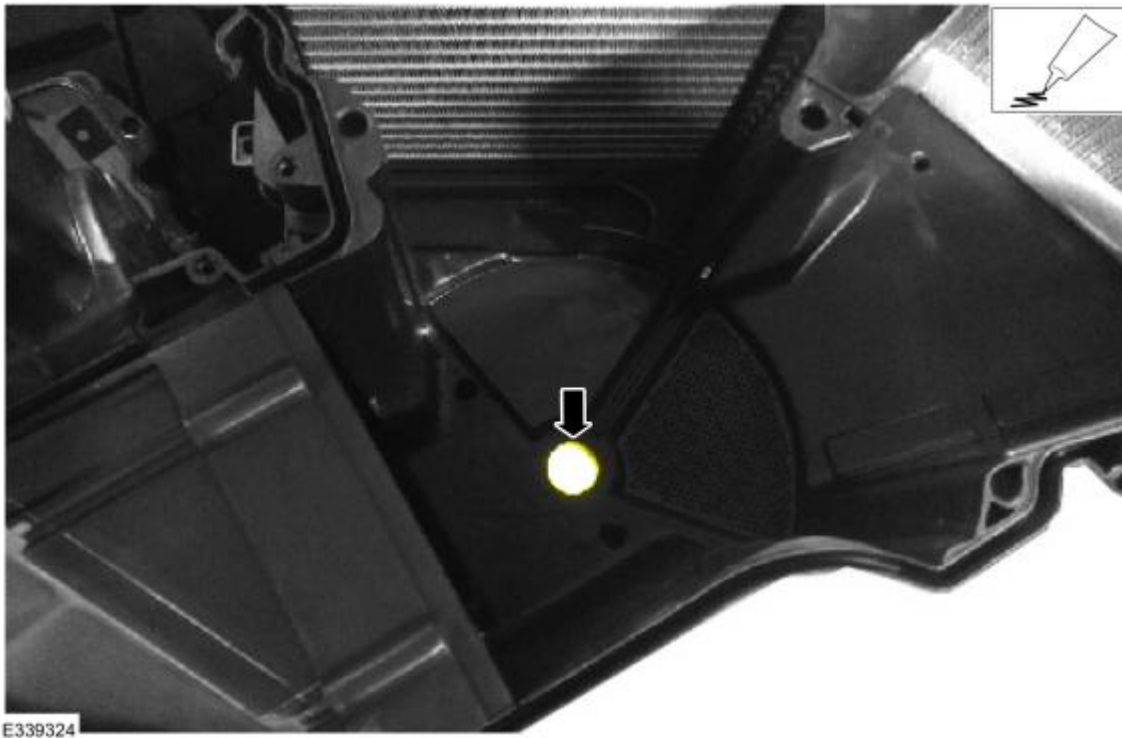
Figure 6 - Arrow indicates where to lubricate the climate control housing surface for the temperature blend door

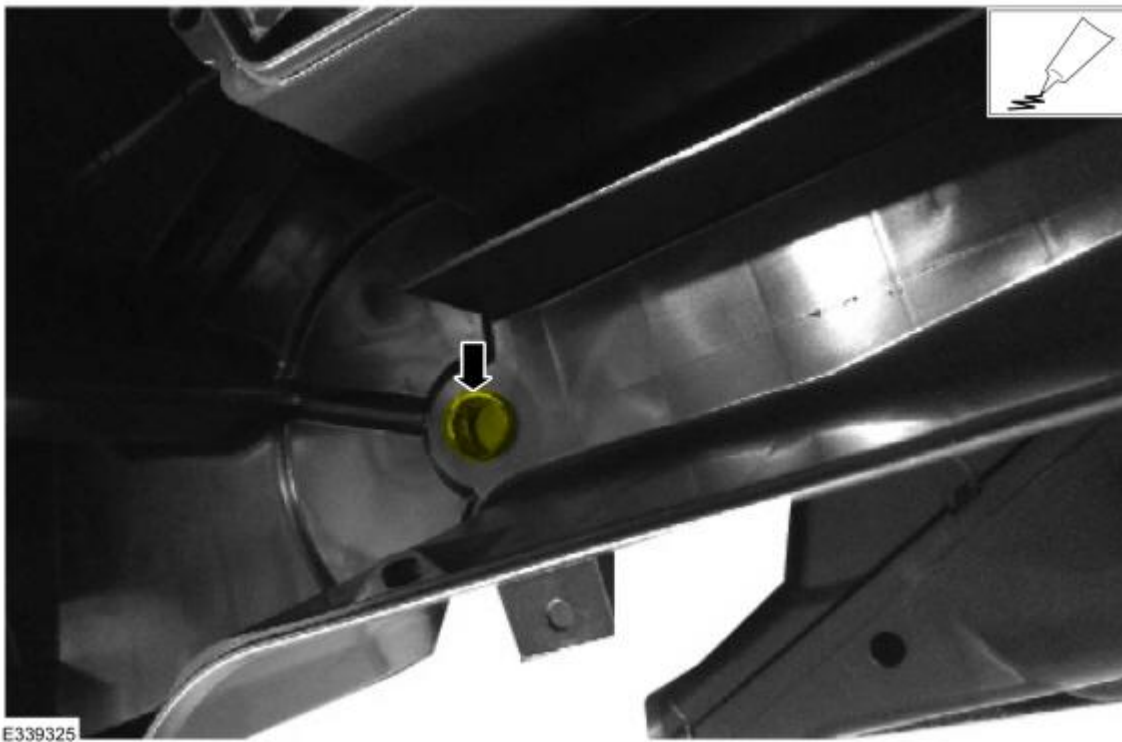
Figure 7 - Arrow indicates where to lubricate the climate control housing surface for the temperature blend door

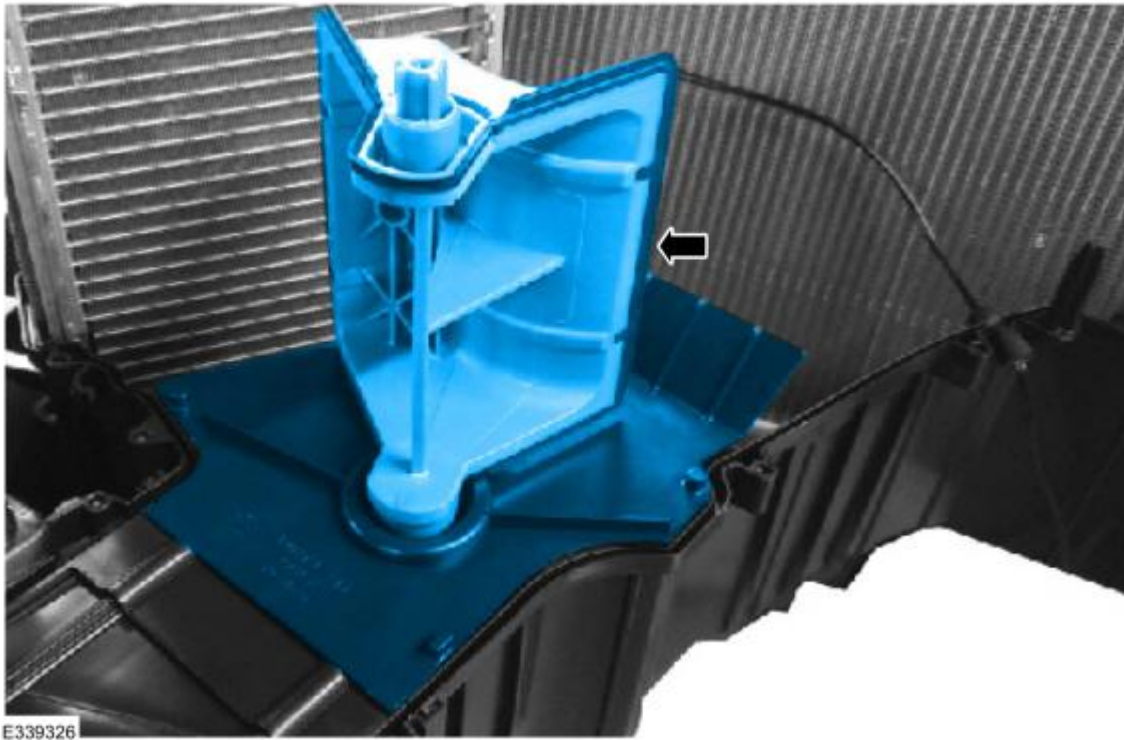
Figure 8 - Highlighted area shows temperature blend door assembly properly installed back into the climate control housing

5. Reassemble the temperature blend door halves and install back into the climate control housing. Align the temperature blend door support half using the dowel pins. (Figure 8)
