# Service Bulletin

Bulletin No.: 20-NA-218

Subject: Possible Crank No Start or Extended Crank with DTC P12A6

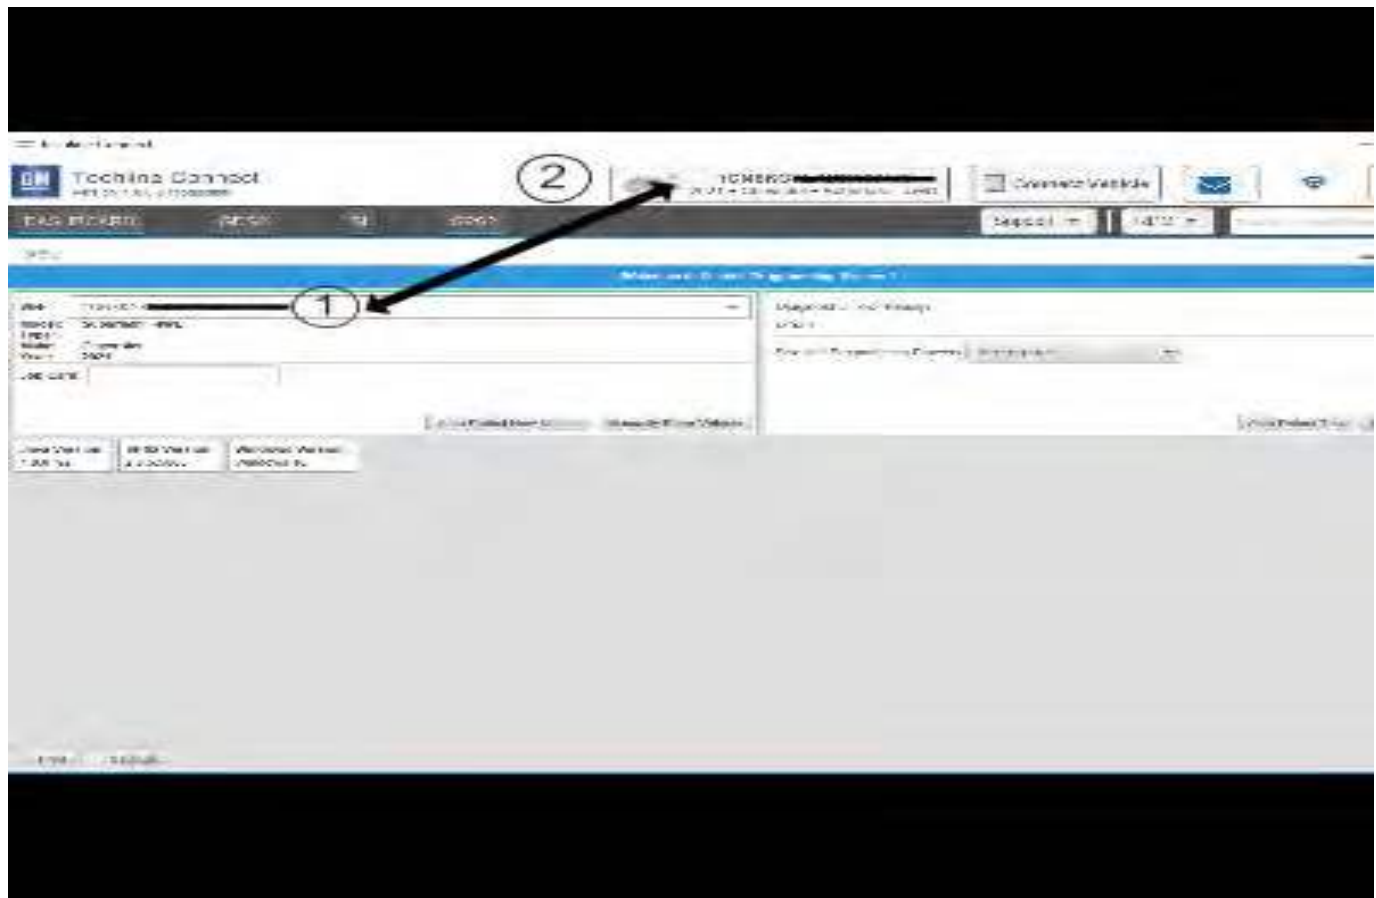
5743643

Caution: Be sure the VIN selected in the drop down menu (1) is the same as the vehicle connected (2) before beginning programming.

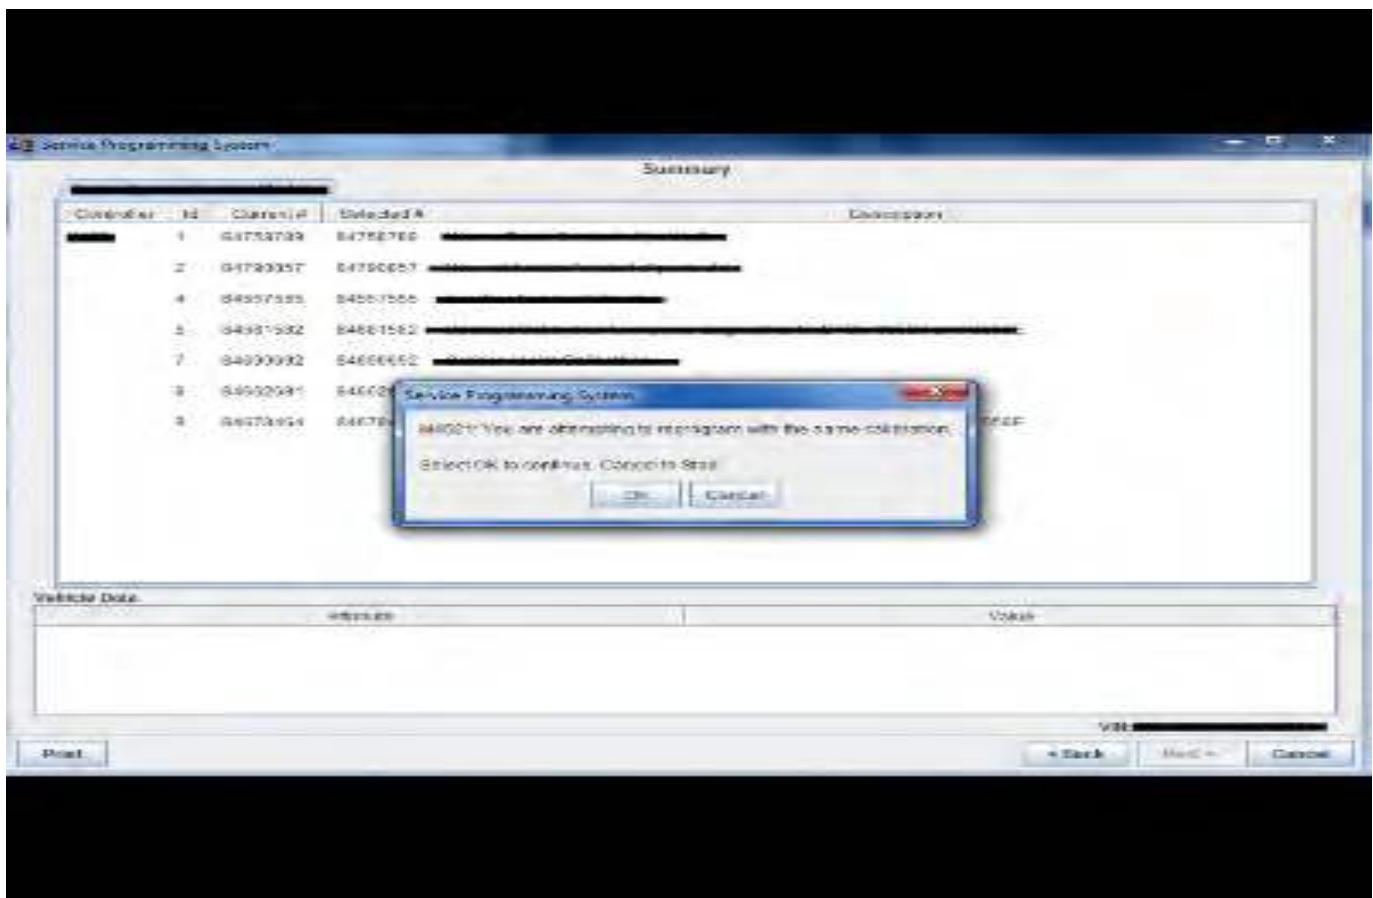
5431207

Important: Techline Connect and TIS2WEB screens shown above.

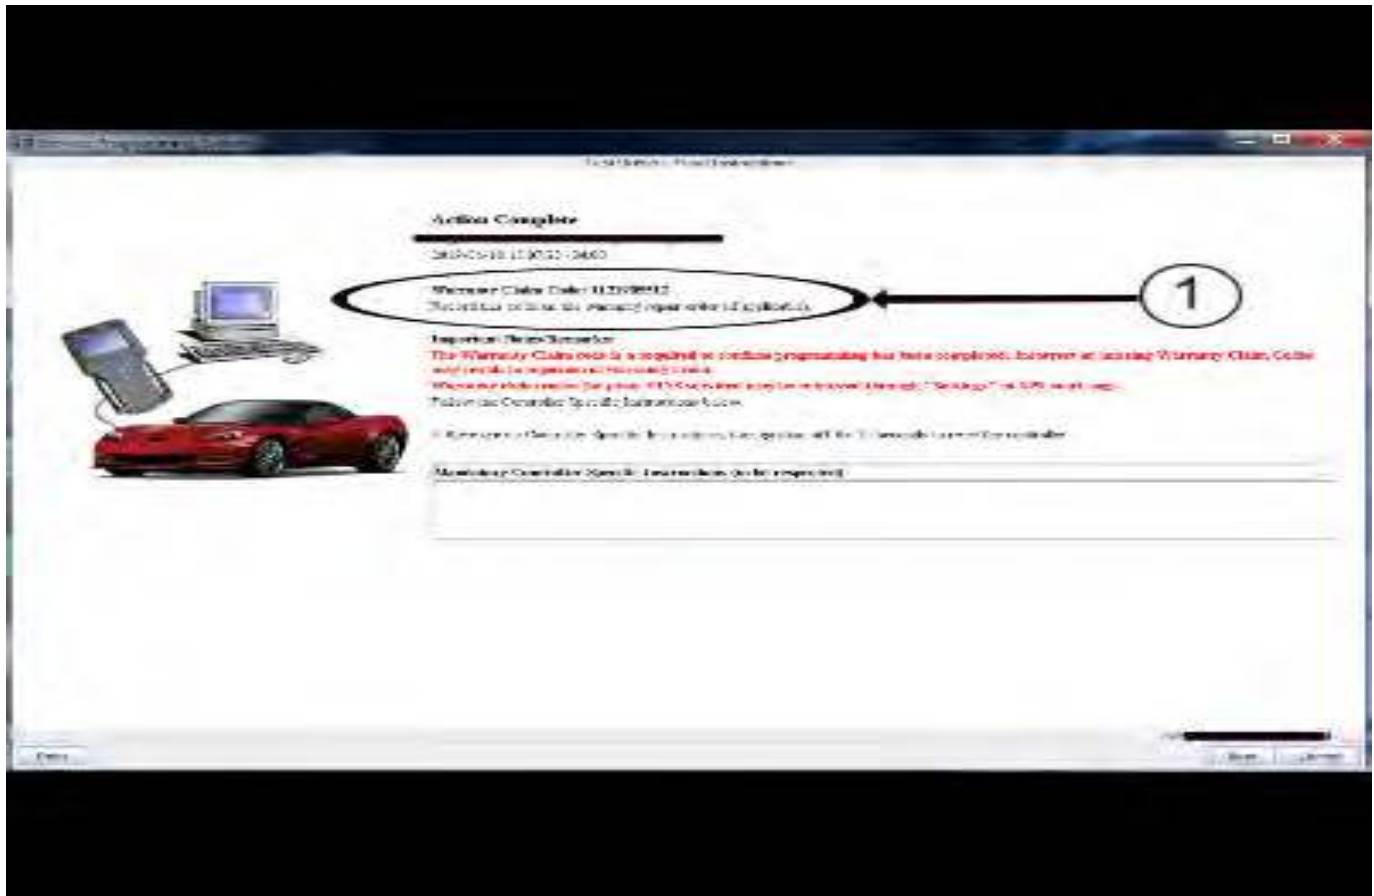
5431209

Important: To avoid warranty transaction rejections, you **MUST** record the warranty claim code provided on the SPS Warranty Claim Code (WCC) screen shown above on the job card. Refer to callout 1 above for the location of the WCC on the SPS screen.

2. Record the SPS Warranty Claim Code on the job card for warranty transaction submission.
