| <b>HYUNDAI</b><br><b>Technical Service Bulletin</b> | | GROUP<br><b>Engine Mechanical</b> | NUMBER<br><b>21-EM-007H</b> |
| | | DATE<br><b>June, 2021</b> | MODEL(S)<br><b>Sonata Hybrid (LF HEV),<br/>Sonata Plug-In Hybrid (LF PHEV)</b> |
| <b>SUBJECT:</b> | <b>DTC P2600 ENGINE ELECTRIC WATER PUMP<br/>DIAGNOSIS AND REPAIR GUIDELINE</b> | | |

**Description:** This bulletin describes the procedure to diagnose and repair the Engine Electric Water Pump (EEWP) on certain Sonata Hybrid (LF HEV) and Sonata Plug-In Hybrid (LF PHEV) vehicles with DTC P2600, causing an HEV and/or MIL warning lamp illumination.

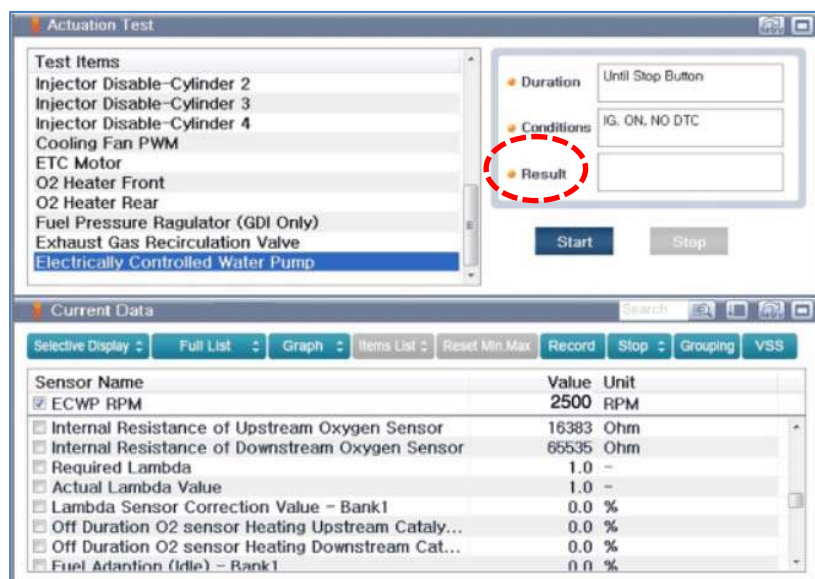
1. Confirm that there are sufficient coolant levels in the Engine Coolant Reservoir.
  - If coolant levels are low, check for leaks and repair as needed.
2. Turn on the engine.
3. Connect GDS and clear all related DTC's.
4. Use GDS and force activate the EEWP with an actuation test.

- If EEWP fails to operate when commanded ON with the GDS Actuation Test, check connectors for loose connections.
    - While EEWP is commanded ON, apply a wiggling motion on the connections to confirm wiring connections and pins are not damaged. Repair as needed.
5. Make note of any DTCs that set or failed operation and listen for the EEWP making noise.
    - If EEWP State displays a Fault Code, then replace the EEWP.
    - If EEWP State displays a Protection Code, check voltage on auxiliary battery.
      - An EEWP static pressure related DTC may be generated in case of abnormal auxiliary battery voltage.
