# Technical Service Bulletin

## 55 Power rear lid cannot be opened, DTC B113E07 and/or B113E29 are stored in the rear lid electronics module

55 21 58 2064020/1 July 16, 2021.

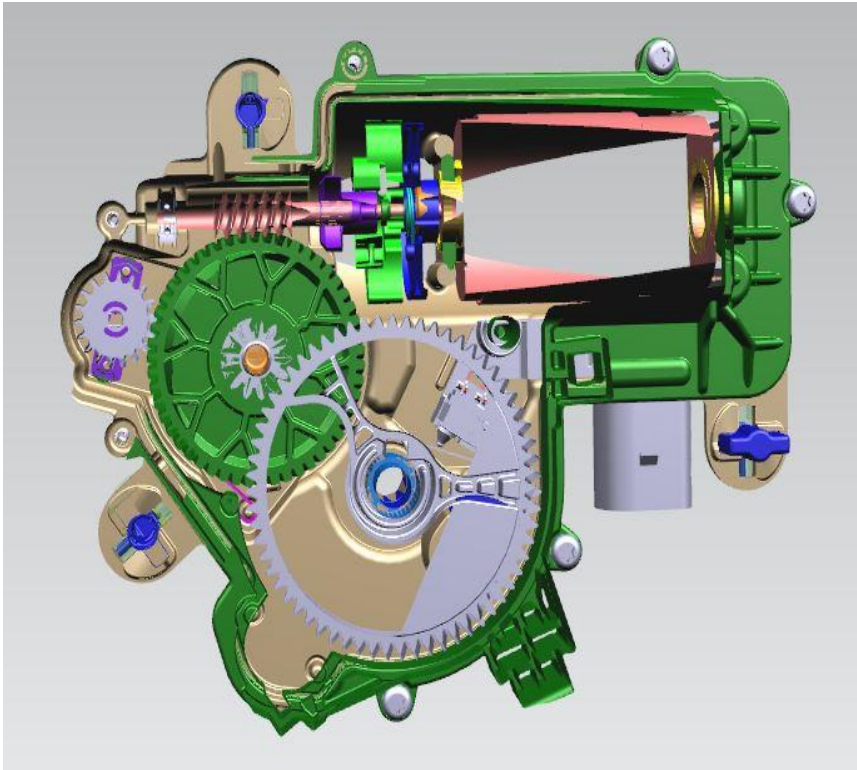
Due to component-related deviations of the rear lid closing assist motor, the closing assist motor can be internally blocked. Consequently, the power rear lid can no longer be opened as the rotary latch of the rear lid lock is not released by the closing assist motor (Figure 1).

**Figure 1.** Rear lid closing assist motor.

Optimized rear lid closing assist motors implemented in series production with MY22.

2. Open the rear lid and remove the rear lid lower trim panel according to the Elsa Repair Manual.
3. Replace the closing assist motor.
4. Check the operation of the closing assist motor and the power rear lid before reinstalling the rear lid lower trim panel.
5. Reinstall the rear lid lower trim panel and clear any relevant DTC(s).

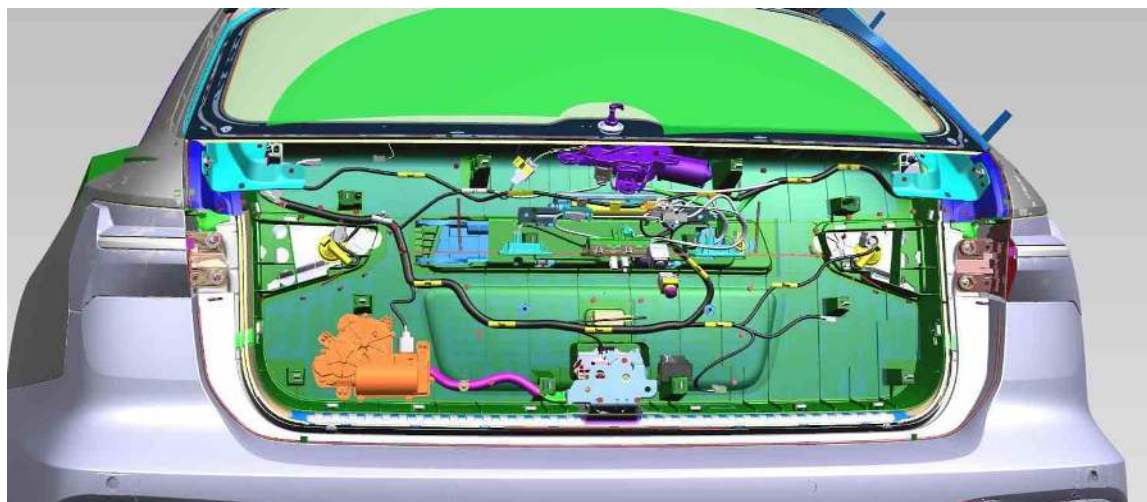
**Figure 2.** Carefully knock in the area of the closing assist motor. Its location varies and is model specific.

1. If it is not possible to open the power rear lid using the vehicle key, the interior/exterior buttons or the emergency release, carefully knock with your hand on the rear lid in the area of the closing assist motor (Figure 2). The resulting vibrations should release the blockage within the closing assist motor.
