# Technical Service Bulletin

## 48 DTC B116831 is stored in the ABS control module

48 21 08 2063526/1 August 2, 2021.

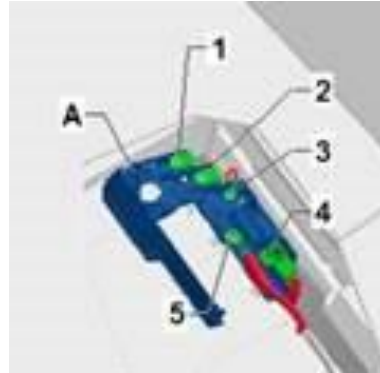
- This can be caused by a voltage drop in the power steering control module, J500 (address word 0044).
- The main fuse carrier may be the cause.

1. When the vehicle is started, the voltage should not drop by more than 1 Volt at contact 4 on the fuse carrier. This is power supply to the power steering control module, J500 (address word 0044) (Figure 1).

**Figure 1.** Fuse carrier's power supply to the power steering control module, J500 (address word 0044).

2. If the voltage drops more than 1 Volt then the fuse carrier must be replaced. Replace the fuse carrier according to the instructions in the Elsa Repair Manual.
3. If this procedure does not lead to an improvement, continue the diagnosis on other components of the power supply for the power steering. Review the battery history data to help find the voltage drop.
