ITB20-025B

## DTC B2724-23 AND/OR C1B56-04 STORED, AND/OR RAB ERROR MESSAGE OR WARNING

**APPLIED VEHICLES:**        2020-2021 QX50 (J55)

**APPLIED SYSTEM:**        Rear Automatic Braking

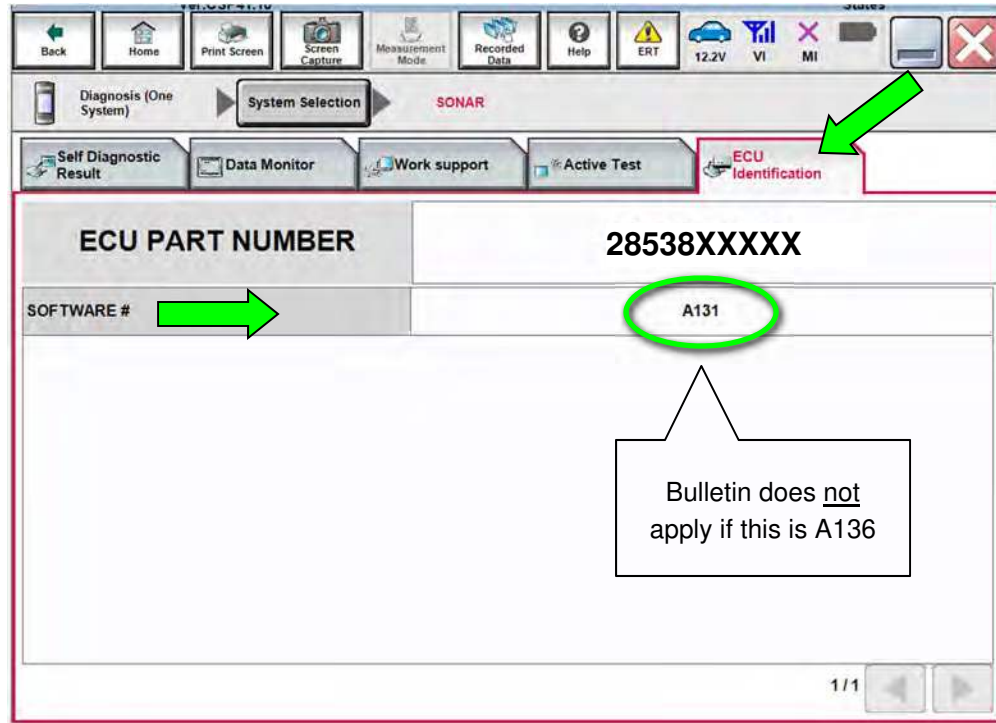
Figure 5

12. Select ECU Identification.
13. Confirm the SOFTWARE #. See Figure 5.
  - If the SOFTWARE # is A136, this bulletin does not apply. See the Electronic Service Manual (ESM) for further diagnostic information.
  - If the SOFTWARE # is not A136, proceed to step 14.

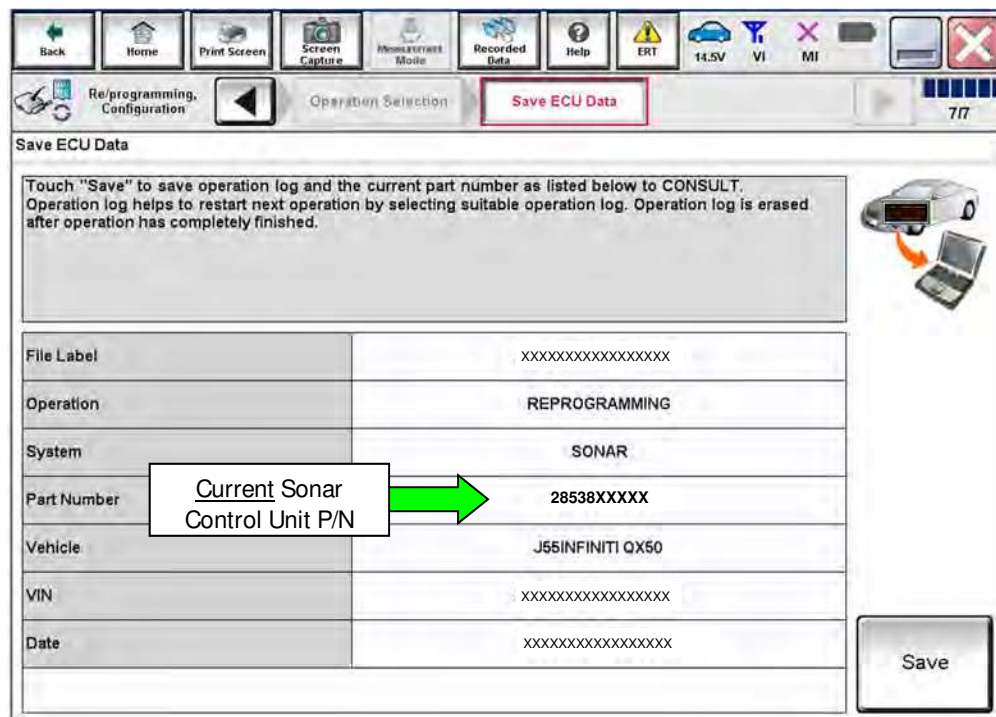
Figure 14

25. When you get to the screen shown in Figure 14, confirm that a reprogram is available as follows.

- A. Find the Sonar Control Unit Part Number and write it on the repair order.

B. Compare the part number you wrote down to the part numbers in Table A.

- If there is a match, continue with the reprogramming procedure.
- If there is not a match in Table A, this bulletin does not apply. See the ESM for further diagnostic information.

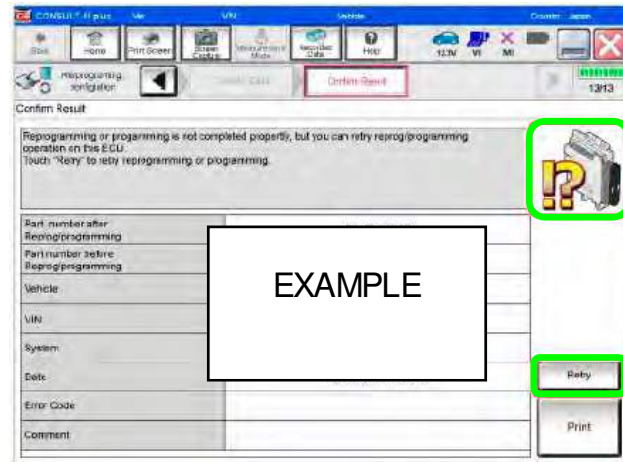
Figure 25

If reprogramming does not complete and the “!?” icon displays as shown in Figure 25:

- Check battery voltage (12.0 - 15.5 V).
- Ignition is ON, engine OFF.
- External Bluetooth® devices are OFF.
- All electrical loads are OFF.
- Select retry and follow the on screen instructions.
- “Retry” may not go through on first attempt and can be selected more than once.

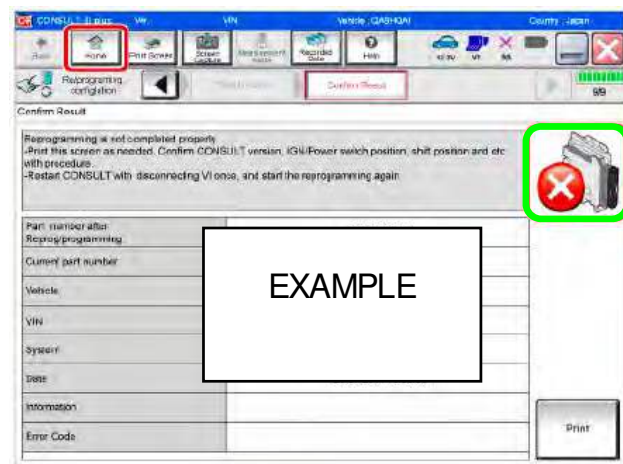
Figure 26

If reprogramming does not complete and the “X” icon displays as shown in Figure 26:

- Check battery voltage (12.0 - 15.5 V).
- CONSULT A/C adapter is plugged in.
- Ignition is ON, engine OFF.
- Transmission is in Park.
- All C-III plus / VI cables are securely connected.
- All C-III plus updates are installed.
- Select Home, and restart the reprogram procedure from the beginning.

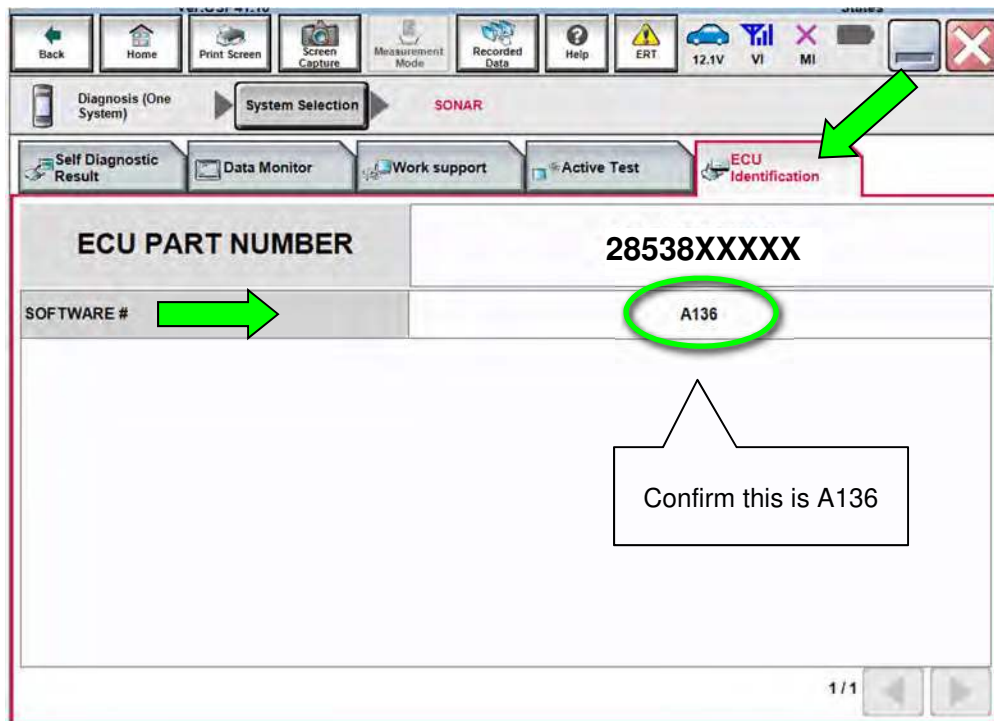
Figure 39

62. Confirm the SOFTWARE #. See Figure 39.

- If the SOFTWARE # is A136, proceed to step 63.
- If the SOFTWARE # is not A136, reprogramming did not successfully complete. Go back to step 15 on page 6 and perform the procedure again.

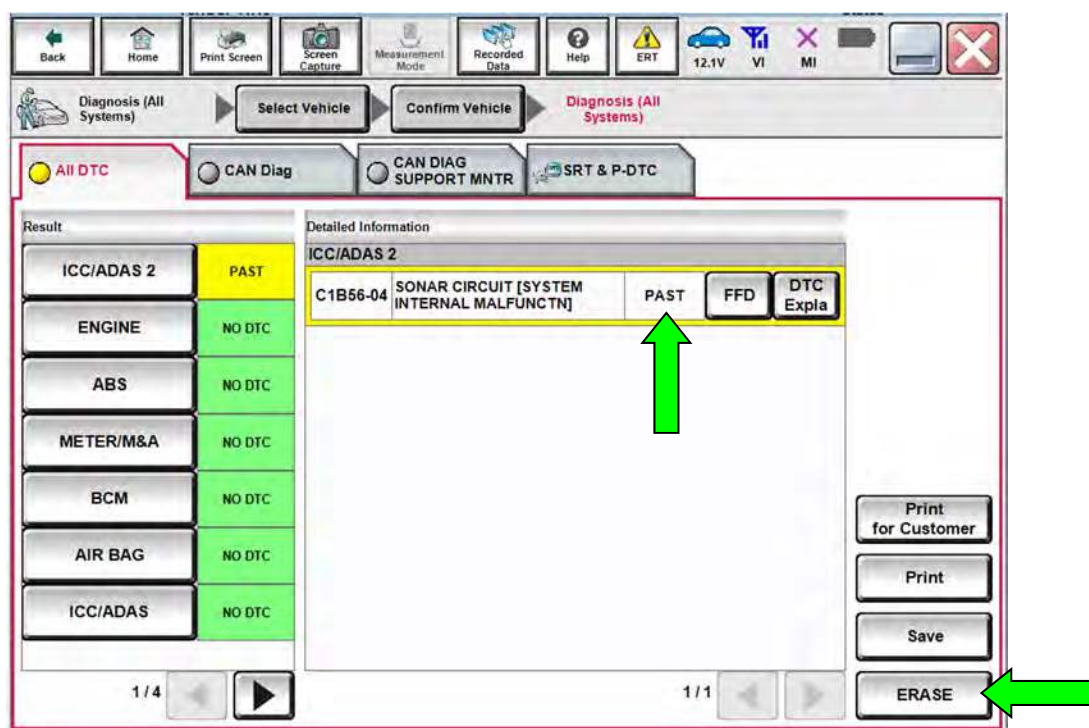
Figure 42

65. Select Automatic Selection(VIN).
66. Select Confirm.
67. Select Confirm.
68. Turn the ignition OFF, then turn the ignition ON.
69. Confirm DTC C1B56-04 is displayed as PAST (not CRNT). See Figure 42.
70. Select ERASE.
