# Technical product information

| <b>Topic</b> | Bentayga - DTC C103129 - Air suspension warning displayed in Driver Instrument Panel |
| <b>Transaction No.</b> | 2063891/1 |

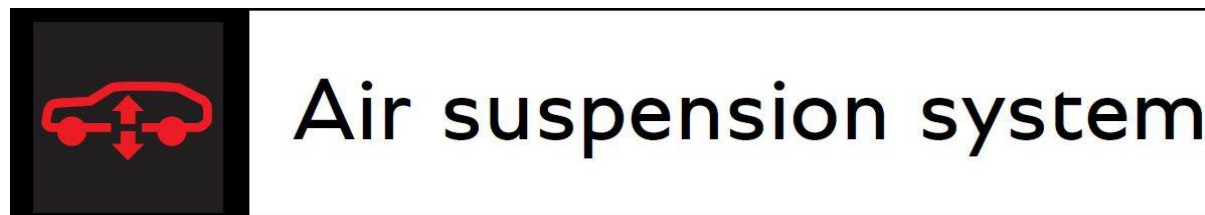
Air suspension system warning displayed in the Driver Instrument Panel (DIP)
