**August 11, 2021**

Version 3

**Product Update: 2016–20 HR-V Software Update and CVT Inspection**

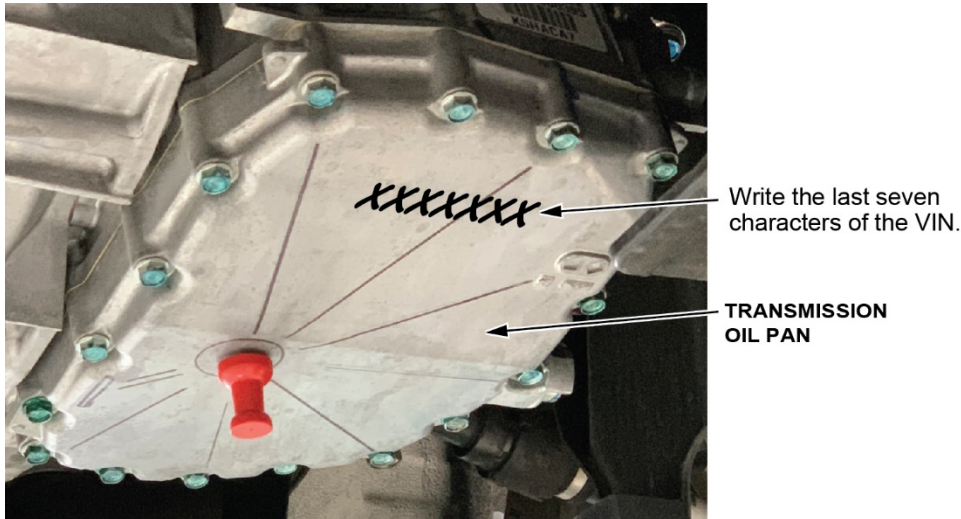
10. After tracing all 7 lines from the outside to the inspection area, let go of the magnet to see if it sticks in place. If the magnet sticks to the oil pan in the inspection area there is a problem with the transmission. Write the last 7 characters or digits of the VIN on the bottom of the oil pan. Take a clear picture of the magnet sticking to the oil pan in the inspection area, make sure the VIN characters are clearly seen in the picture, then go to service bulletin 21-047, *Warranty Extension 2016 - 20 HR-V CVT Premature Belt Deterioration*. If the magnet does not stick to the oil pan, go to the next step.
