NUMBER  
**231 (Rev 2, 08/24/2021)**

## TECHNICAL SERVICE BULLETIN

### FRONT VIEW CAMERA REPLACEMENT FOR DTC C160449 & C160649

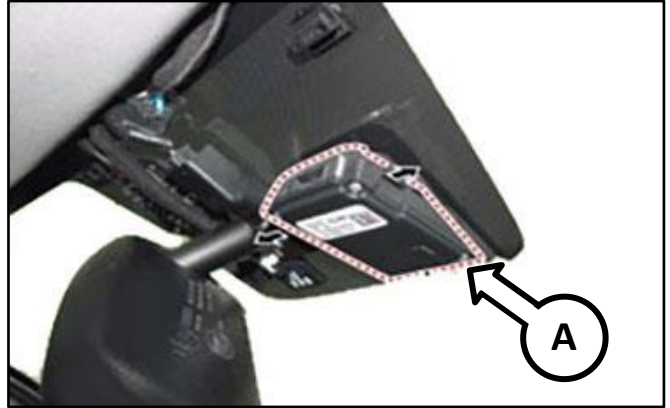
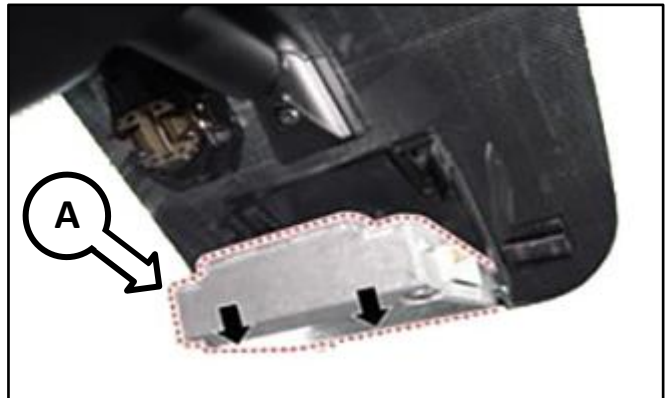
This bulletin provides information on the inspection and replacement of the front camera on some vehicles listed below. Due to an internal control chip concern inside the camera, the vehicle may exhibit a Forward Collision Avoidance Assist Warning Lamp (A) and/or Master Warning Lamp (B) with C160449 and/or C160649 codes. Certain systems may become temporarily disabled during occurrences: Smart Cruise Control (SCC), Lane Keep Assistance (LKA), Lane Departure Warning (LDW), Forward Collision-Avoidance Assist (FCA), Forward Collision Warning (FCW) and/or Driver Attention Warning (DAW). Follow the procedure outlined in this publication to diagnose and replace the front view camera assembly.

1. Remove and replace the Front View Camera (A) by referring to the “Body Electrical System → Front Camera System → Front View Camera Unit → Repair Procedures” chapter in the applicable Shop Manual on KGIS.
