**TECHNICAL SERVICE BULLETIN****Illuminated ABS Indicator, Engine Will Not Turn Off And/Or Various Electrical Symptoms - BJB Cover Not Fully Seated****21-2176**13 August  
2021

| <b>Ford</b><br>2020-2021 Super Duty |

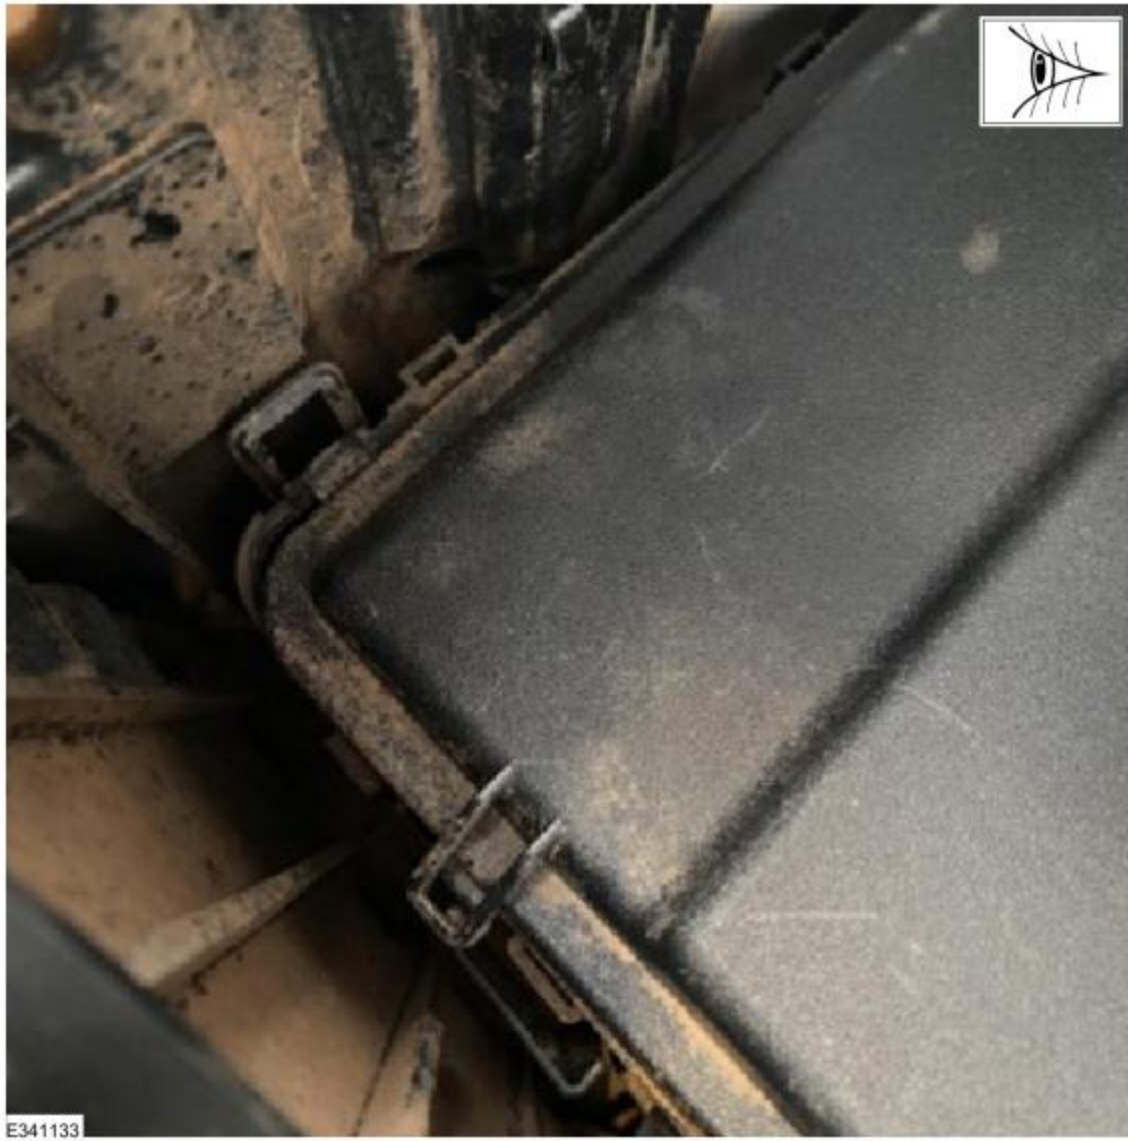
1. Visually inspect the BJB for signs of water/moisture intrusion. Are there signs of water/moisture intrusion into the BJB and/or broken cover tabs/locking fingers?

Figure 1 - Example of moisture intrusion with BJB cover on

## 2. Replace the BJB assembly.

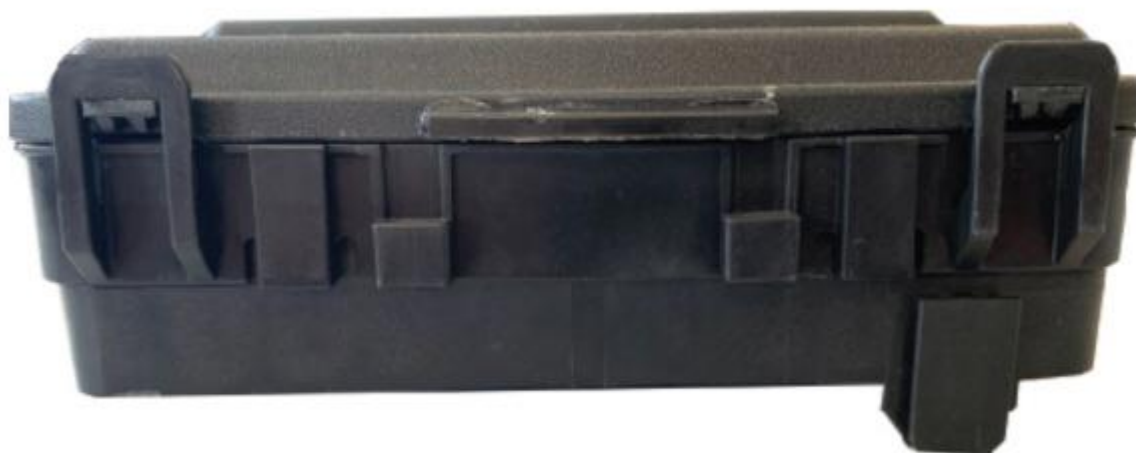
E341135

Figure 3 - Correct cover installation

- (9). Install the new BJB cover making sure the cover tabs/locking fingers are installed correctly.
- (10). Install the battery tray and battery back into the vehicle. Refer to WSM, Section 414-01.

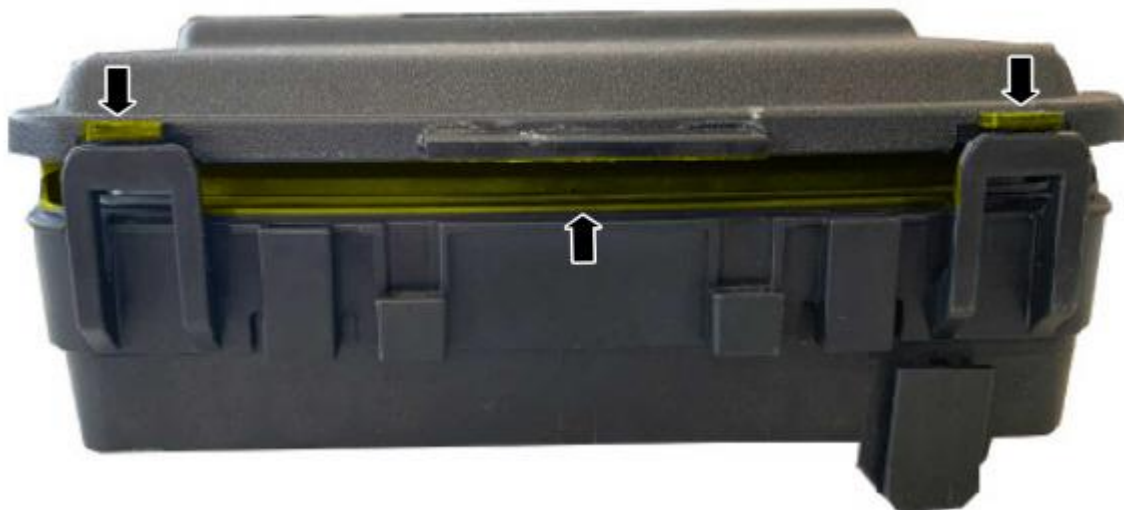
E341136

Figure 4 - Incorrect cover installation

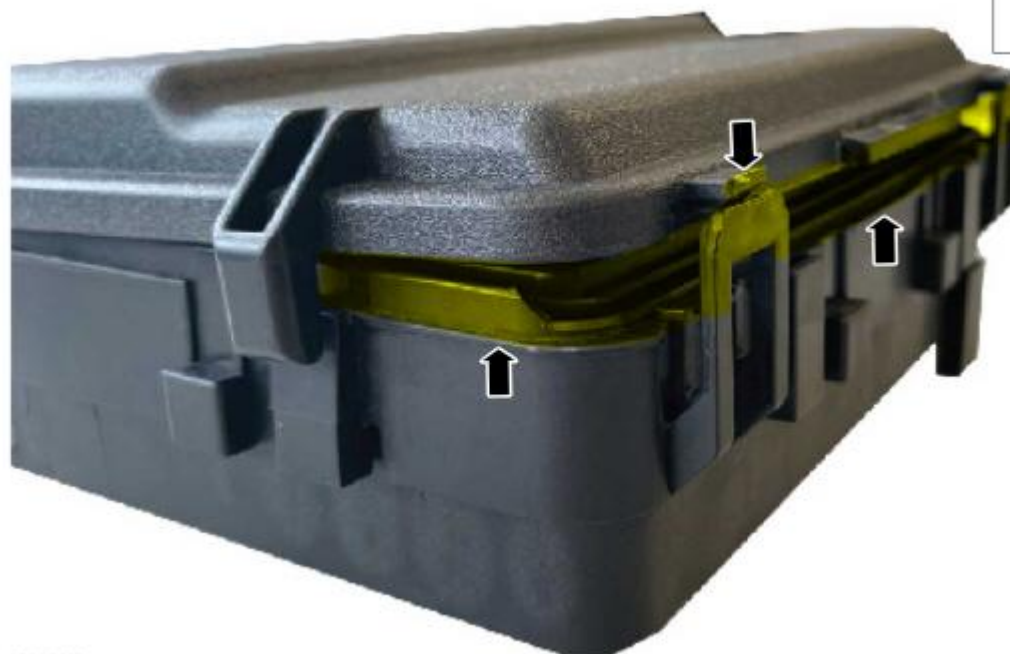
E341138

Figure 6 - Incorrect cover installation
