# Preliminary Information

PIP5651E Possible Charge Air Cooler Outlet Hose Disconnected From Throttle Body And One or More of The Following DTCs  
P0172, P0299, P0101, P0506, P1101

Proactive  
Product Investigation Review Required  
Models

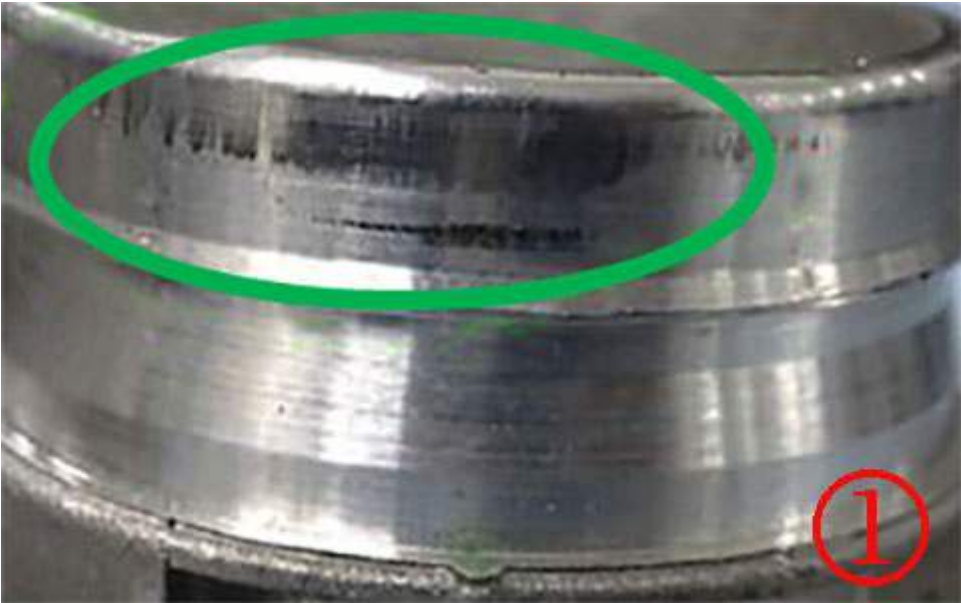
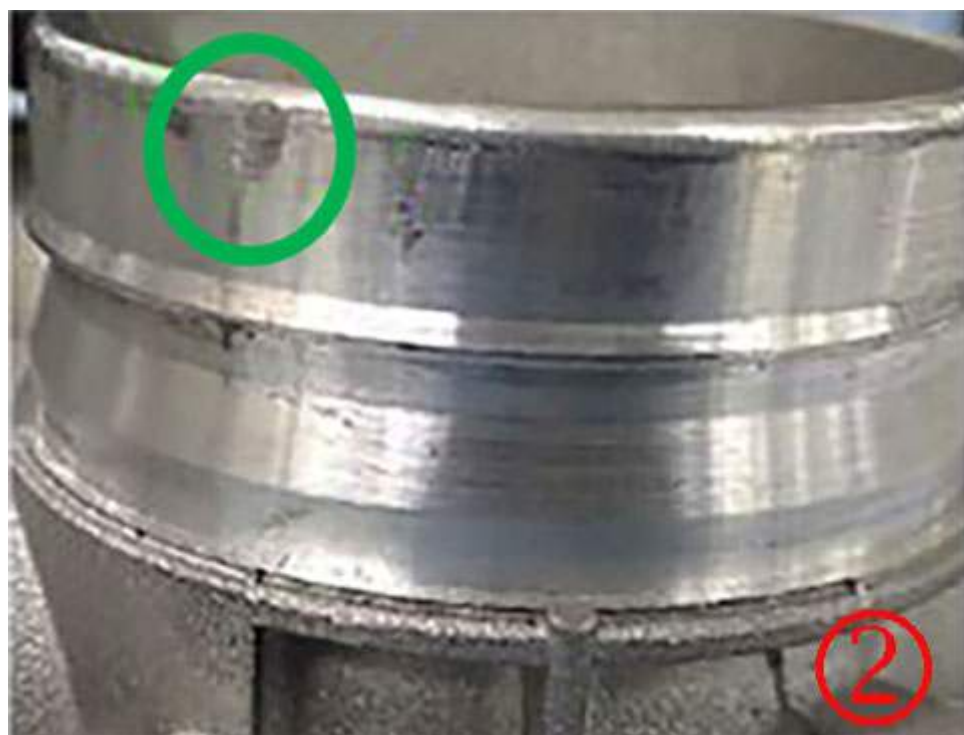
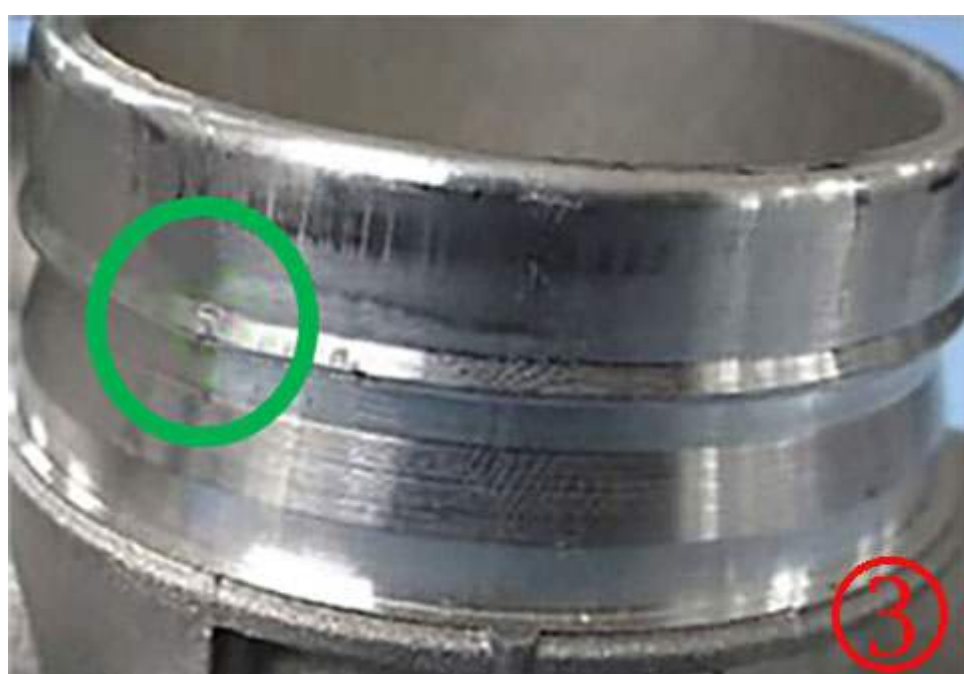
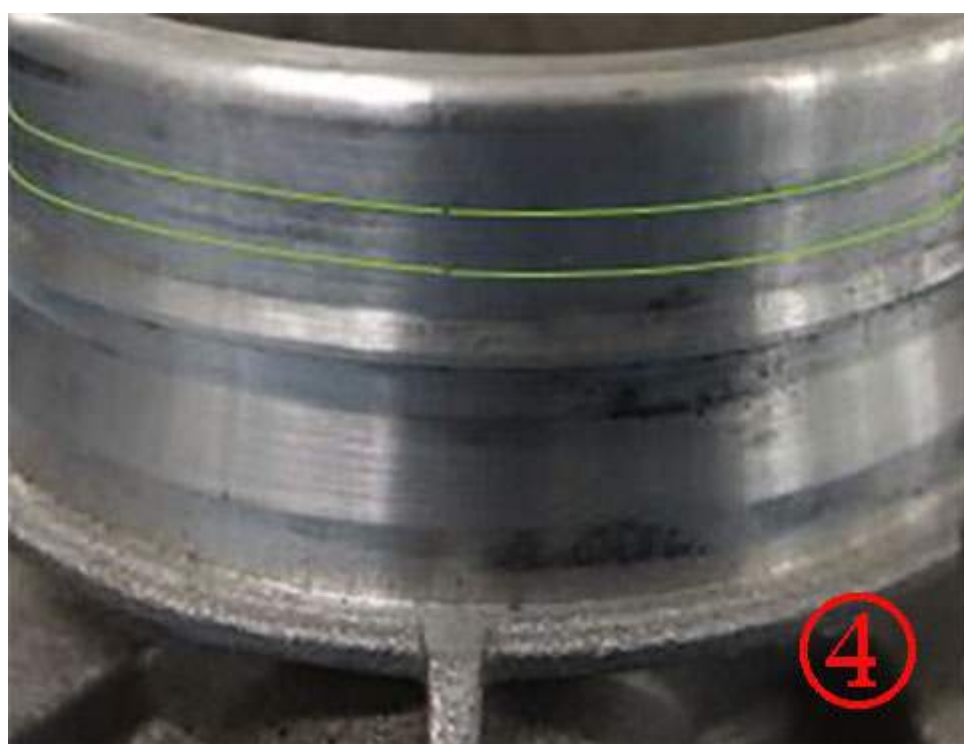
Photos 1-4 below show normal witness marks on the throttle body and normally will not require replacement.

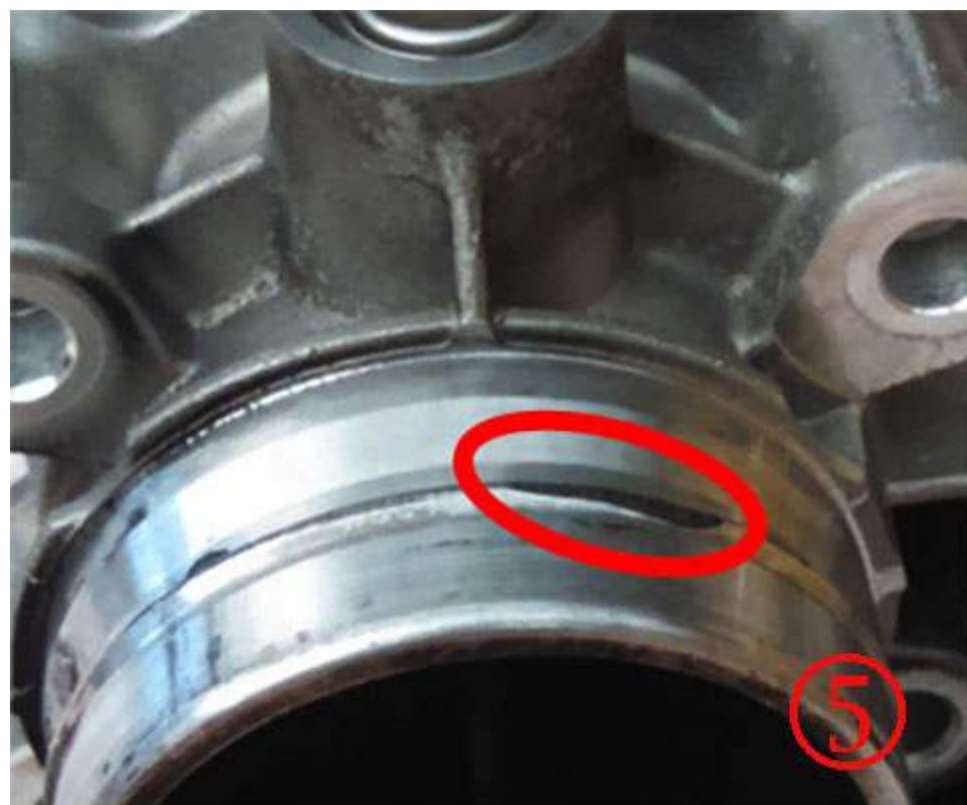
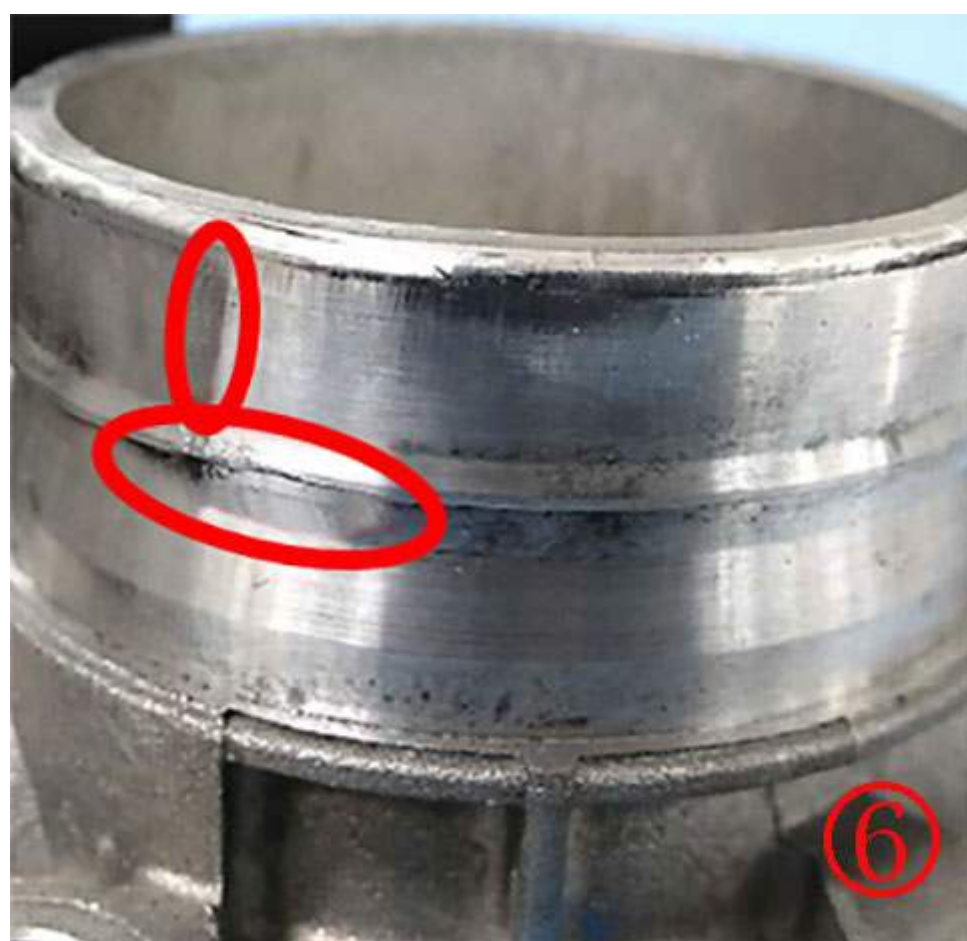
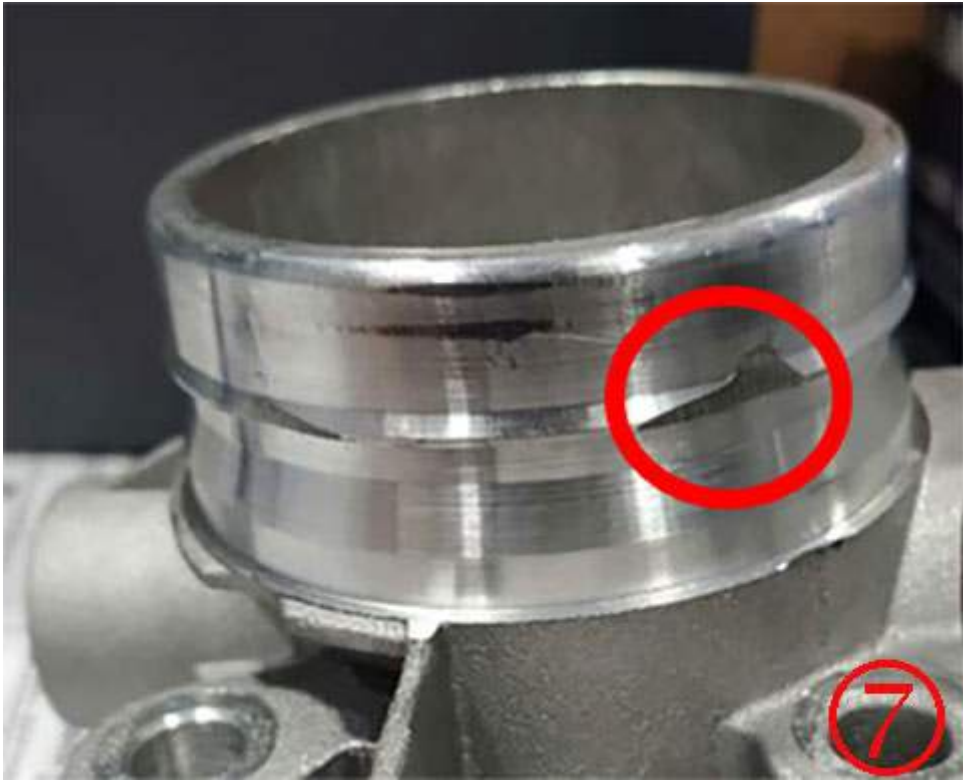
Photos 5-7 below show abnormal witness marks or damage to throttle body and replacement would be required.

If the tube is disconnected from the throttle body, inspect the charge air cooler tube and throttle body for damage. In rare cases either are damaged then replace the damaged part (reference photos below showing).The throttle body and mass airflow (MAF) sensor associated with the listed codes should only be replaced if they are damaged or found to be the cause of the code.
