# Technical Service Bulletin

## 55 Power rear lid not closing fully, rear lid lock not engaging secondary latching position, DTC B113E29

55 21 59 2064476/1 September 10, 2021.

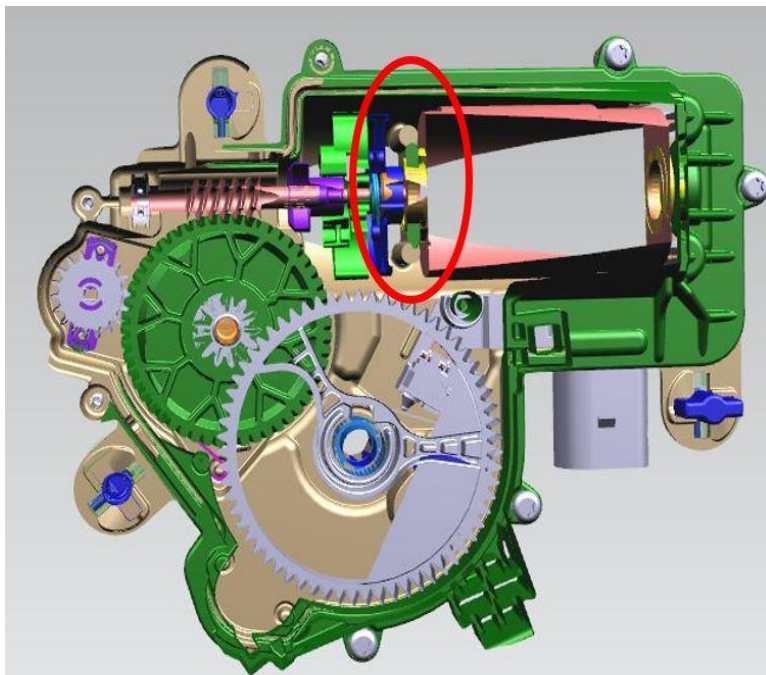
- 1 The internal clutch of the closing assist motor can be blocked due to a dimensional deviation (Figure 1).

**Figure 1.** Blocked clutch due to a dimensional deviation.

Replace the rear lid closing assist motor according to the Elsa Repair Manual.

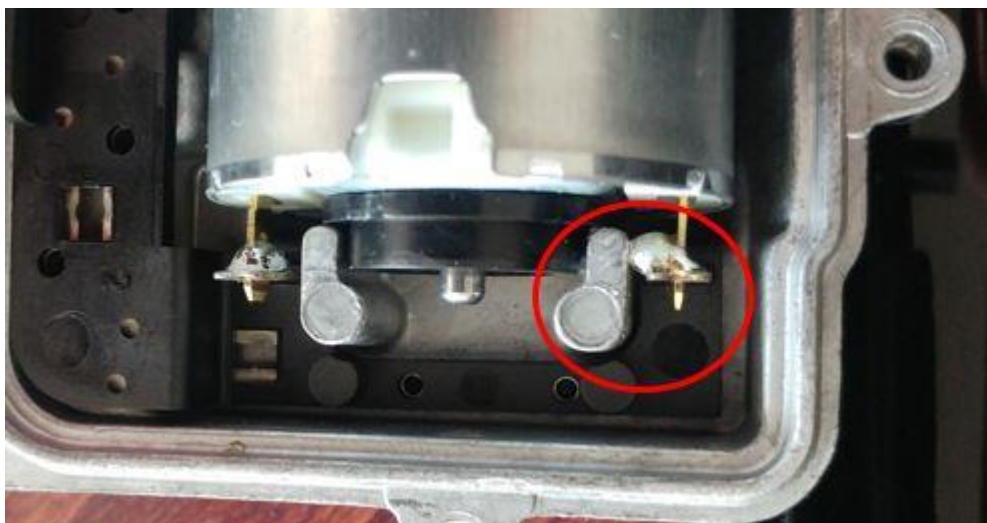
- 2 An improper solder joint inside the closing assist motor can cause a short circuit (Figure 2).

**Figure 2.** Short circuit caused by solder joint.

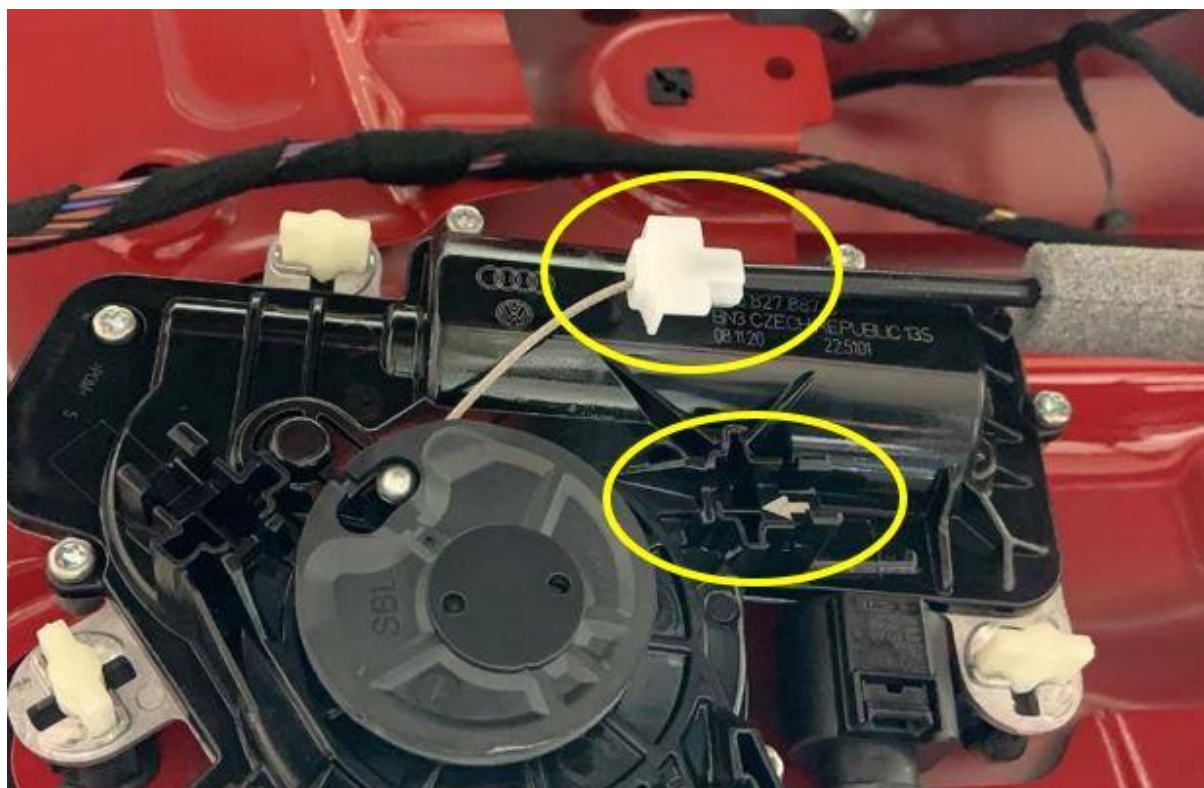
- 3 The Bowden cable clip has detached from the closing assist motor housing (Figure 3).

**Figure 3.** Detached Bowden cable clip.
