# Technical Service Bulletin

## 94 Reverse lamp is inoperative, DTC(s) B12CB15 or B12CC15 stored in the comfort system control module

94 21 45 2063766/1 September 2, 2021.

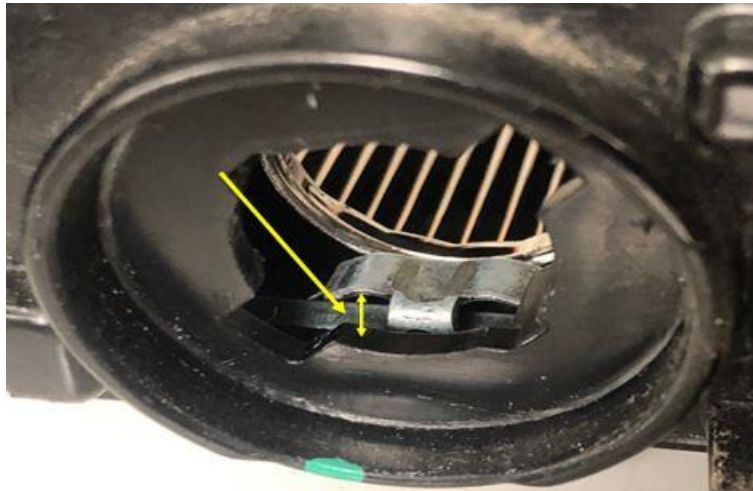
The internal circuit board for the reverse lamp (located in the lamps on the rear bumper) may become separated from the tail lamp housing. When this occurs the metal contact loses connection with the bulb socket.

**Figure 1.** Tail lamp contact loose/pulled away from housing.

1. If the bulb socket contact is loose/pulled away from the housing, the lamp will need to be replaced (Figure 1).

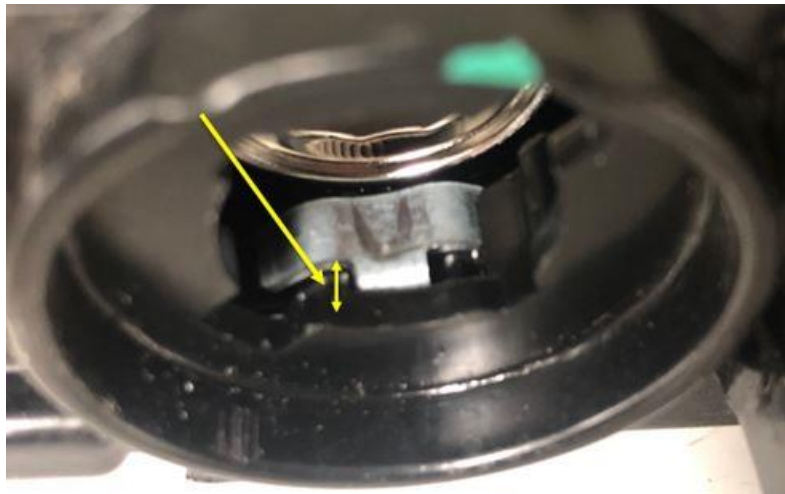
**Figure 2.** Lamp contact has separated from housing.

2. If the bulb socket contact is flush with the housing then no repair is needed (Figure 2).  
Continue with normal diagnosis outside of this TSB.
