# Technical Service Bulletin

## 94 Rear lights do not switch from bumper to hatchgate after closing

94 21 47 2050234/5 September 22, 2021. Supersedes Technical Service Bulletin Group 94 number 18-96 dated January 30, 2018 for reasons listed below.

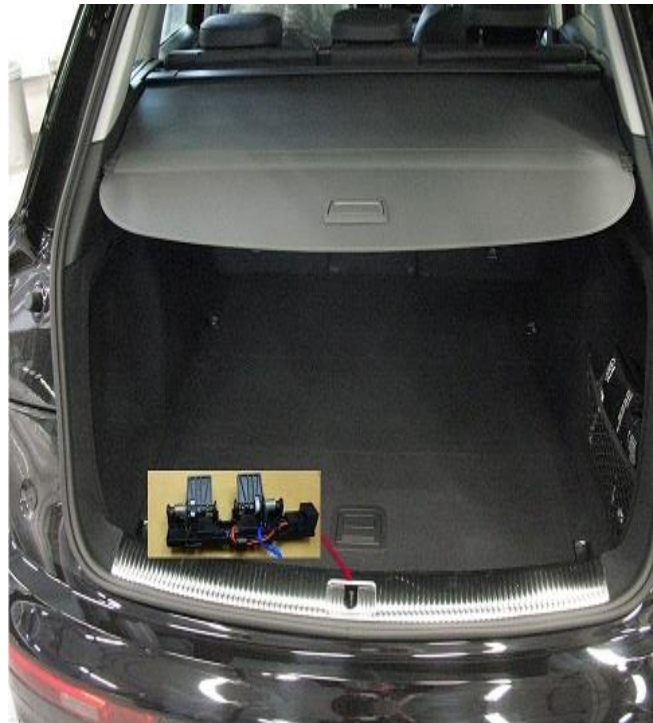
**Figure 1.** Rear lid closed sensor.

The two micro switches for the reverse light change-over are under the loading sill cover on the rear cross panel and are secured to the striker for the rear lid lock (Figure 1).

1. The paddle on the micro switch was broken due to the adjustment of the rear hatch or the striker in production.
2. Dirt can block one/both paddles on the micro switch, which is fastened to the striker of the rear lid (Figure 2).

3. Replace the rear lid closed sensor if found broken (Figure 1).
4. If debris is found to be obstructing proper switch activation/deactivation, activate the switch paddles using your fingers and remove the debris. Using compressed air is effective.
5. Then check the measuring values for the G525 and G526 switches and replace the rear lid closed sensor if the malfunction persists. Only the improved rear lid closed sensor with the protective enclosure is available.
