## TECHNICAL SERVICE BULLETIN

### Illuminated Airbag Warning Indicator With DTC B1404:13 And/Or B1407:13

**21-2297**

10 September  
2021

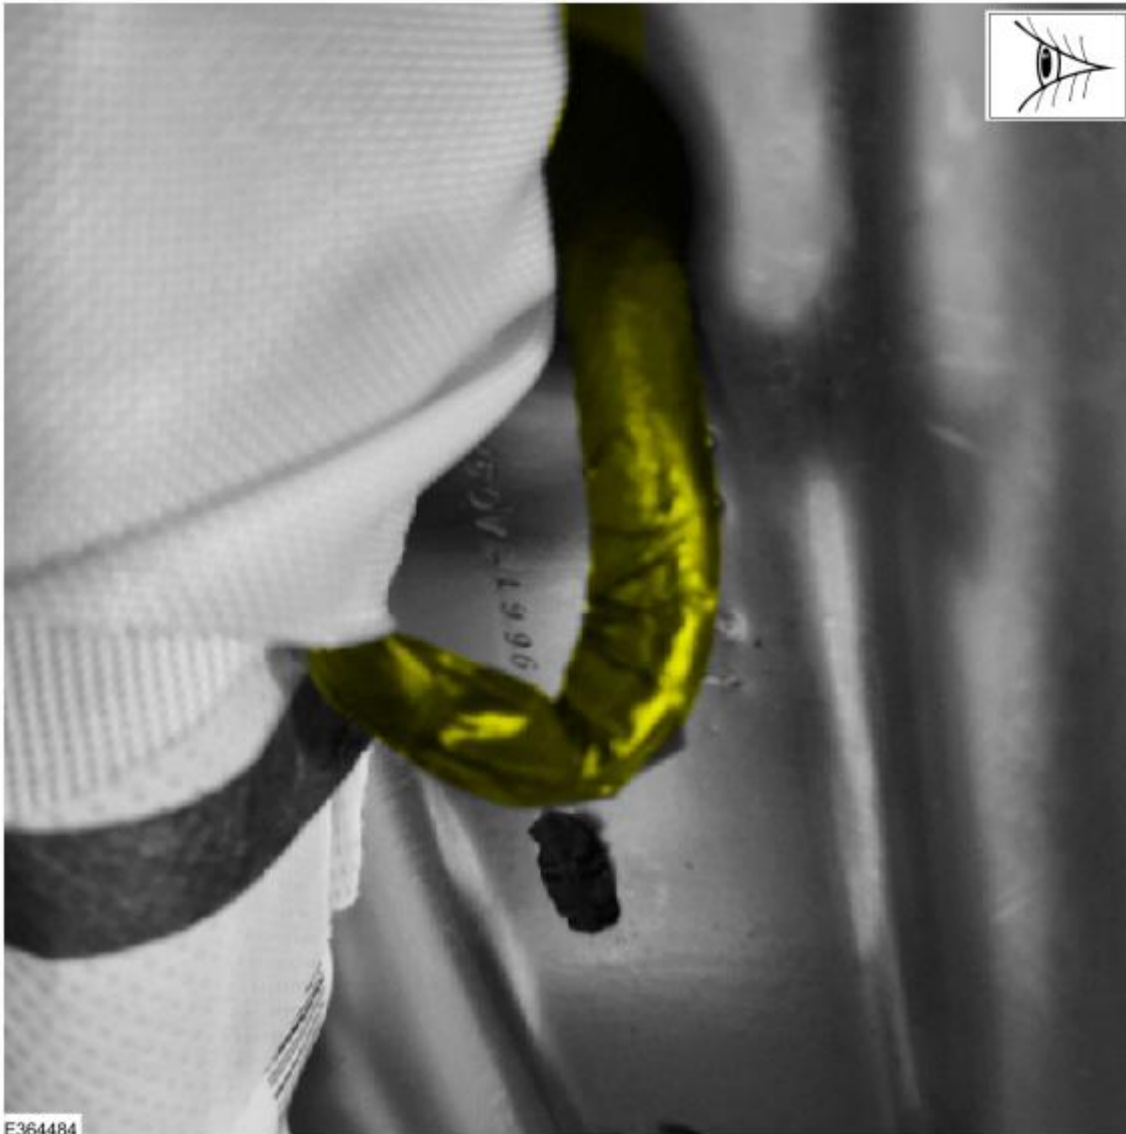
Figure 1

**Issue:** Some 2020-2021 Explorer/Aviator and 2021 Bronco vehicles may exhibit an illuminated airbag warning indicator with diagnostic trouble code (DTC) B1404:13 and/or B1407:13. This may be due to contamination and relative movement in the connection between the wiring harness and the side airbag. To correct the condition, follow the Service Procedure steps to replace the affected connector with a service pigtail and the affected side airbag.

5. Make sure the wiring harness is pulled outboard of the seat frame to prevent strain on the connector after replacing the side airbag. (Figure 1)
