# Technical Service Bulletin

## 55 Power rear lid not closing fully, rear lid lock not engaging secondary latch position, DTC B113E29, B12E015, B113E07

55 21 60 2064476/2 September 30, 2021. Supersedes Technical Service Bulletin Group 55 number 21-59 dated September 10, 2021 for reasons listed below.

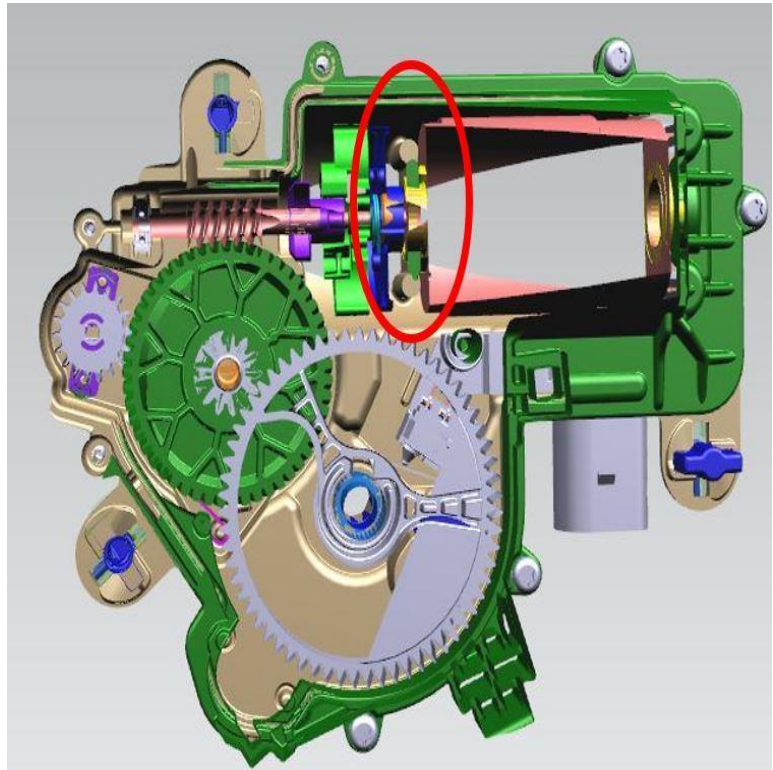
1. The internal clutch of the closing assist motor can be blocked due to a dimensional deviation. This failure mode could cause DTC B113E07 to store (Figure 1).

**Figure 1.** Blocked clutch due to a dimensional deviation.

Replace the rear lid closing assist motor according to the Elsa Repair Manual.

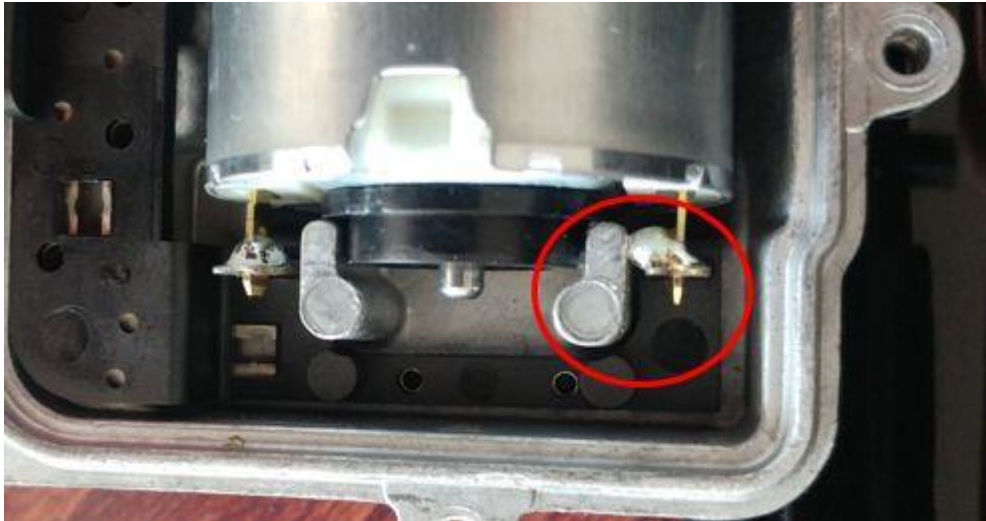
2. An improper solder joint inside the closing assist motor can cause a short circuit. This failure mode could cause DTC B12E015 to store (Figure 2).

**Figure 2.** Short circuit caused by solder joint.

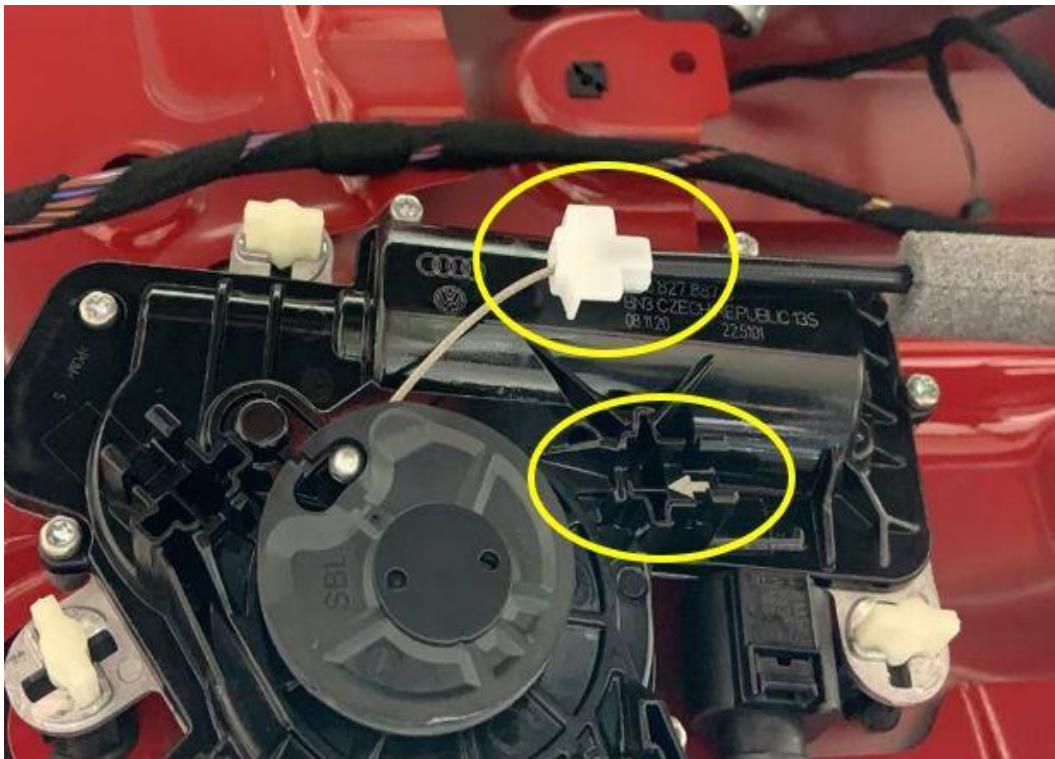
3. The Bowden cable clip has detached from the closing assist motor housing. This failure mode could also cause DTC B113E07 to store (Figure 3).

**Figure 3.** Detached Bowden cable clip.
