## Technical product information

| <b>Topic</b> | Air suspension warning light within the DIP - DTC's P089200 - C104707 - C103B13 - Evident within Address 74 |
| <b>Brand</b> | Bentley |
| <b>Transaction No.</b> | 2062259/3 |

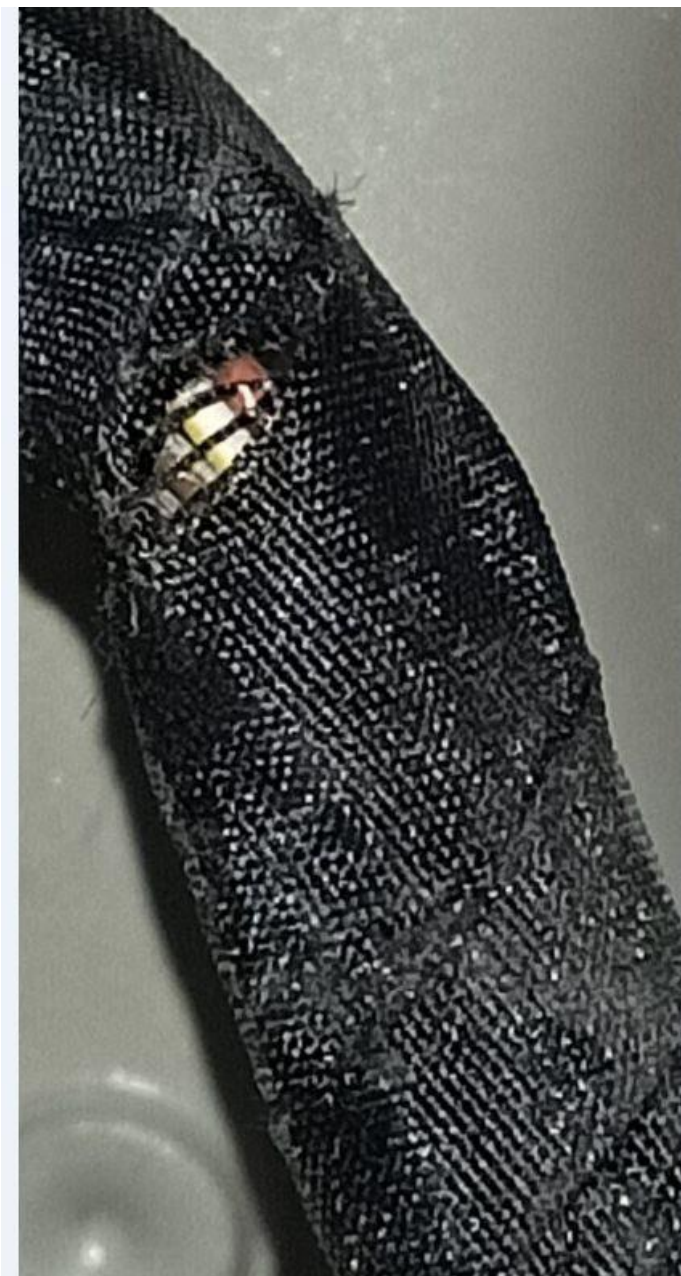
- Broken wires
- Kinked wiring
- Pin/s missing
- Pin/s broken
- Pin/s loose

NOTE: Refer to the example shown in Figure 1 of a damaged wiring harness

2) Repair any broken or damaged wires as per Rep.Gr 97
