## Technical product information

| <b>Topic</b> | New Continental GT / GTC and New Flying Spur - Exhaust Flap - Diagnostic Trouble Code |
| <b>Transaction No.</b> | 2060432/3 |

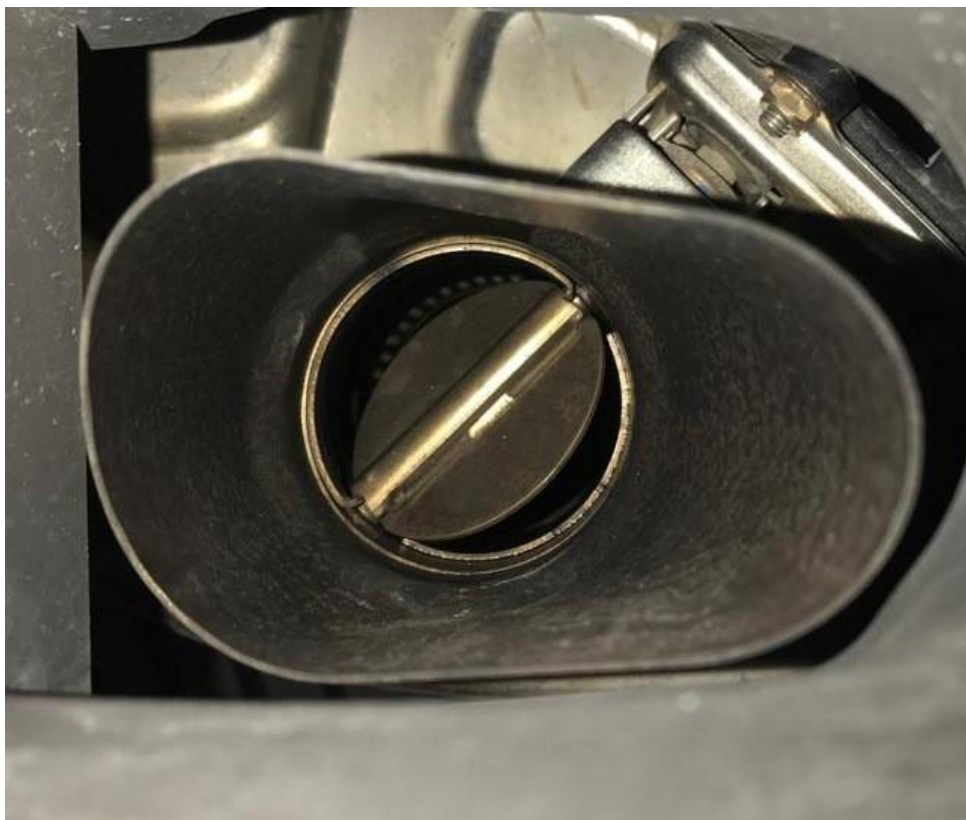
Figure 1.

If an Exhaust Flap is stuck in an open, closed, partially closed position or does not achieve a full range of motion continue to follow the instructions within this Technical Product Information (TPI) document—figure 1.

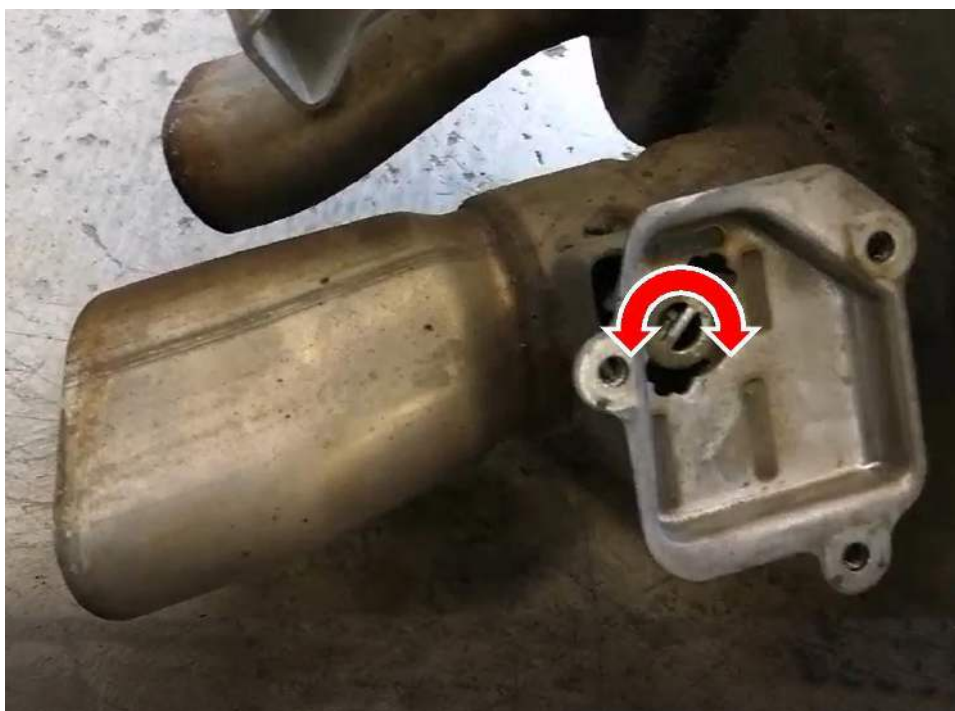
Check and confirm the Exhaust Flap spindle is free to open and close by hand - Figure 2.

If no issue is evident and the Exhaust Flap oscillates freely by hand - replace the defective Exhaust Flap Control Unit, refer to *Repair Group. 26 Exhaust system – Exhaust flap control units (J883, 945) – To remove and fit.*
